The Pennsylvania State University

**DESCRIBING DAMAGE TO STREAM MODIFICATION PROJECTS**

A Thesis in

Civil Engineering

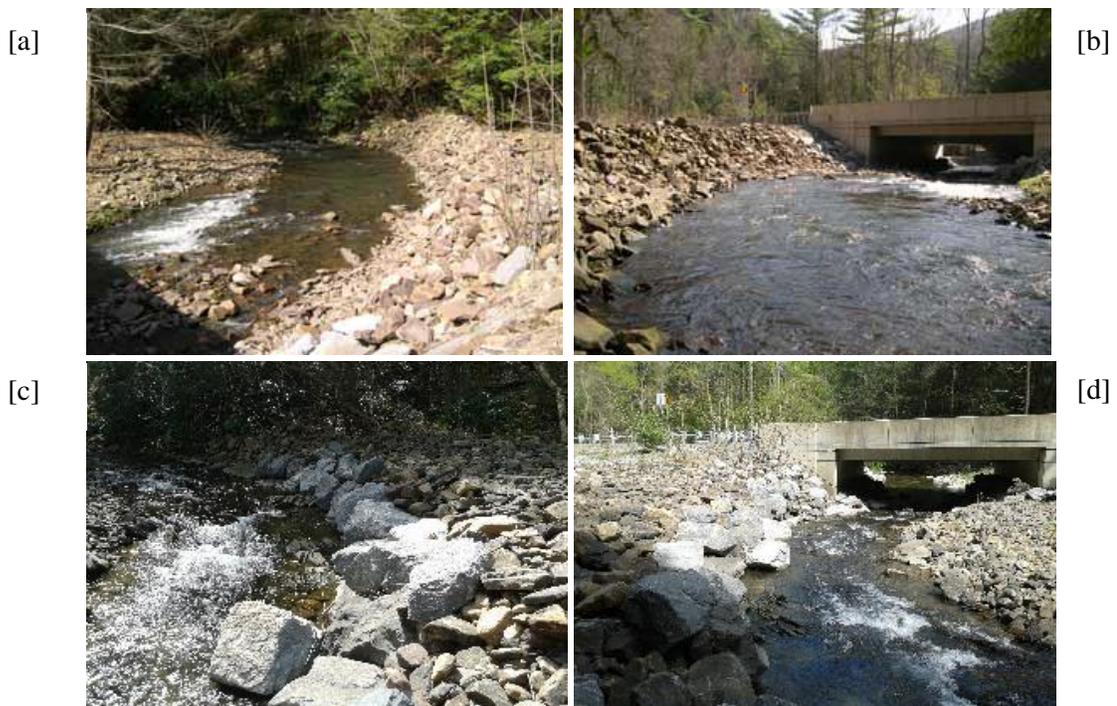
70° angle riprap wall with a median size of 152-229mm (Figure 4-2, [a, b]) (Johnson, 2006). The project was evaluated in 2006 and it was determined that this riprap was undersized and failure was evident from the stone deposited in the channel (Johnson, 2006). Following a large flow event and further damage to the riprap along the left bank (LB), repair work was performed using stone up to 1.2 m in size (Figure 4-2 [c]) and the channel along the right bank (RB) upstream of the bridge was shaped with an elevated floodplain in channel (Figure 4-2 [d]).

Figure 4-2: [a] and [b] Original riprap placed in 2000, images from FHWA report (Johnson, 2006). [c] and [d] Photographs of repair work taken during 2013 damage evaluation. [a] and [c] are taken looking upstream from bridge and [b] and [d] are taken looking downstream at bridge.

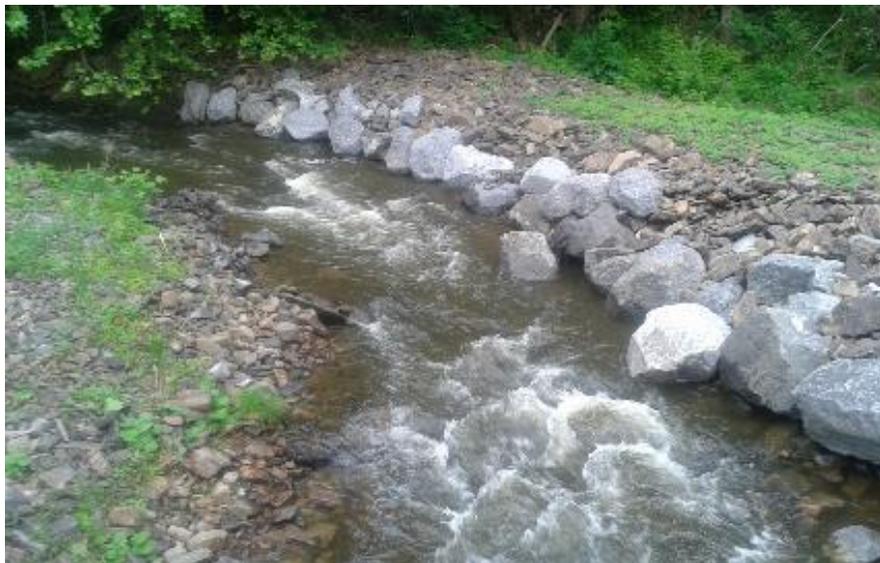
There were no instances of bank failures or raw banks within the project reach. Since the left bank is entirely protected by the riprap structure, damage to bank stability would only be possible after components were detached from the bank. Few components were displaced and there was no evidence observed of bank erosion behind these displaced components. The gravel bar shows no sign of erosion or instability and the right bank above the gravel bar appeared stable and vegetated.

Figure 4-3: Riprap on the left bank, photograph looking upstream from bridge.

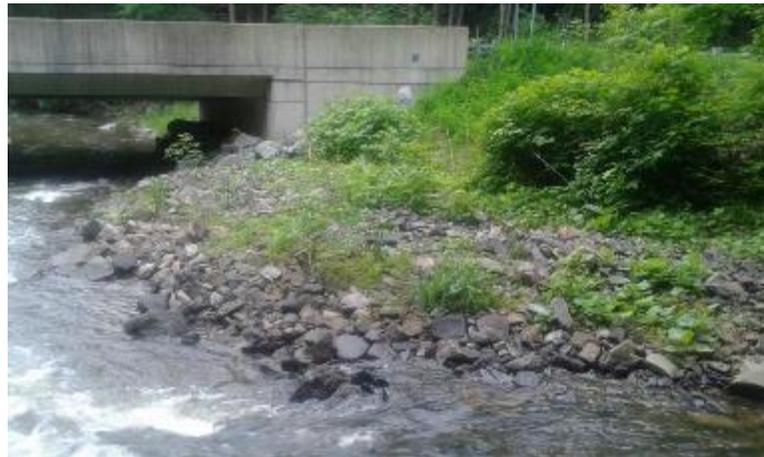
The waterway adequacy was evaluated in the 2012 DOT bridge inspection and the roadway approaches were given a slight chance of overtopping but the bridge deck was not (FHWA, 2012). There were no unstable, unintended obstructions in the channel present during the damage evaluation. The displaced riprap components were minor obstructions but showed no signs of being unstable and are not likely to impact the flooding limits. The gravel bar is an intended obstruction that affects the majority of the project reach; the project design purposefully left an elevated floodplain in the channel approximately 0.15m above the channel bed. Growth of intentional obstructions is only considered damage if the structure unintentionally increases the flood hazard. Significant growth of this gravel bar could endanger the infrastructure onsite and lead to further damage. While it appears that the bar has grown in height from as-built conditions, there is no evidence that the flood hazard has definitely increased. As intended in the design, the bar is low enough to be inundated in high flow conditions (Figure 4-4).

Figure 4-4: Elevated floodplain structure, photograph taken looking downstream.

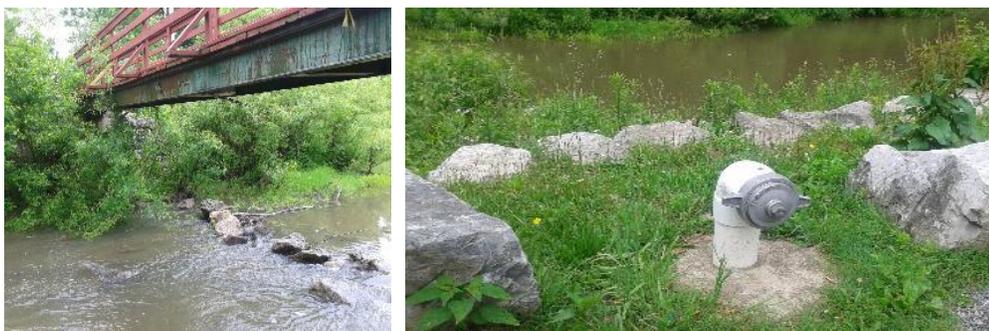
Figure 4-7: Undamaged infrastructure near Bald Eagle Creek. The right bank of the pedestrian bridge (left) and the hydrant between dirt parking area and the stream channel (right).

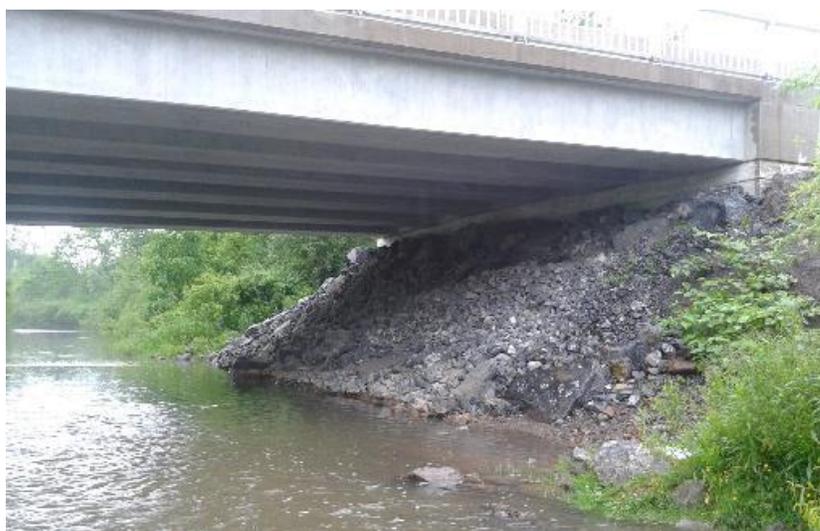
The bridge inspection record from 2011 reported that the bridge was built in 1930 and while the maintenance record is not known, an evaluation of the bridge prior to replacement described the bridge site as “low” vulnerability due to an otherwise stable channel, good waterway adequacy, and no scour (Johnson and Whittington, 2011).

Figure 4-8: Embankment of SR-3017 bridge from June, 2013. Bridge was replaced in 2011.

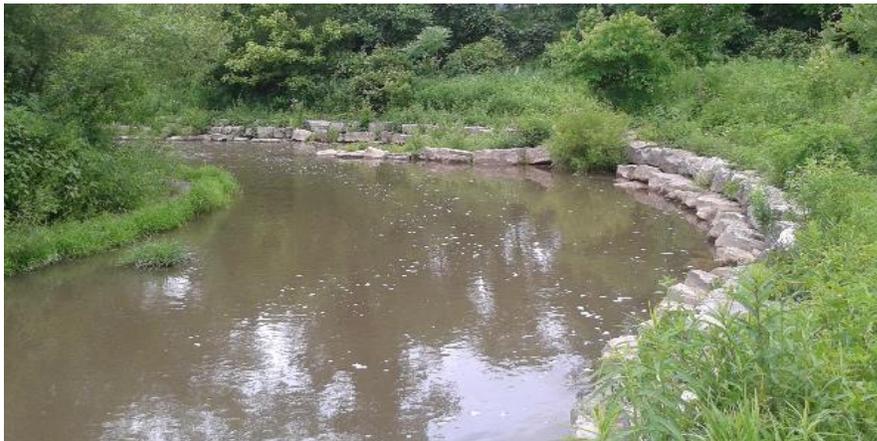
Within the reach, there are two imbricated riprap walls and six J-hooks. The locations of the six J-Hooks in the project reach are indicated in Figure 4-6 and will be discussed in order from upstream to downstream. The outside of the first meander bend, the left bank (LB) of the channel following the pedestrian bridge, is lined with imbricated riprap. The first J-Hook comes out of the imbricated riprap wall at the apex of this meander. The large rocks in both the imbricated riprap and the J-Hook may have slightly shifted but no components are displaced (Figure 4-9). At the end of the riprap wall, there is a short straight section with a completely submerged but otherwise undamaged J-Hook.

Figure 4-9: Looking upstream at imbricated riprap wall on the left bank of the channel and the first J-Hook.

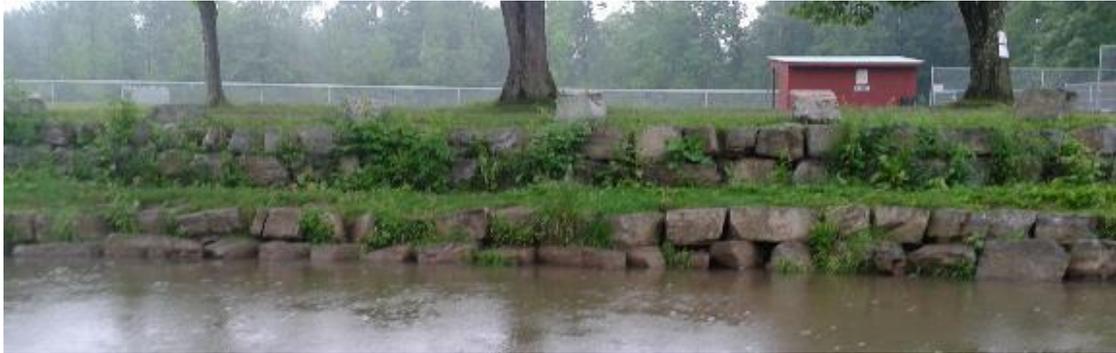
Continuing downstream, the channel is near the dirt road, parking area, and hydrant which are protected by a two-tiered imbricated riprap wall on the right bank (RB) of the channel (Figure 4-10). While some components have shifted and settled, there is no evidence of erosion and no components are displaced from this riprap wall.

Figure 4-10: Two-tiered imbricated riprap on the right bank.

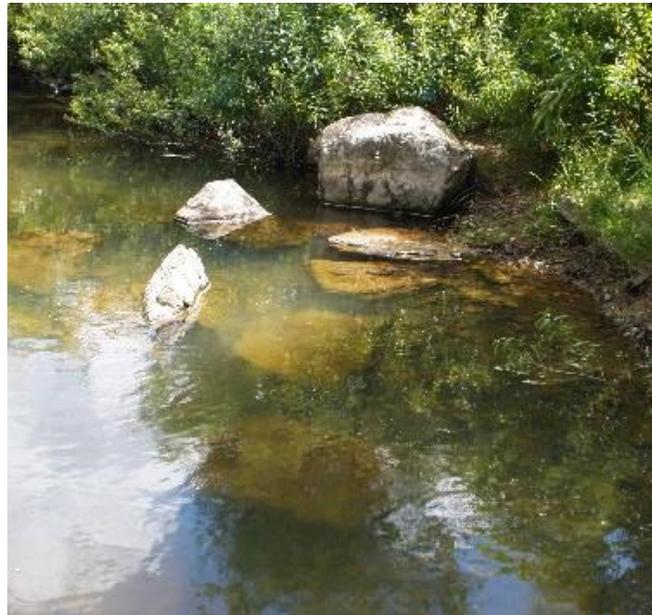
Figure 4-11: The extensively damaged fourth J-Hook with displaced components and partial detachment from the bank.

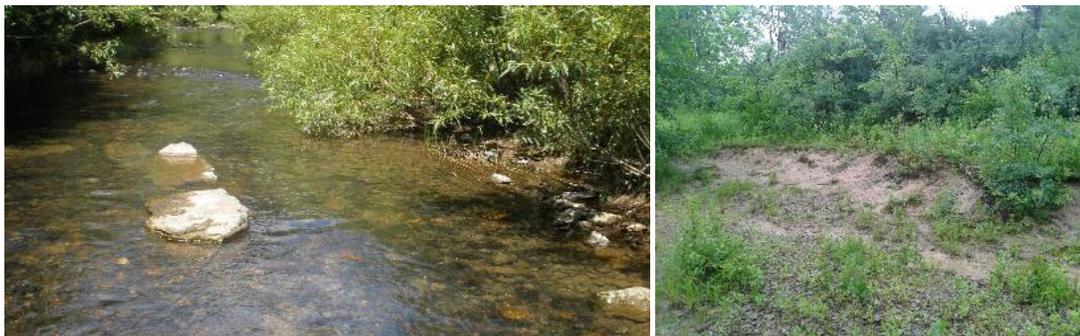
There were no instances of recent bank failure and few reaches of raw banks evident in the reach during the damage assessment of June, 2013. Dense vegetation obscures the streambanks along much of the channel reach. However, there is evidence that the channel is migrating from as-built conditions and that bank erosion has occurred or is occurring in a few areas on the left bank within the project reach. There is a stretch of short, raw banks between the fourth and fifth J-Hook structures. In this region, channel flow has detached one of the channel-spanning, unintended obstructions from the left bank and the left bank upstream of the fifth J-hook is recessed from the bank adjacent to the structure arm. More extensive damage is evident near the sixth J-Hook structure. The arm of this J-Hook that ties in to the right bank is buried while the other end of the structure is in the middle of the channel (Figure 4-12). Since J-Hook structures are intended to span the channel cross section, the channel has evidently migrated from as-built conditions. Further evidence of this migration is visible in a large area of terrace erosion on the left bank of the last meander before the SR 3017 bridge. This eroding area is visible in the aerial image of the project reach in Figure 4-6.

Figure 4-12: Looking upstream at the fifth J-Hook (left) that ends in the middle of the channel. Terrace erosion on left bank (right) across from fifth J-Hook.

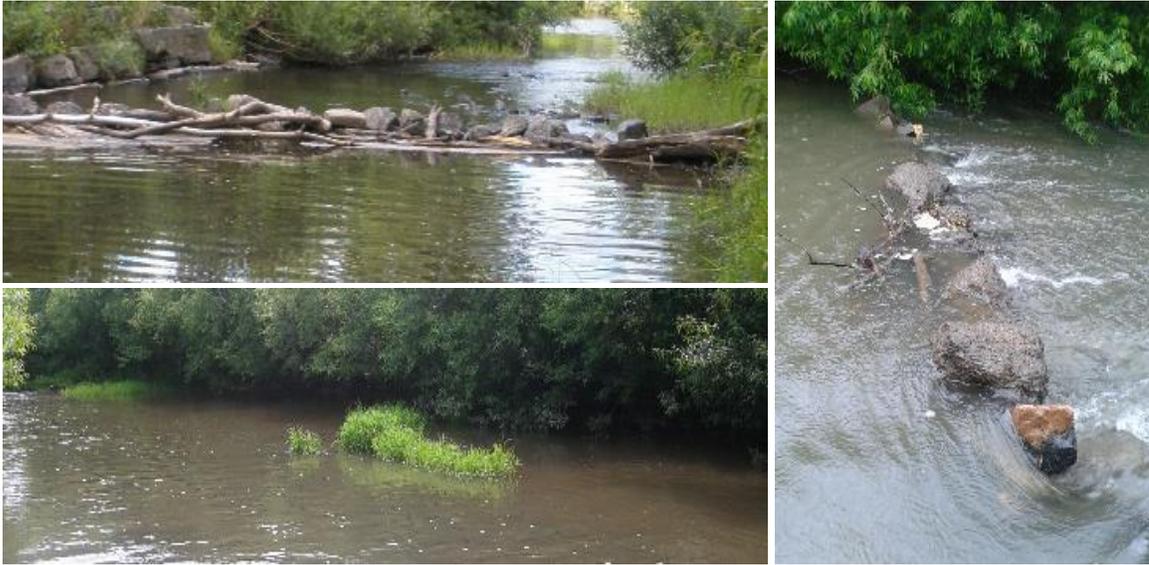
Unintended obstructions within the project reach consisted of bars within the channel and four unidentified channel-spanning structures that were man-made, but not part of the stream modification plan (Figure 4-13). These man-made unintended obstructions affect flow within the channel; the structure upstream from the fifth J-hook has deflected flow toward the bank. These obstructions have also accumulated some debris and have contributed to observed deposition throughout the reach. Channel bars were vegetated and only one of the channel bars, upstream of the SR 3017 bridge, was significantly affecting channel flow (Figure 4-14). Unintended obstructions are moderately frequent within the reach.

Figure 4-13: Unintended obstructions in the channel.

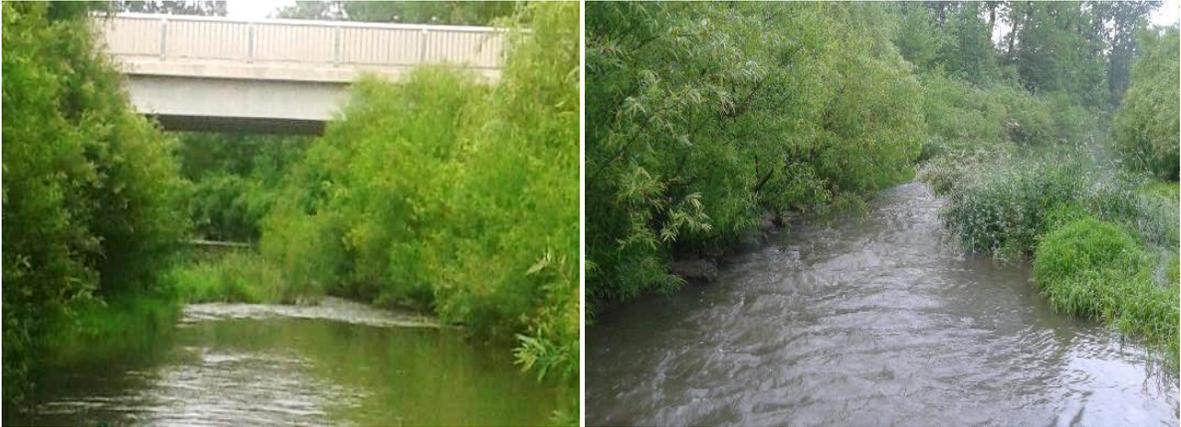
The frequency of unintended obstructions and extents of sediment deposition throughout the project reach have extensively damaged the Bald Eagle Creek stream modification project in the category of *wood, sediment, and debris transport*. One of the two volunteers that evaluated this project for damage determined that the project was completely damaged in this category of damage. This can likely be attributed to expectations and impressions of damage. The bed is not homogeneous and without As-built plan sets, there is no evidence that pools have filled in or that the majority of the reach. Also without As-built plan sets, determining whether more than 80% of the bed within the project reach has been affected is an impression of conditions onsite. The disagreement could also be due to the distinction between moderately frequent and frequent unintended obstructions. While there are more than a handful of unintended obstructions, there are significant stretches without unintended obstructions within the project reach.

Figure 4-14: Channel bar constricting flow within the channel immediately upstream of SR 3017 bridge. Left picture is taken looking downstream at bridge and the right picture is taken looking upstream from the bridge.

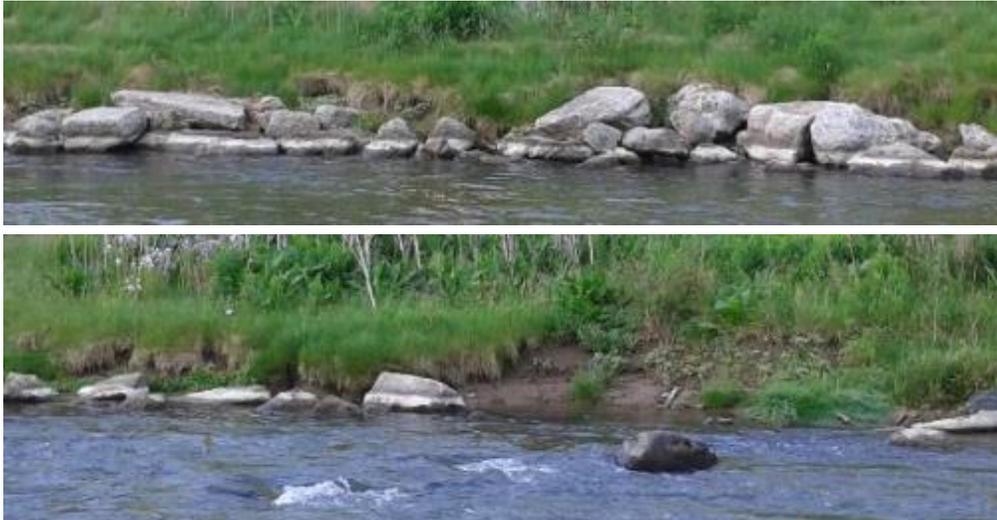
evident scour above and behind all components with some either completely detached from the bank or partially detached (Figure 4-18).

Figure 4-18: One stretch of boulder revetment along the left bank. Mild to extensive scour has detached components from the bank and some components have been displaced.

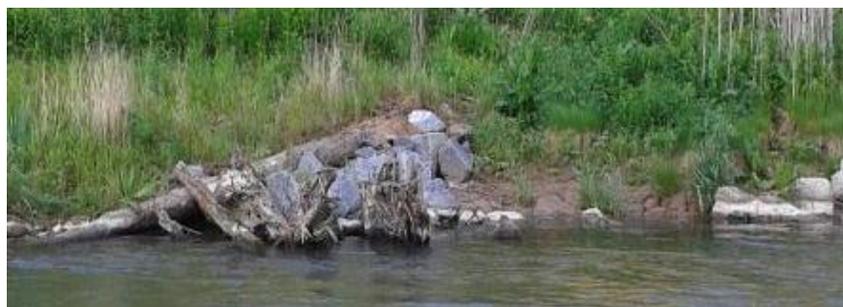
Eight rootwad-log vanes were installed along the left bank of the channel. The rootwad component of one rootwad-log vane structure was been displaced, extensively damaging the structure. Two other rootwad-log vanes were moderately damaged due to scour surrounding the entire contact area between the structure and the bank that exposed the top of the structure as depicted in Figure 4-19.

Figure 4-19: Moderately damaged rootwad-log vane.

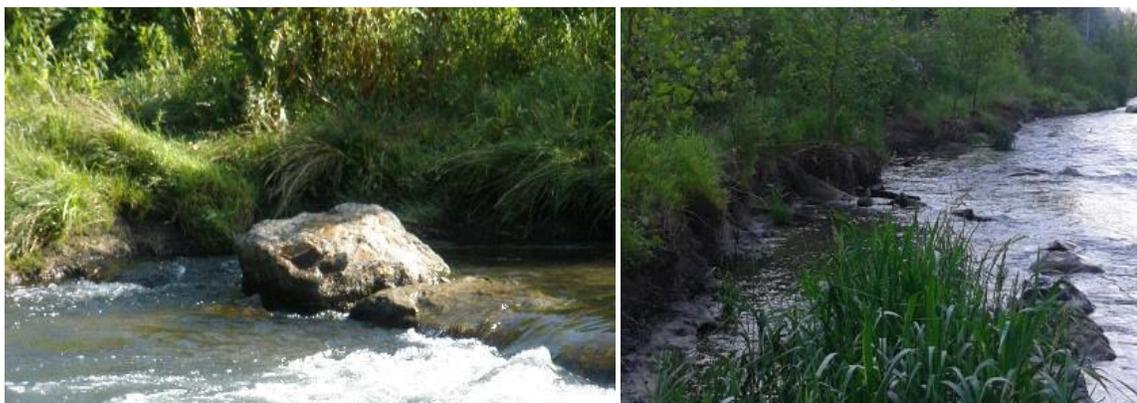
There were eight rock vanes within the project reach, five of which are located at the downstream end of the reach. These five rock vanes exhibited some scour; the scour around two of these structures was sufficient to indicate moderate damage. Additionally, two of these rock vanes appeared distinctly shorter than other structures in the reach. It is possible structure components on these two vanes were displaced but without as As-built plan set, this could not be verified. The remaining three rock vanes were completely or partially detached from the bank. Figure 4-20 shows one of these rock vanes and the stretch of riprap detached from the bank.

Figure 4-20: Structures detached from the right bank. One of two rock vanes completely detached from the right bank (left) and the detached stretch of riprap (right; visible on the right edge of the right photograph).

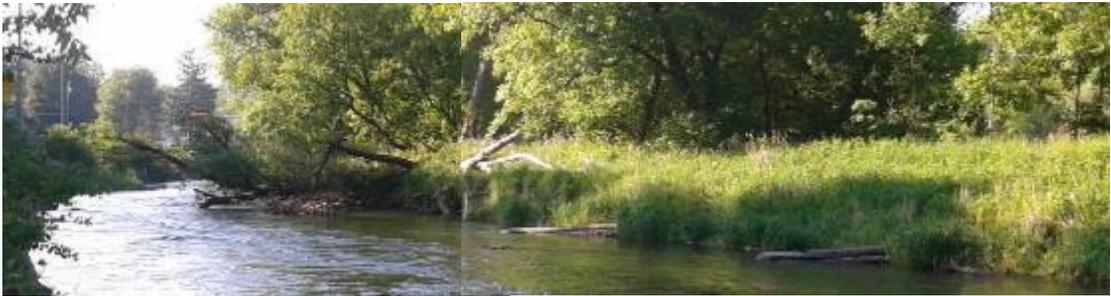
Figure 4-21: Obstruction upstream of project reach and undamaged log vane structures.

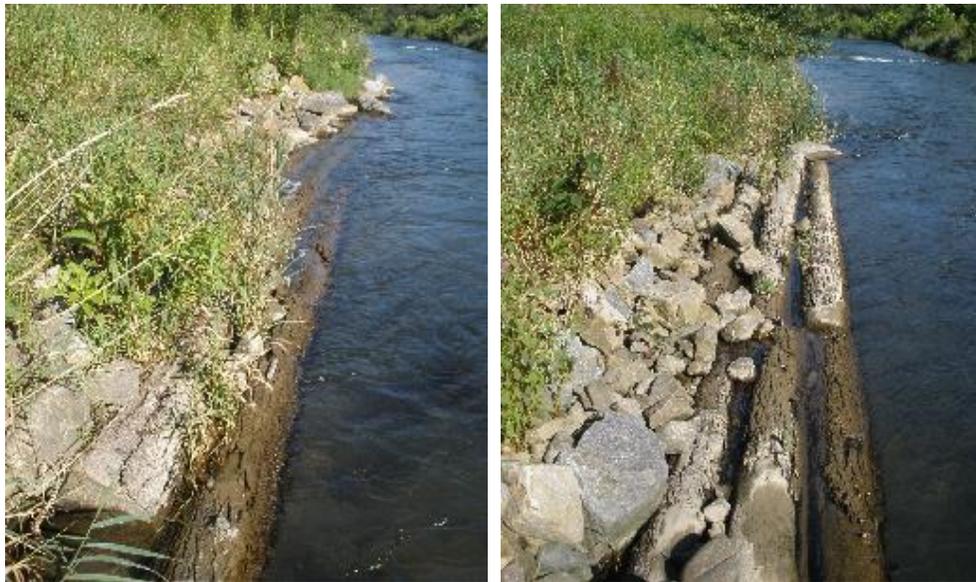
Figure 4-22: Damaged lunker structures. Second half of upstream lunker has fallen in (left); the rock cover on the downstream lunker has washed away (right).

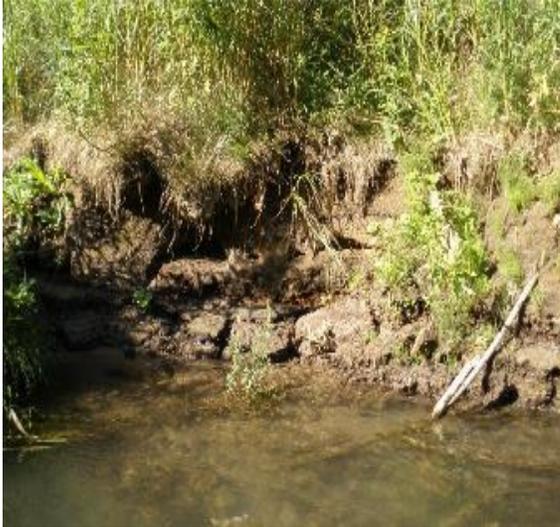
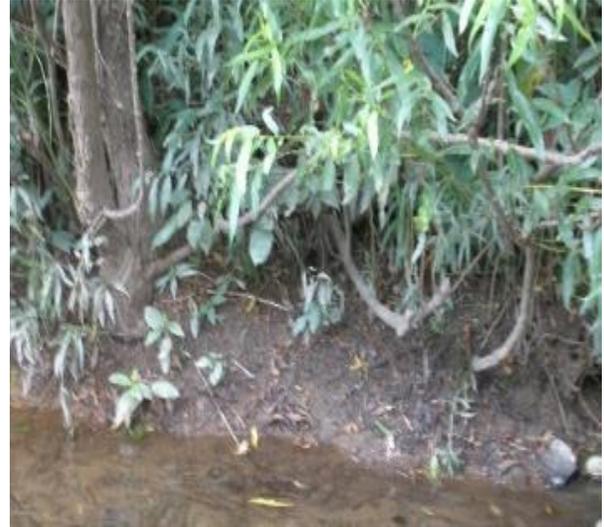
Raw banks were present at both the Spring Creek case study (left) and Bald Eagle Creek case study (right). Raw banks, or cut banks, are vertical, non-vegetated surfaces that have undergone recent erosion.

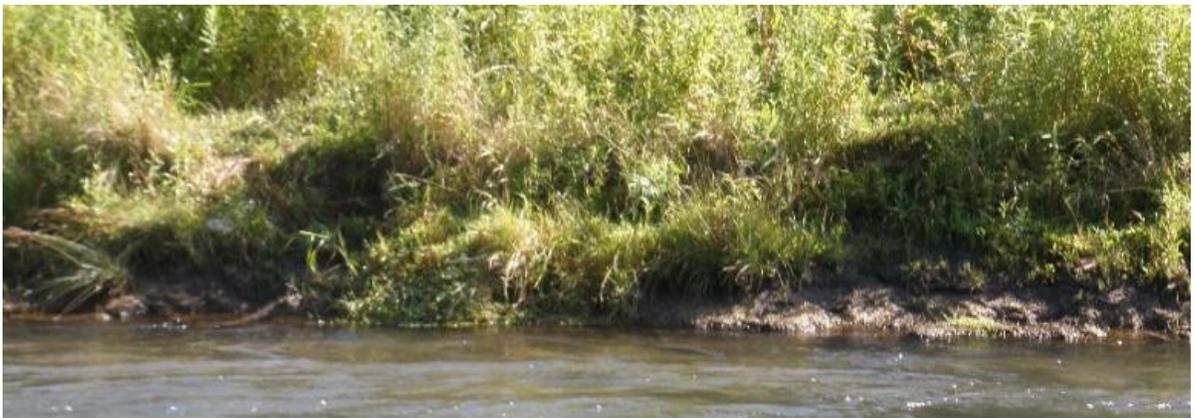
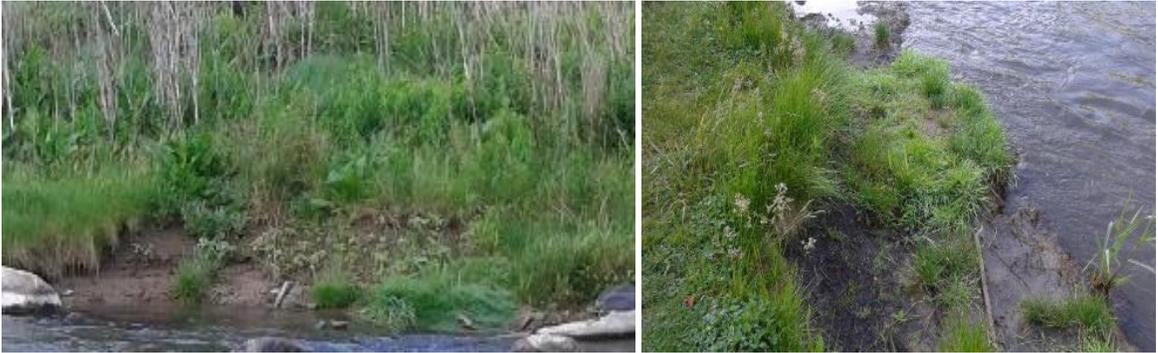
Bank failures include instances of mass wasting, block failures, and severe undercutting. There were no instances of severe undercutting at the case study sites. There was evidence of block failures and mass wasting at the Spring Creek site.

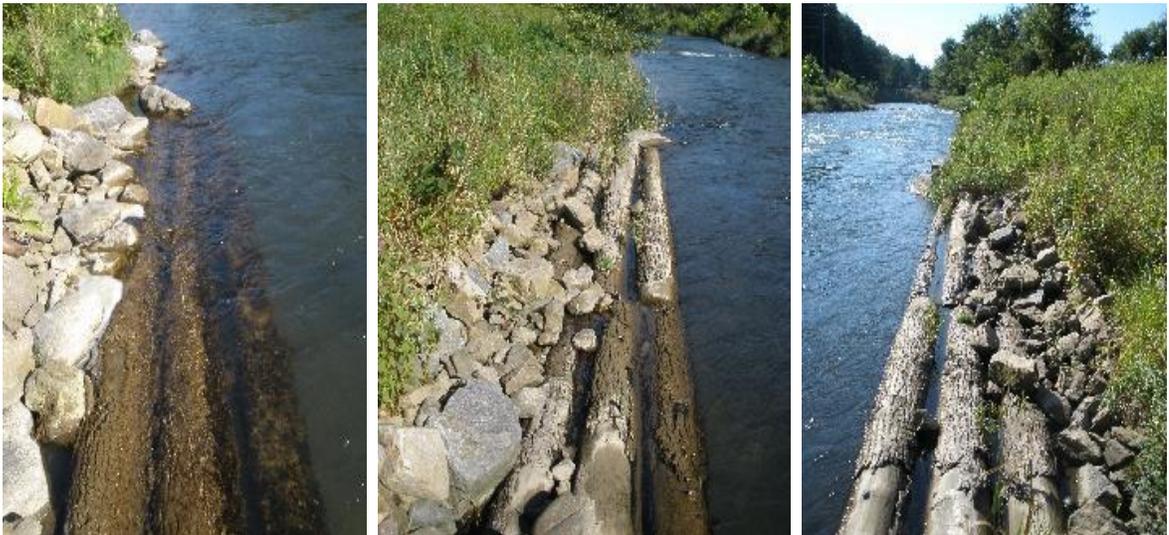
The following images are of the lunkers (aka mud sills) installed on Spring Creek. Usually, the logs are underneath rock and earth, hiding the lunkers from sight. These lunkers are damaged due to displacement of structure components. The lunker on the left that is sinking has experienced more displacement and is extensively damaged while the other (two photos on the right) is only moderately damaged.

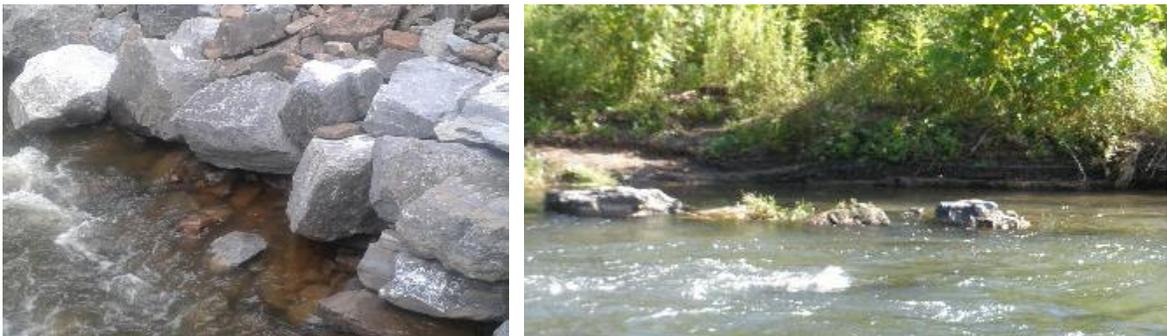
The following images depict a displaced footer rock at the Roaring Run case study, left, and detached portion of riprap at the Spring Creek case study, right. The riprap shown on the right in Spring Creek is the upstream extent of the structure which extends significantly downstream, out of the photograph. This structure is partially detached and extensively damaged. Also, since the structure is detached from the bank, the raw banks visible in this photo count contribute toward damage in the *bank stability and migration* category of damage.

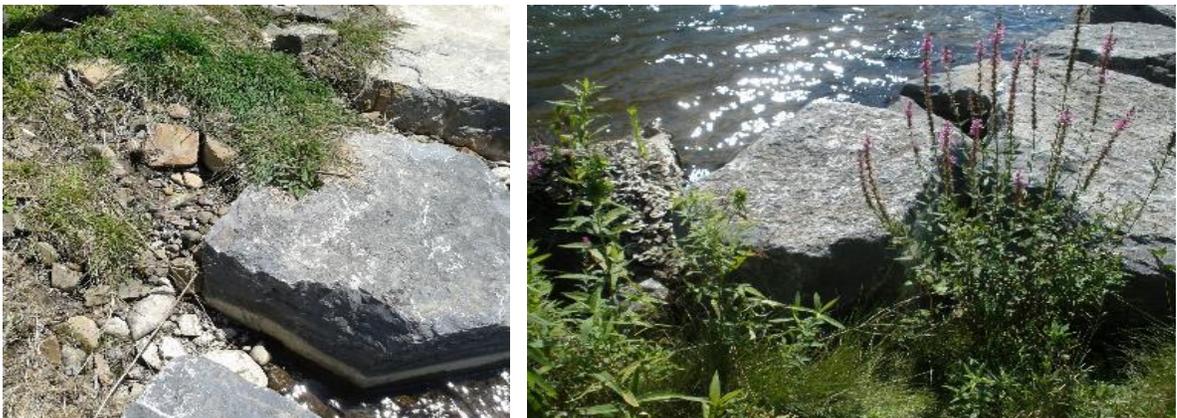
One of these rock cross vanes exhibited scour surrounding structure components on both banks and was therefore moderately damaged. The following images depict scour surrounding the bank tie-in components that led to the evaluation of structure damage. The components shown on the right are the end of the structure arm and intended to be buried or flush with the ground.

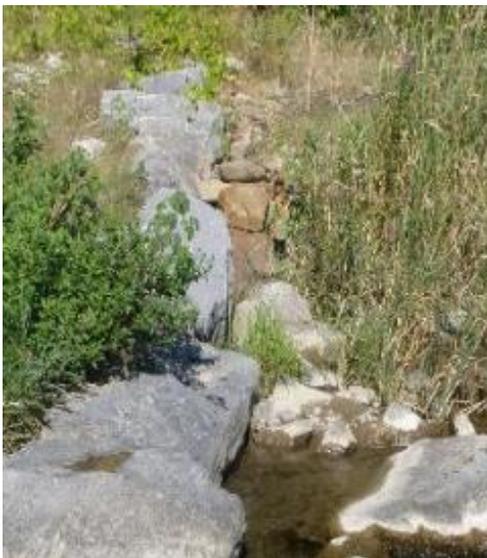
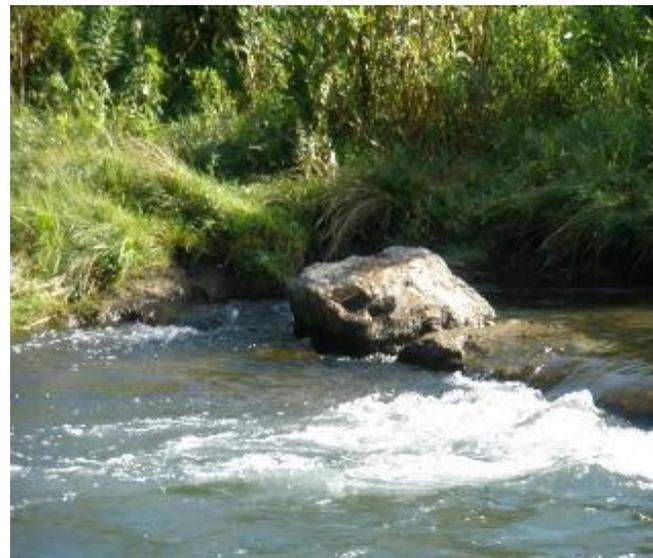
Rock vanes on Spring Creek did not experience component displacement, although without As-built plans it would be difficult to determine whether the end of the structure is intact. Moderately damaged rock vanes experienced scour everywhere the structure was in contact with the bank (left). There were two rock vanes that were completely detached from the bank and therefore completely damaged (right). This structure is completely detached from the bank and the raw banks visible in this photo count contribute to damage in the *bank stability and migration* category of damage.
