The Pennsylvania State University

**MECHANICAL RESPONSE OF OUT-OF-AUTOCLAVE COMPLEX FIBER  
ARCHITECTURE COMPOSITES FOR MARINE STRUCTURES**

A Thesis in

Master of Science

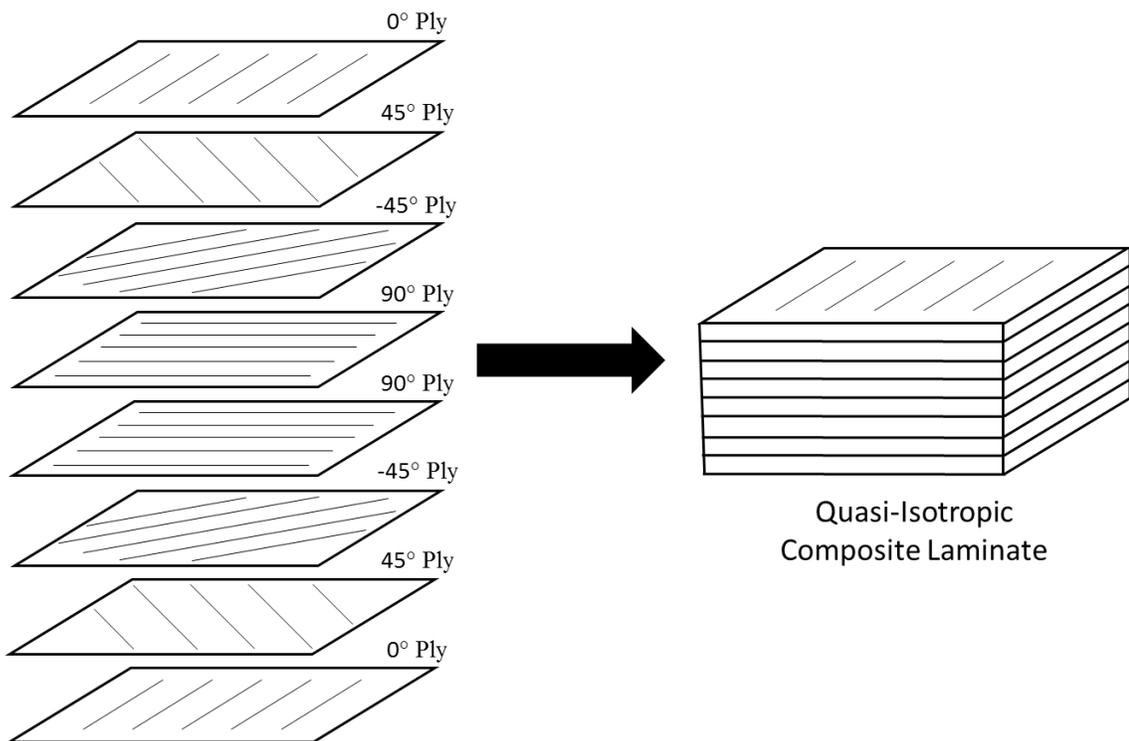
Figure 2-3. Illustration of quasi-isotropic composite laminate stacking sequence

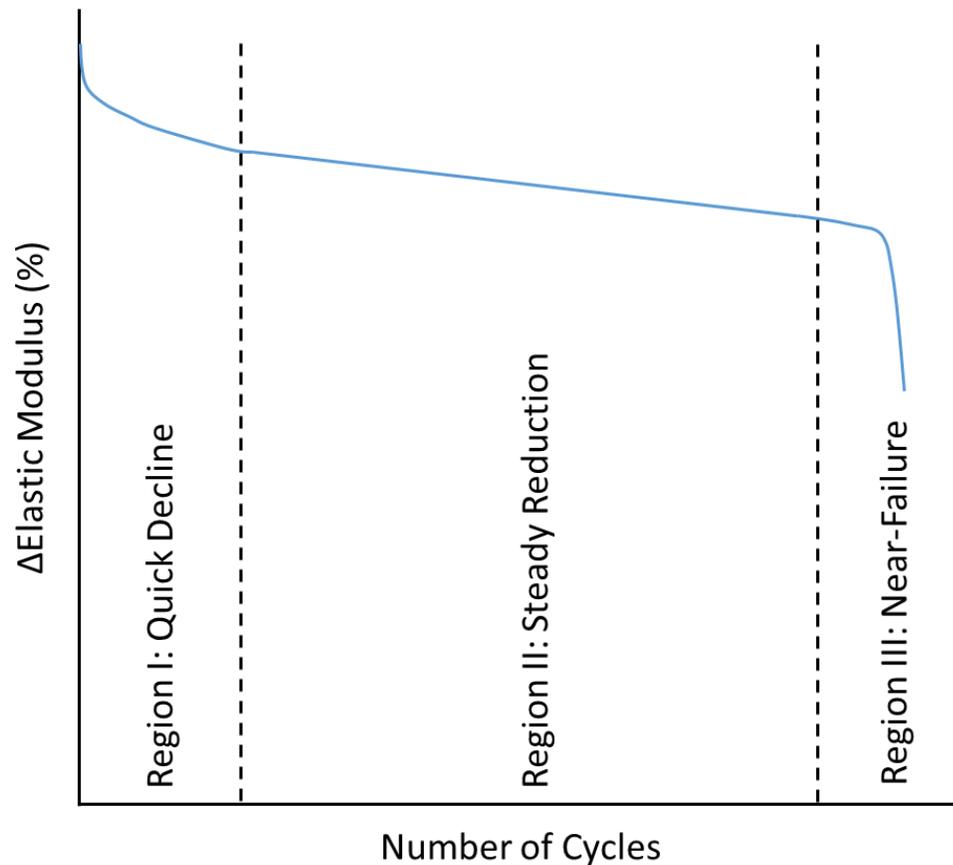
Figure 2-4. General shape of elastic modulus loss throughout an  $R=0.1$  tension-tension fatigue test using finite element models of quasi-isotropic glass/epoxy laminates (based on Kennedy, 2013)

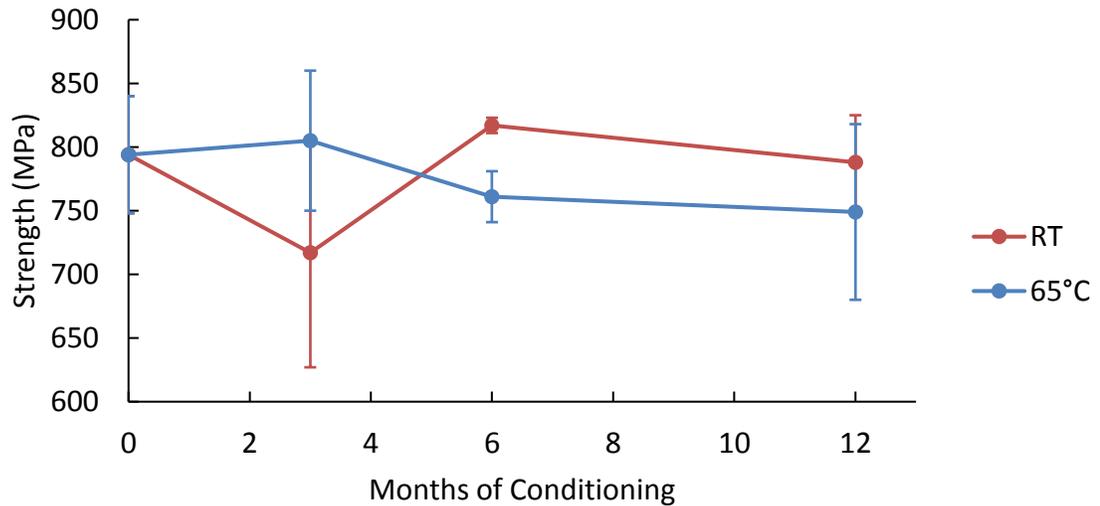
Figure 2-5: Plot of tensile strength vs. conditioning time in Arabian Gulf seawater of a unidirectional glass/epoxy composite (based on Mourad et al., 2010)

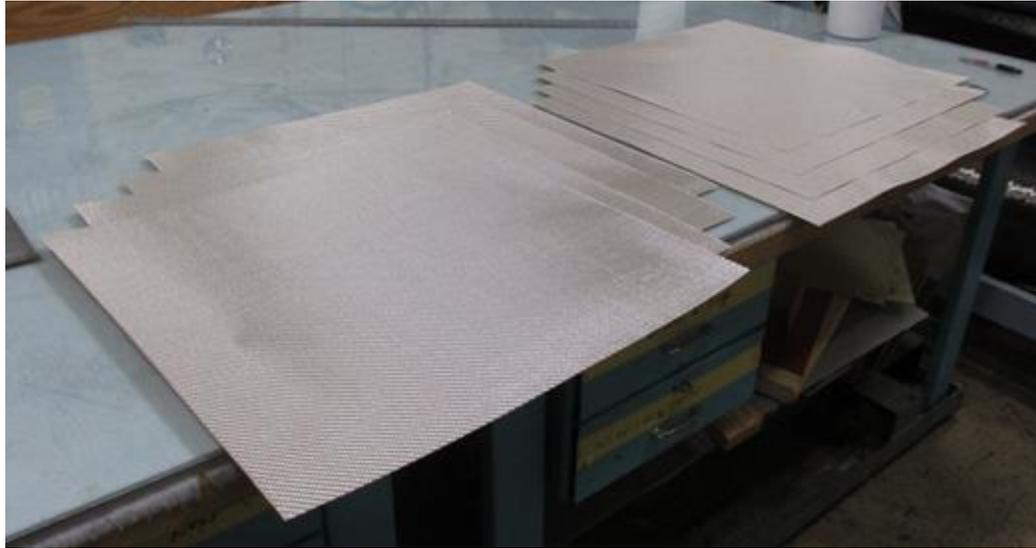
Figure 5-1. Four  $[0^\circ/90^\circ]$  and four  $[\pm 45^\circ]$  plies of WRE581T/ST94 twill weave prepreg awaiting hand layup

A quasi-isotropic layup was desired and thus the WRE581T/ST94 is cut into four [0°/90°] squares and four [±45°] squares. Each square was cut from the same roll using a common 24 in. x 24 in. aluminum plate as a guide. The aluminum plate was rotated 45° to cut the [±45°] squares. The squares are then laid up into a [0°/90°/±45°]<sub>2s</sub> laminate by creating two identical 8-ply stacks and flipping them over at the mid-plane to consolidate the full, 16-ply composite panel. It should be noted that there is an epoxy-epoxy bond at the mid-plane where back-to-back adhesion occurs. Figure 5-1 shows the prepreg sheets prior to layup.

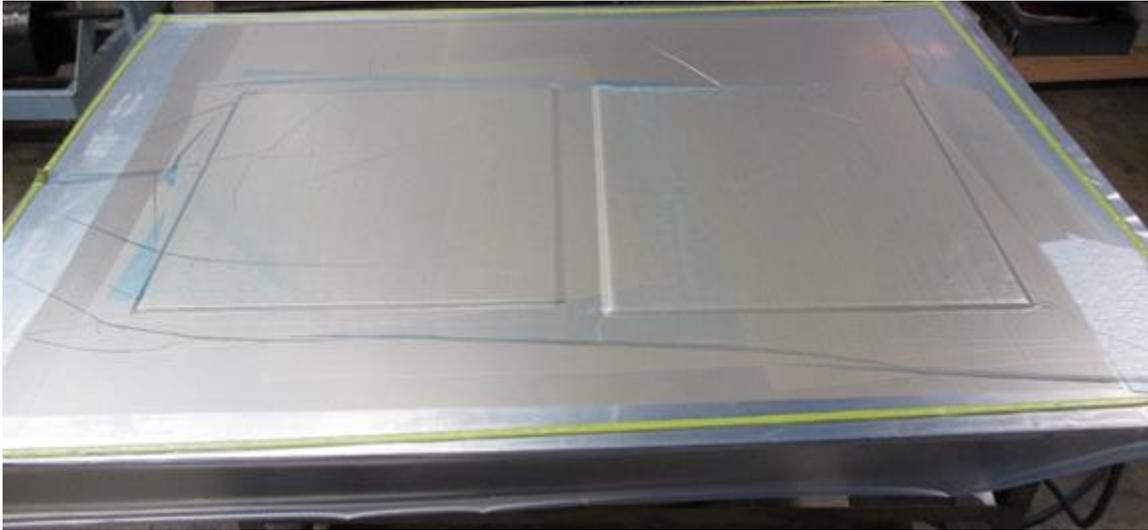
Figure 5-2. Woven and stitched laminates under vacuum bag before insertion into oven

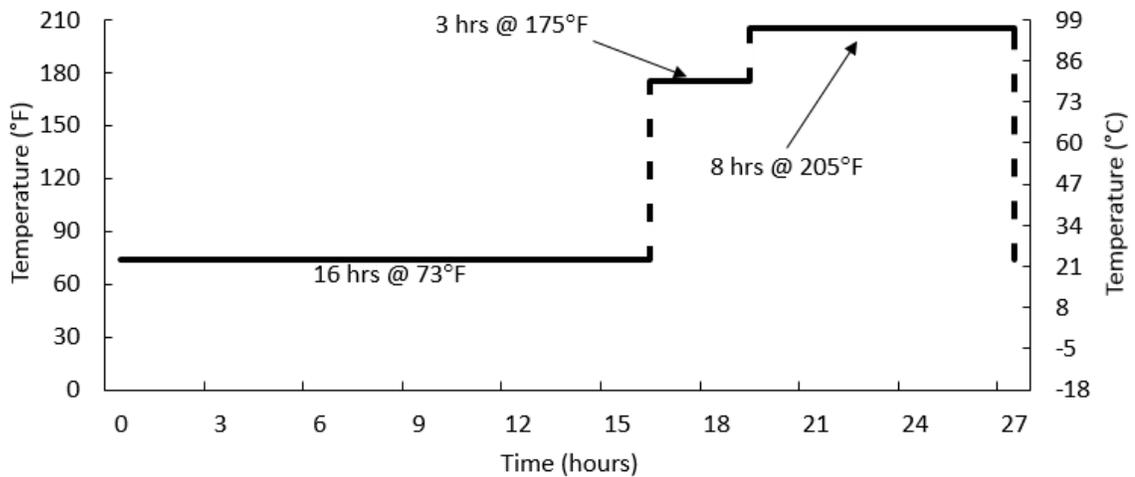
Figure 5-3. Diagram of oven curing cycle for WRE581T/ST94 and QE1203/ST94 panels

Once all leaks were mitigated, the tool was inserted into an oven with vacuum constantly being applied. The oven curing cycle is illustrated in Figure 5-3. Changes in temperature are denoted as dashed lines because the oven used did not have programmable ramp capabilities. After curing and cooling, the samples were de-bagged and sent to ARL's machine shop to be cut into dogbone samples.

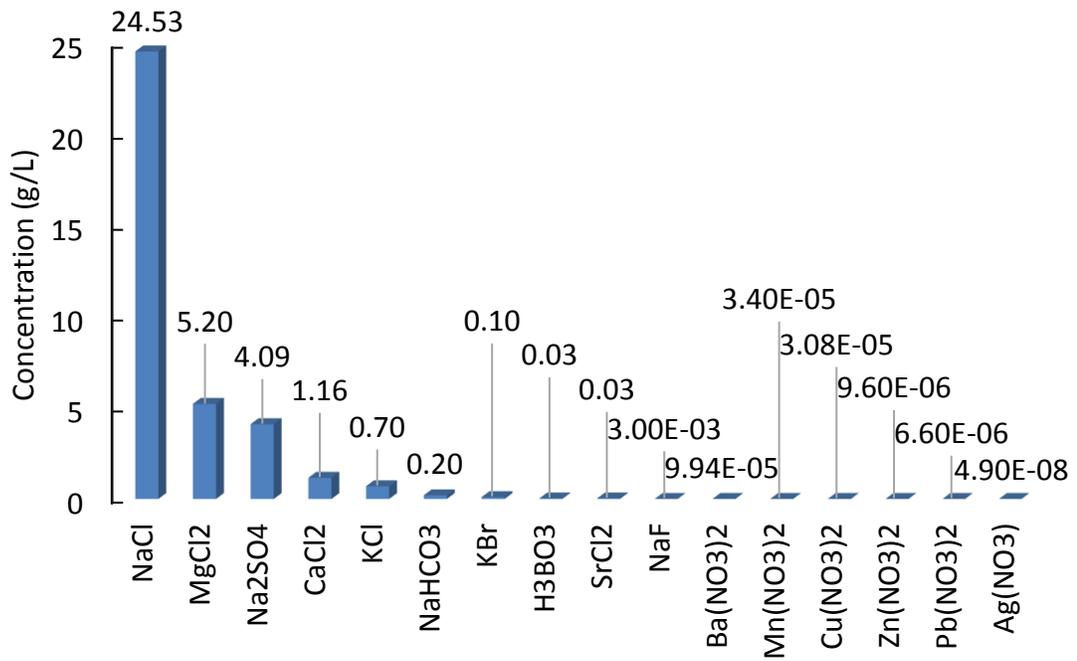
Figure 5-6. Bar chart depicting concentrations of compounds in ASTM D114 artificial seawater (ASTM, 2003)

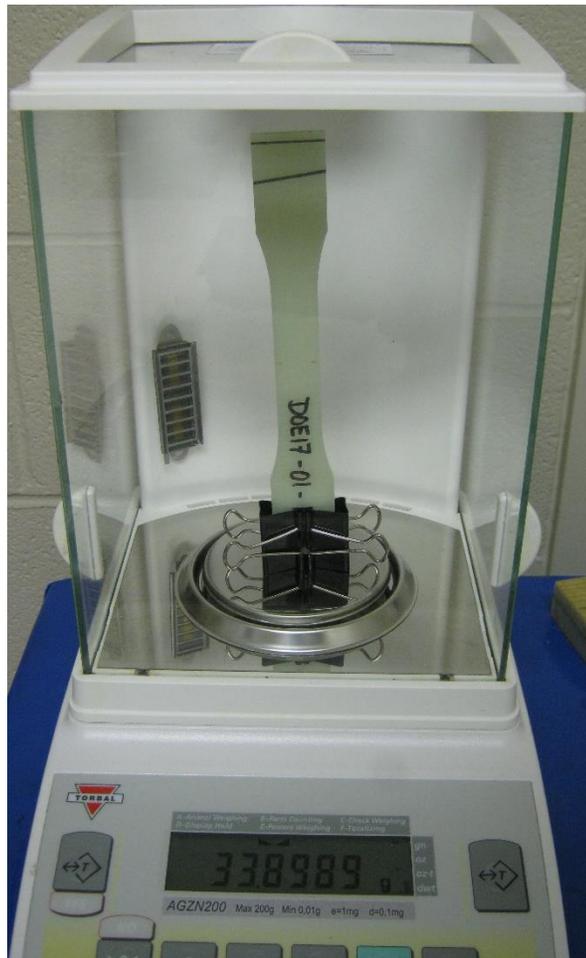
Figure 5-8. Dogbone specimen weight measurement procedure including binder clips

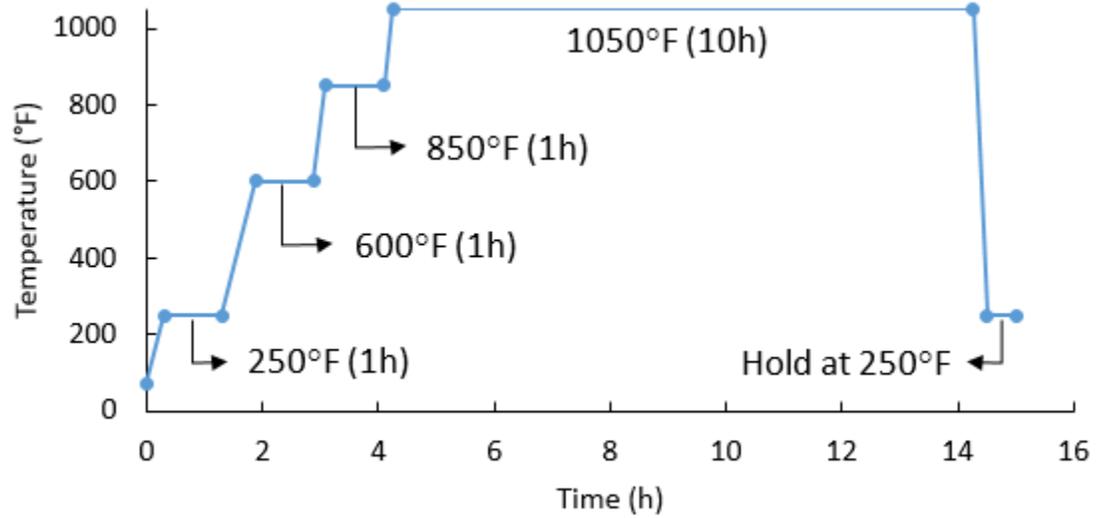
Figure 5-9. Burnoff heating procedure including times and temperatures of holds

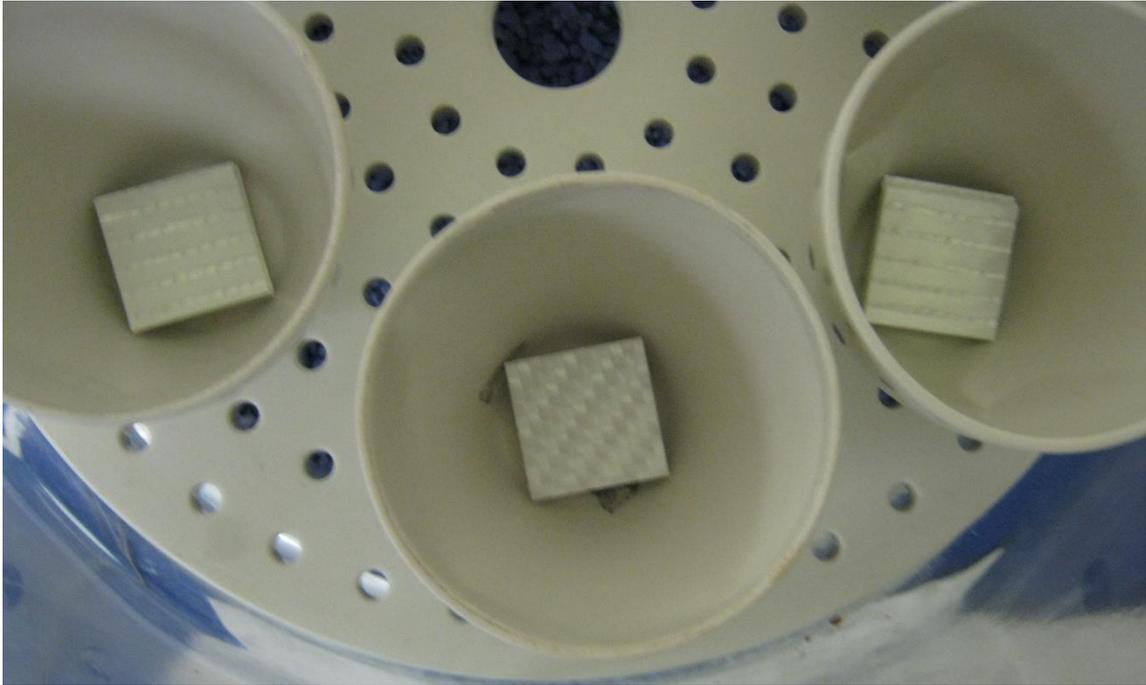
Figure 5-10. Remnants of burnoff procedure with woven sample (middle) and stitched samples (left & right)

lids were removed and each crucible was weighed again. After burnoff, only the tows of the E-glass fibers remained, as shown in Figure 5-10. Equations 9 through 13 list the calculations necessary to calculate fiber volume and void volume percentages.

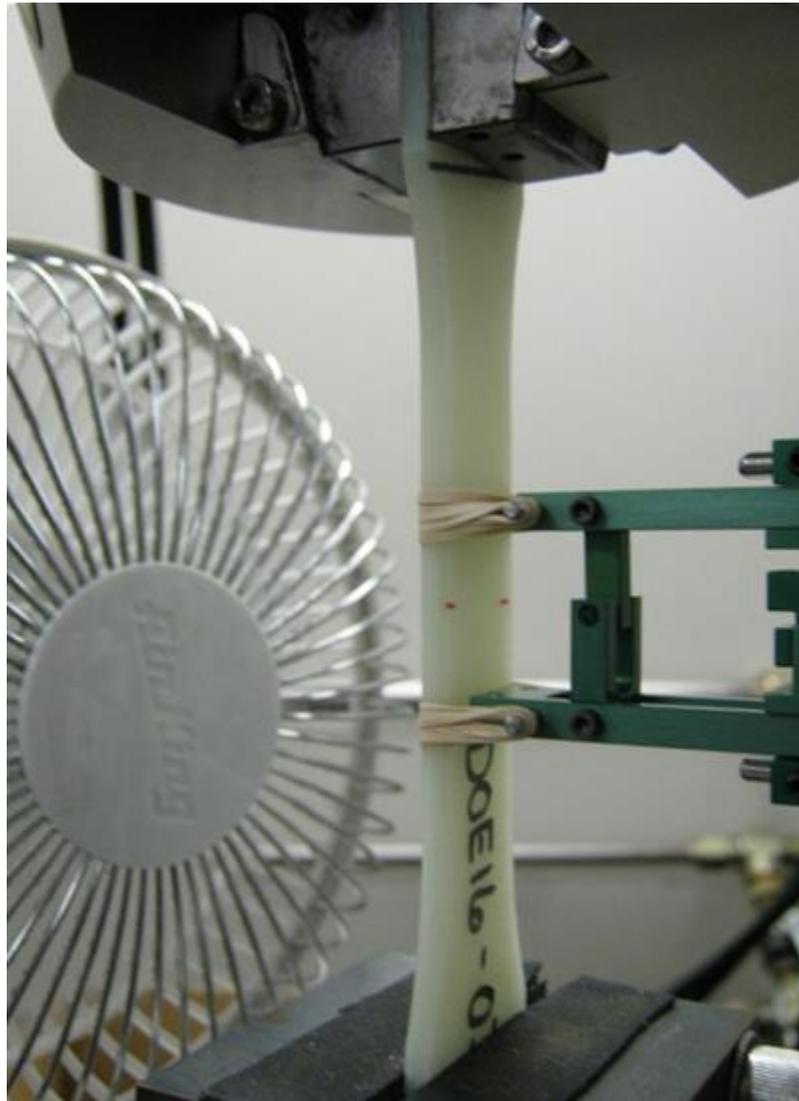
Figure 5-11. Hydraulic grip, specimen block, extensometer, and specimen during pre-fatigue modulus testing

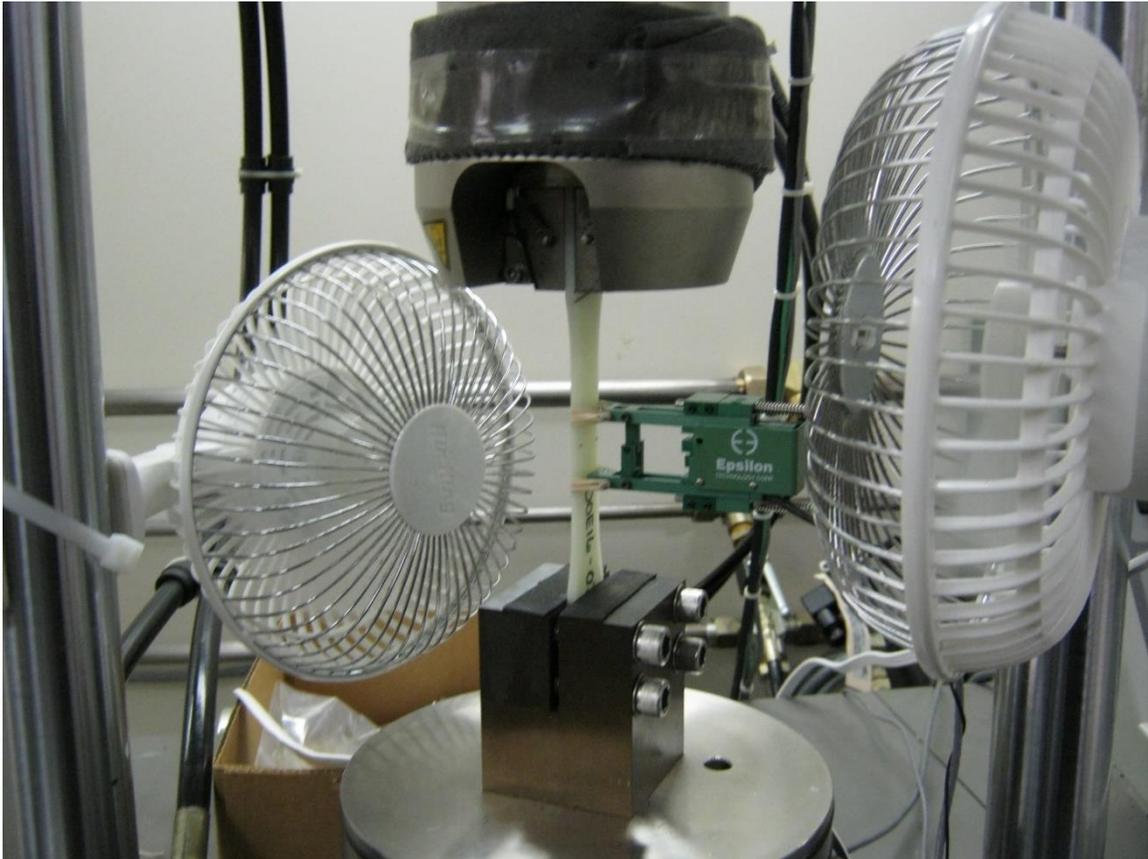
Figure 5-12. RTA T-T fatigue setup with hydraulic grips, extensometer, specimen, and cooling fans

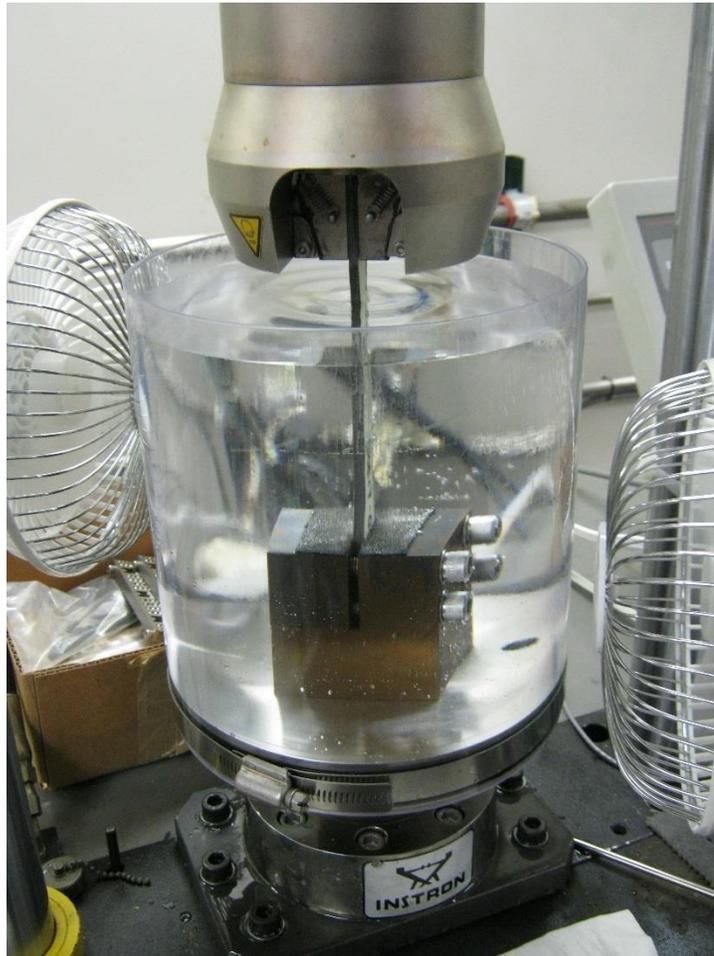
Figure 5-15. Full WET testing setup during fatigue loading including immersed specimen (viewed on edge), grips closed, hose clamp tightened, and cooling fans running

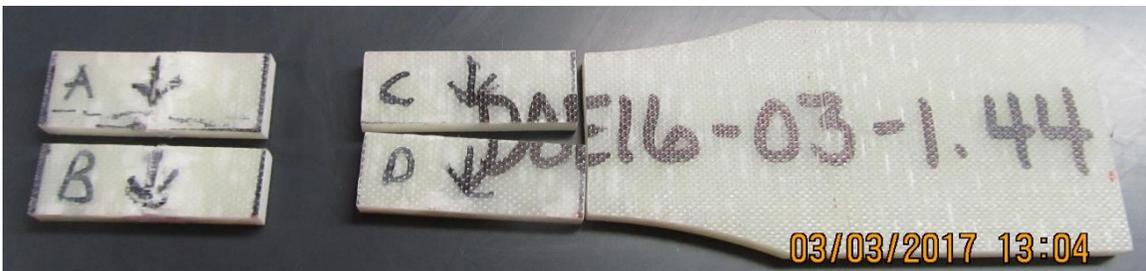
Figure 5-18. Longitudinal sections cut into four pieces.

For damaged specimens, four longitudinal sections were cut as shown in Figure 5-17 and Figure 5-18. Once separated into the four sections, two mid sections (A & C) and two edges (B & D) were polished to evaluate damage within the samples. These sections were between 0.25 in. to 0.5 in. away from the midpoint of the dogbone specimen (shown as a red dashed line) and the sections were 1 in. long so that they fit in the ARL polishing puck mold.

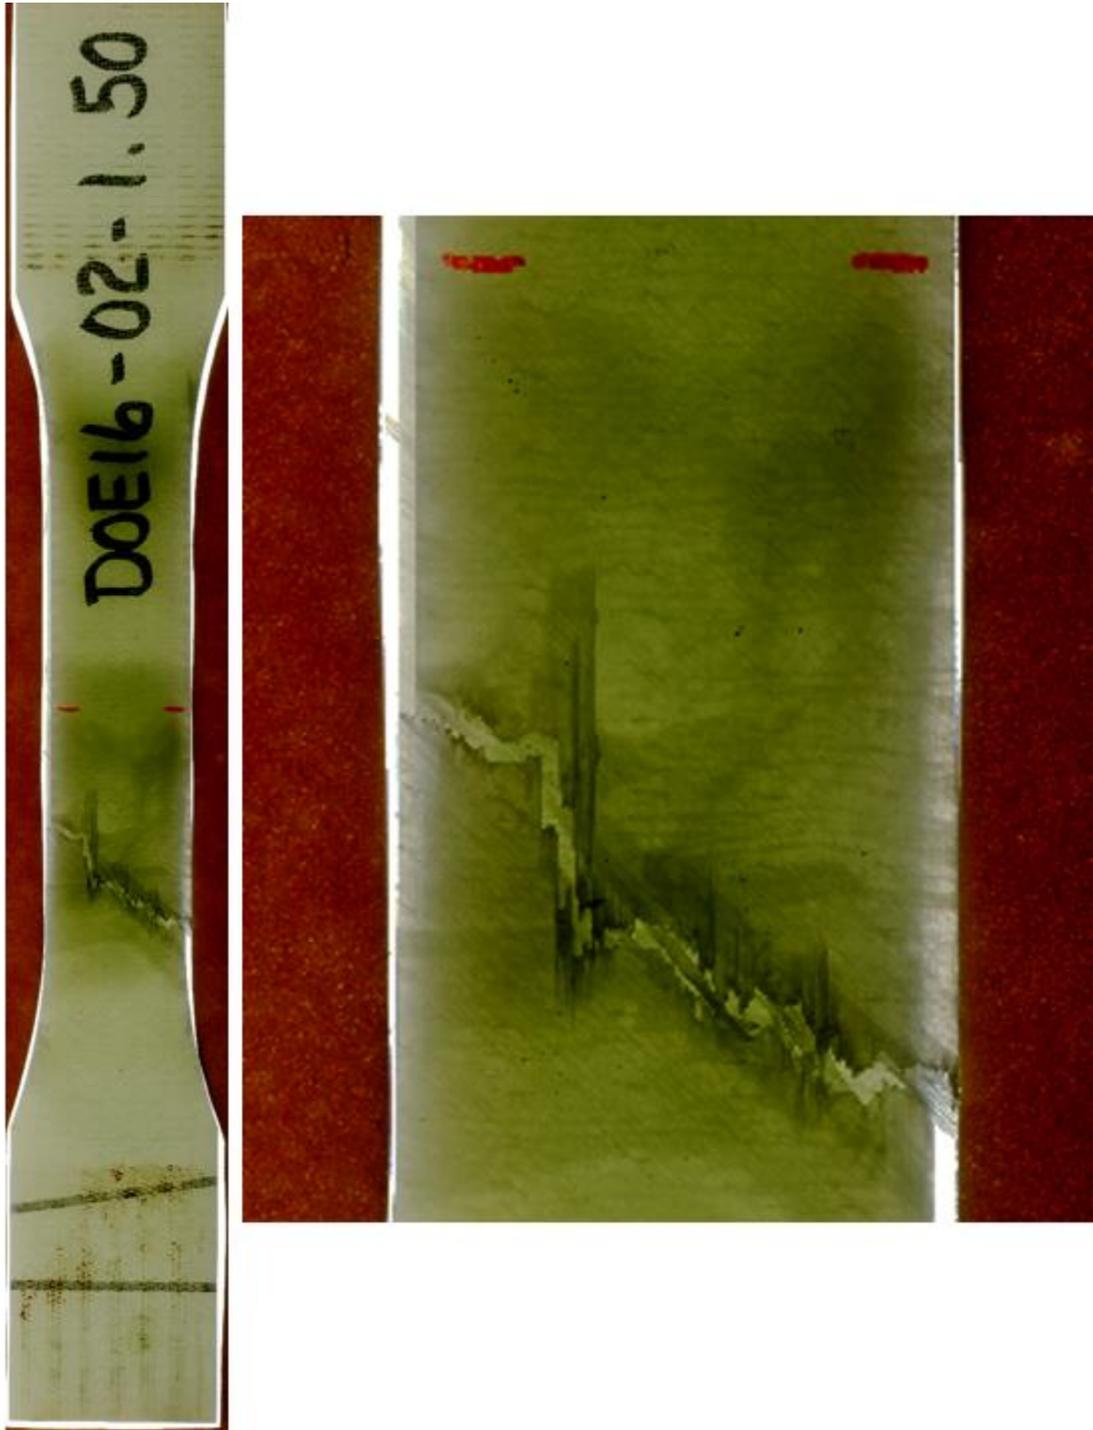
Figure 5-24. Example of scanned image with magnified image displaying macro cracks

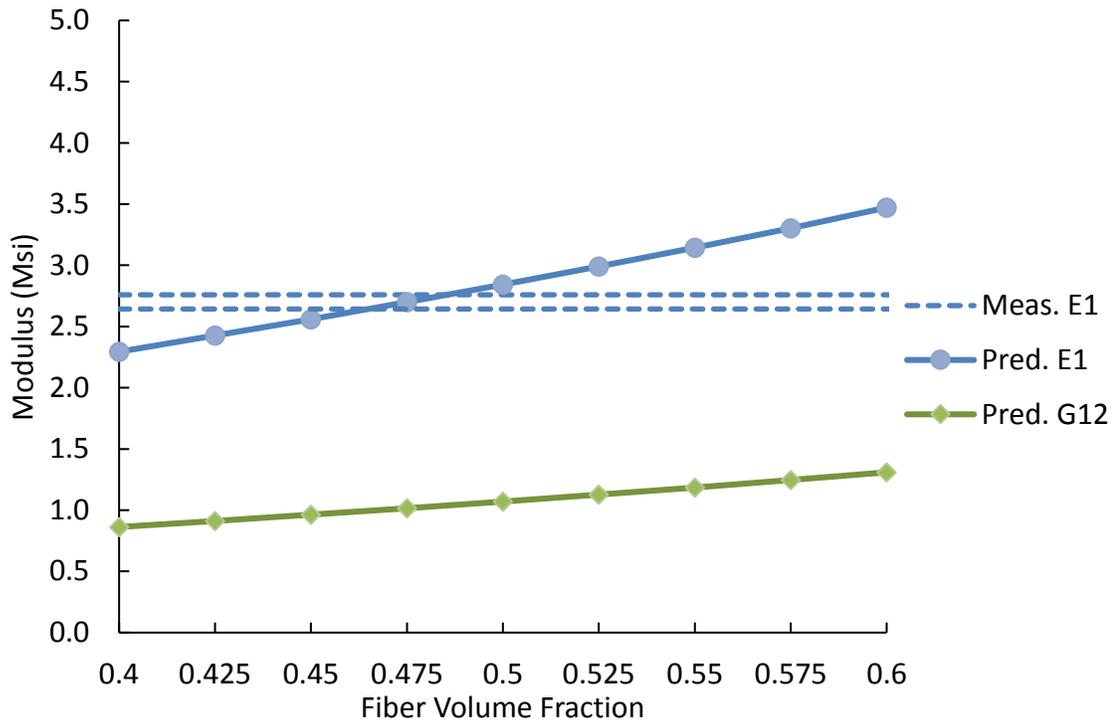
Figure 6-4. Comparison of quasi-static baseline results and Sun-Li model for stitch-bonded QE1203/ST94 quadaxial laminate with experimental results (dashed lines) shown as mean  $\pm$  1 std. dev.

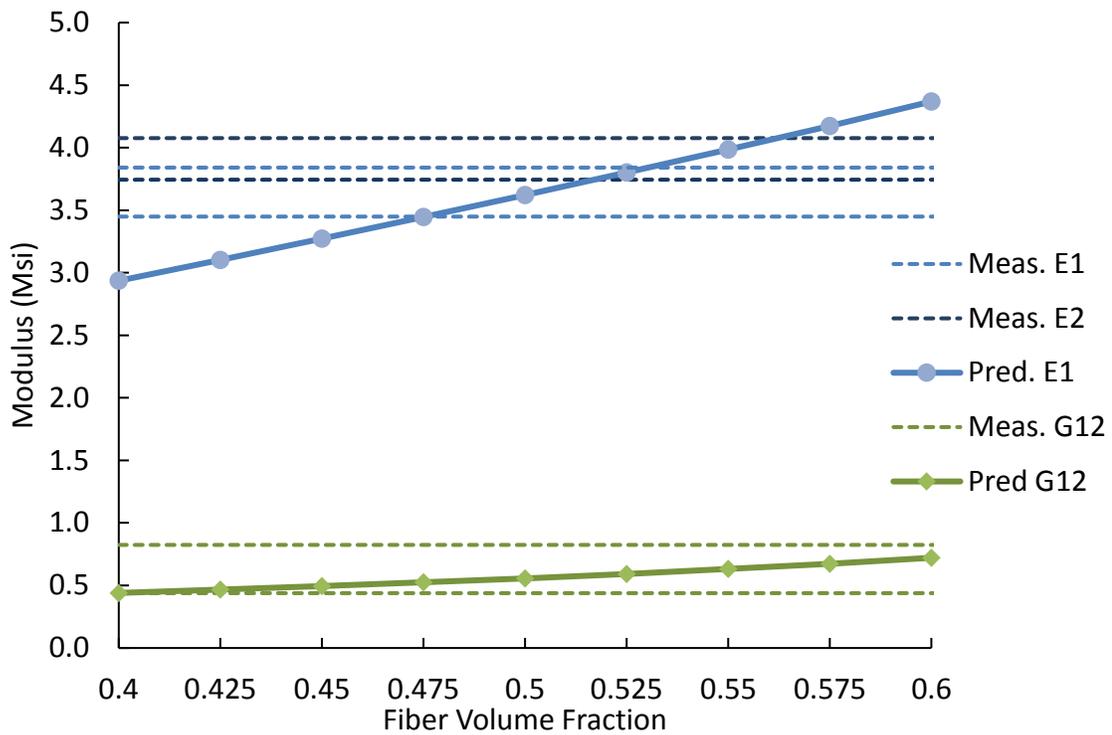
Figure 6-5. Comparison of quasi-static baseline results and Sun-Li model for woven roving WRE581T/ST94 [0°/90°] laminate with experimental results shown as mean  $\pm$  1 std. dev.

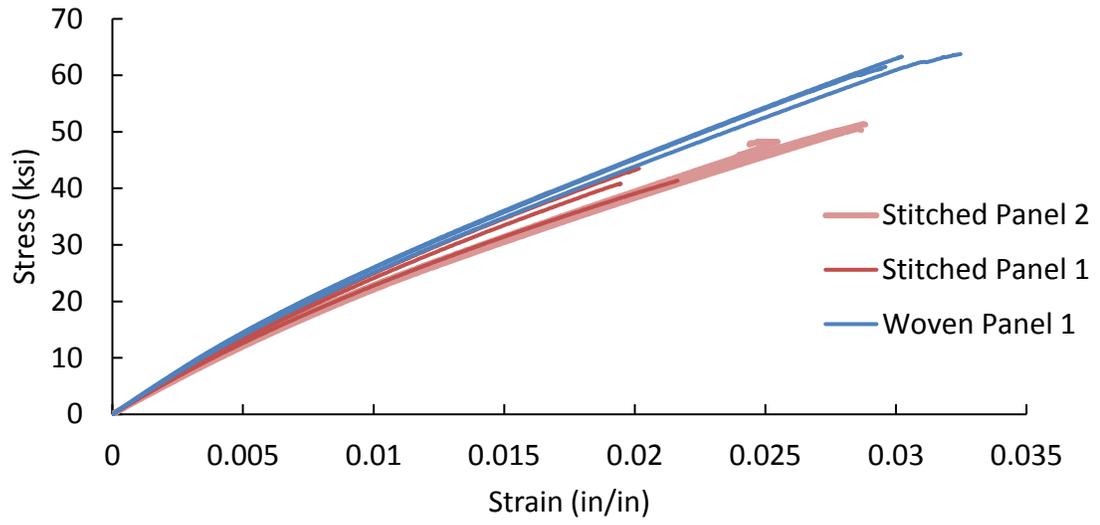
Figure 6-6. Stress-strain curves for three RTA baseline samples from each of the three panels manufactured for this study

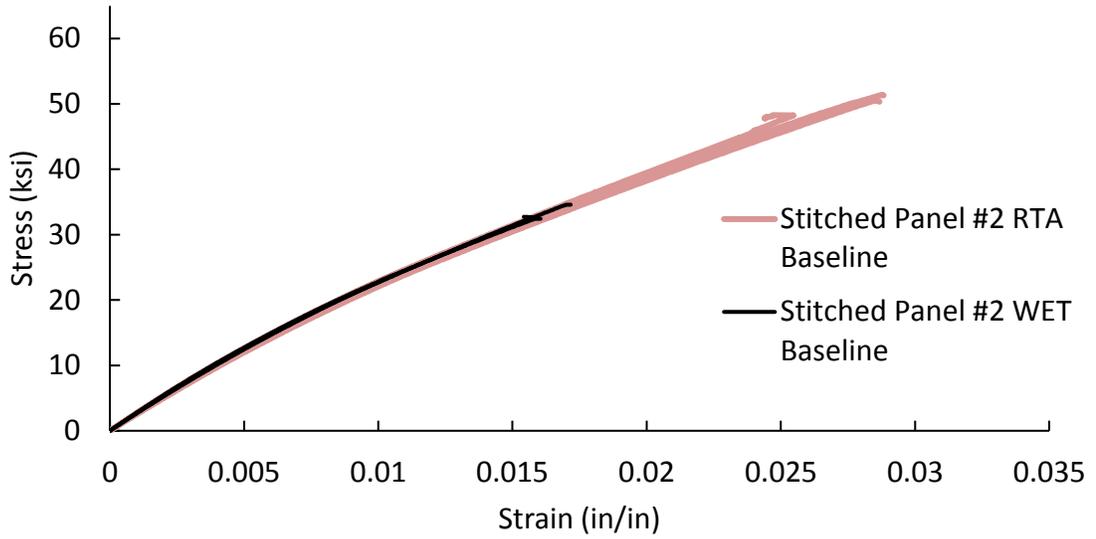
Figure 6-8. Stress-strain curves for three RTA baseline and three WET conditioned baseline samples from the second stitched panel used for WET testing

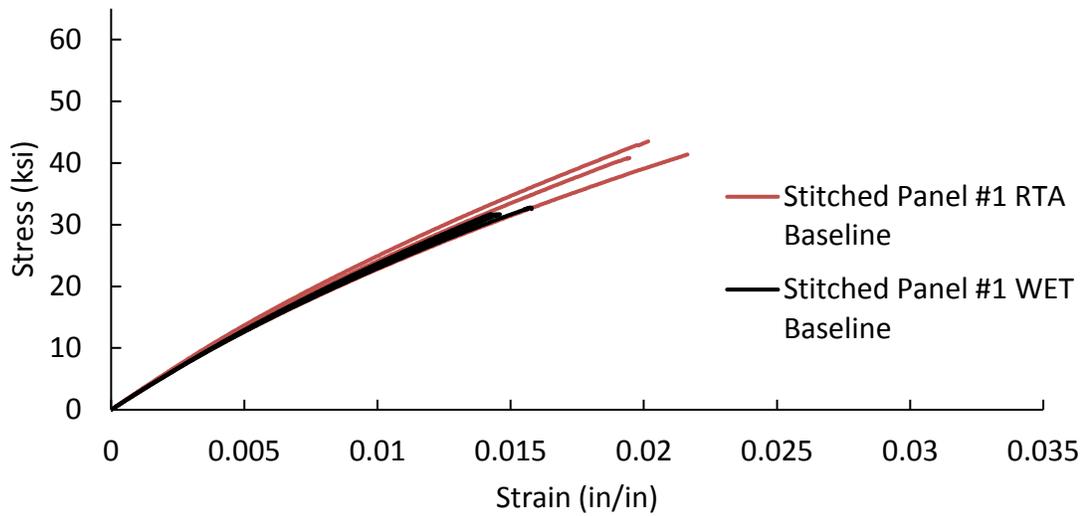
Figure 6-9. Stress-strain curves for three RTA baseline and three WET conditioned baseline samples from the first stitched panel used for RTA testing

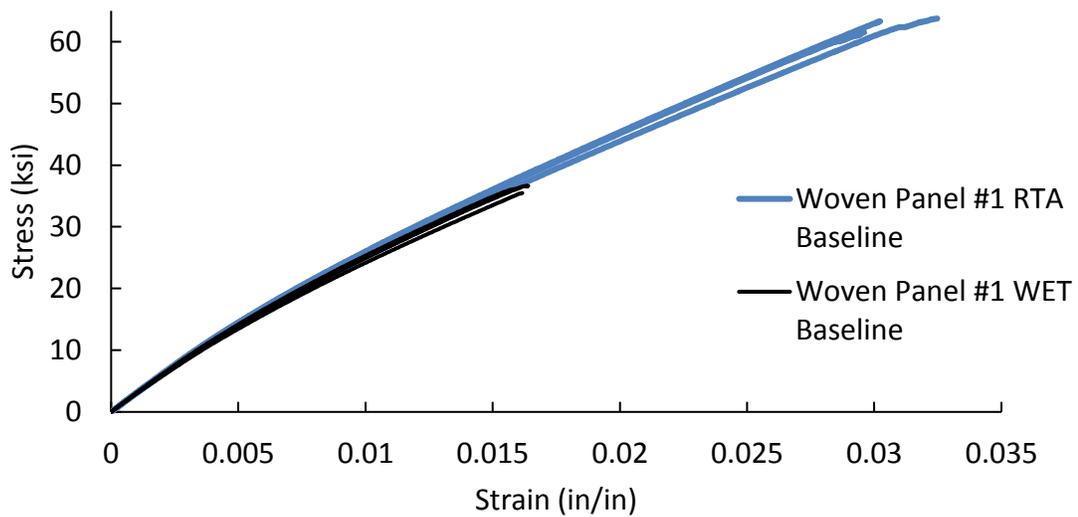
Figure 6-10. Stress-strain curves for three RTA baseline and three WET conditioned baseline samples from the woven panel used for RTA testing

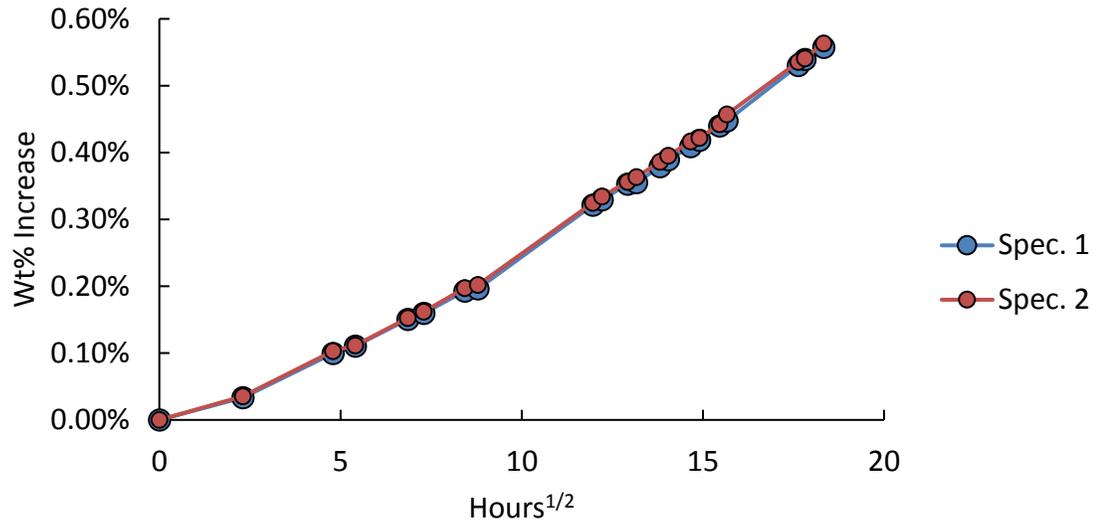
Figure 6-11. Water uptake measurements for two conditioned stitched dogbone samples over two weeks (336 hours)

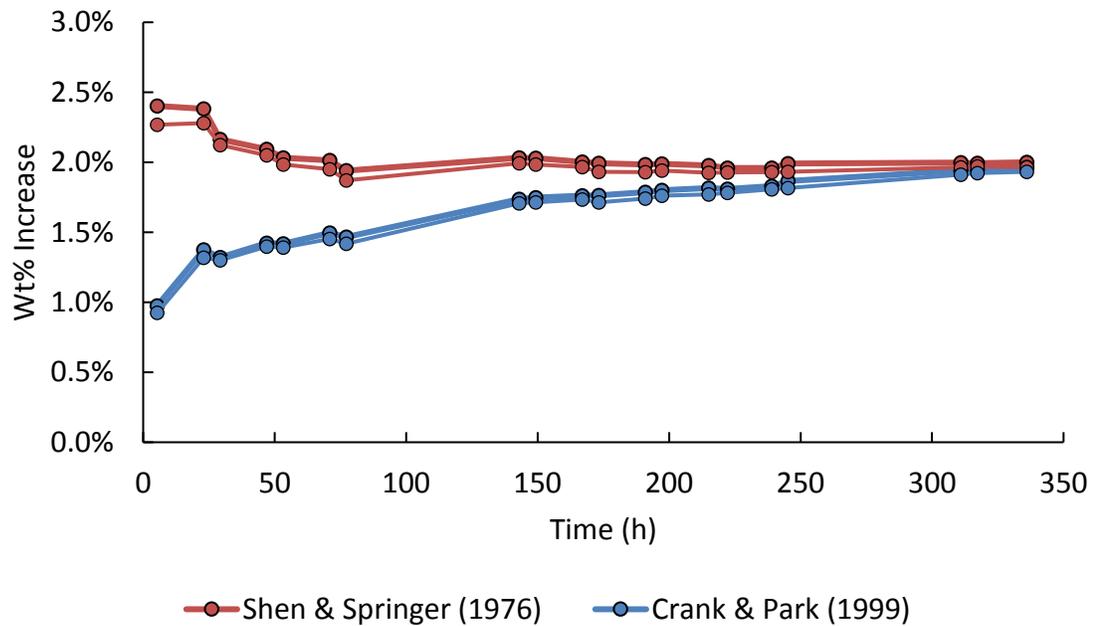
Figure 6-12. Water uptake models from Shen & Springer (1976) and Crank & Park (1999) plotted to predict saturation using weight uptake data points from two stitched samples with  $D=2.8 \text{ mm}^2/\text{s}$  (Jones, 2003)

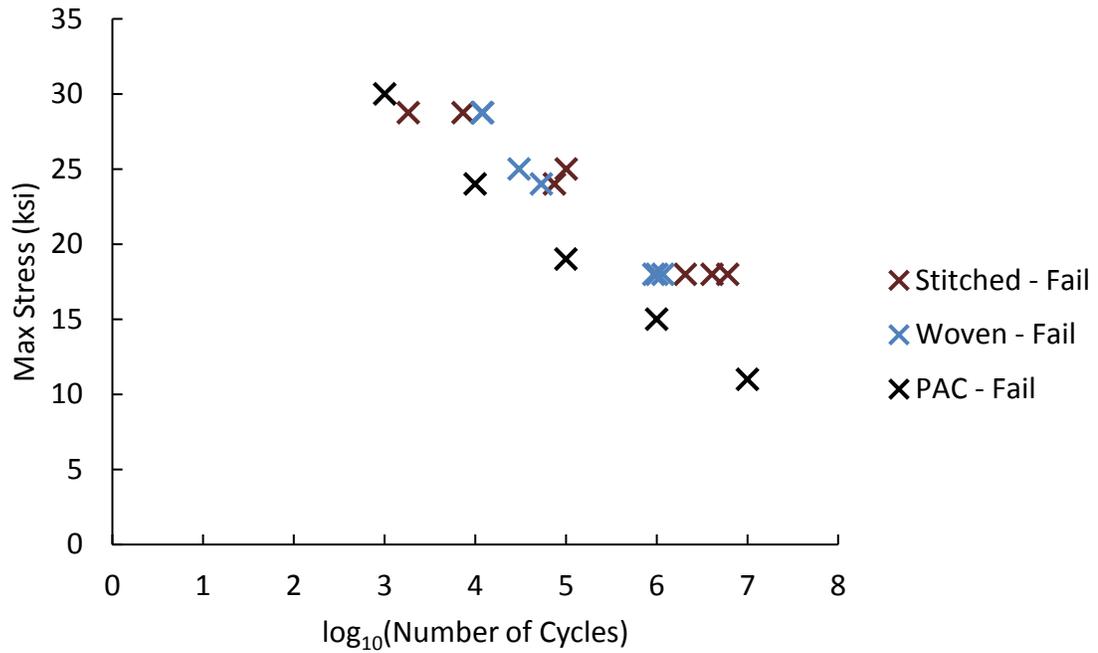
Figure 6-13. RTA S-N curve including QE1203/ST94 (Stitched), WRE581T/ST94 (Woven), and PAC data at maximum fatigue stresses of 28.75, 24, and 18 ksi (PAC data from Koudela, 2016)

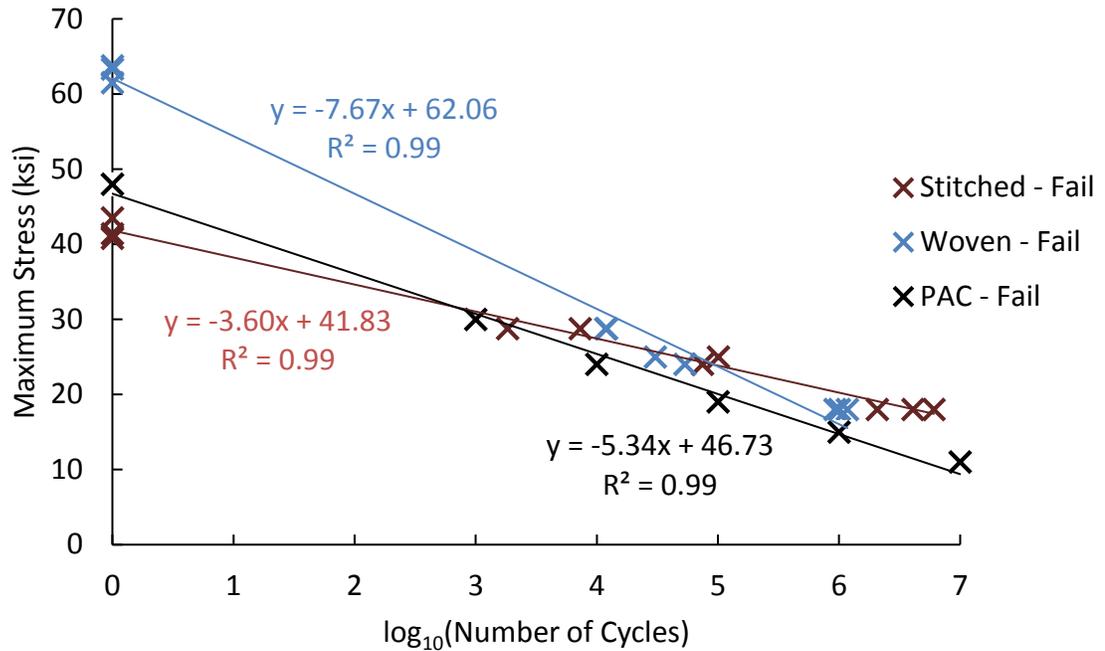
Figure 6-14. RTA S-N curve for stitched, woven, and PAC material systems including quasi-static strength data and trendlines with equations shown in matching colors (PAC data from Koudela, 2016)

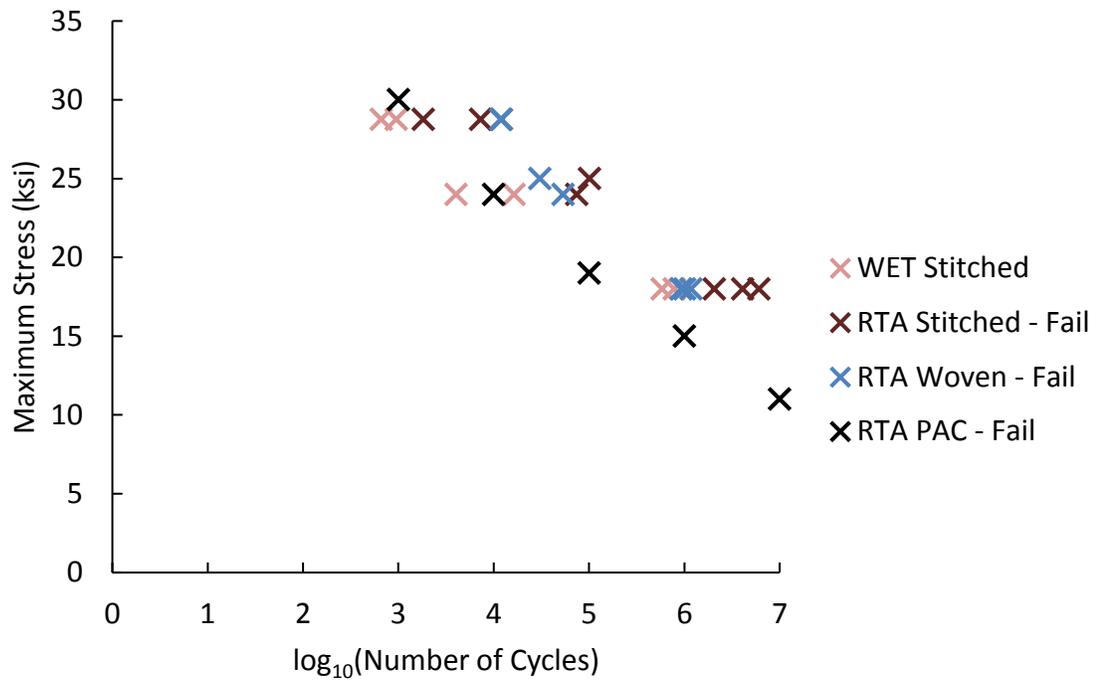
Figure 6-15. WET and RTA S-N curve including QE1203/ST94(Stitched), WRE581T/ST94 (Woven), and PAC data at maximum fatigue stresses of 28.75, 24, and 18 ksi (PAC data from Koudela, 2016)

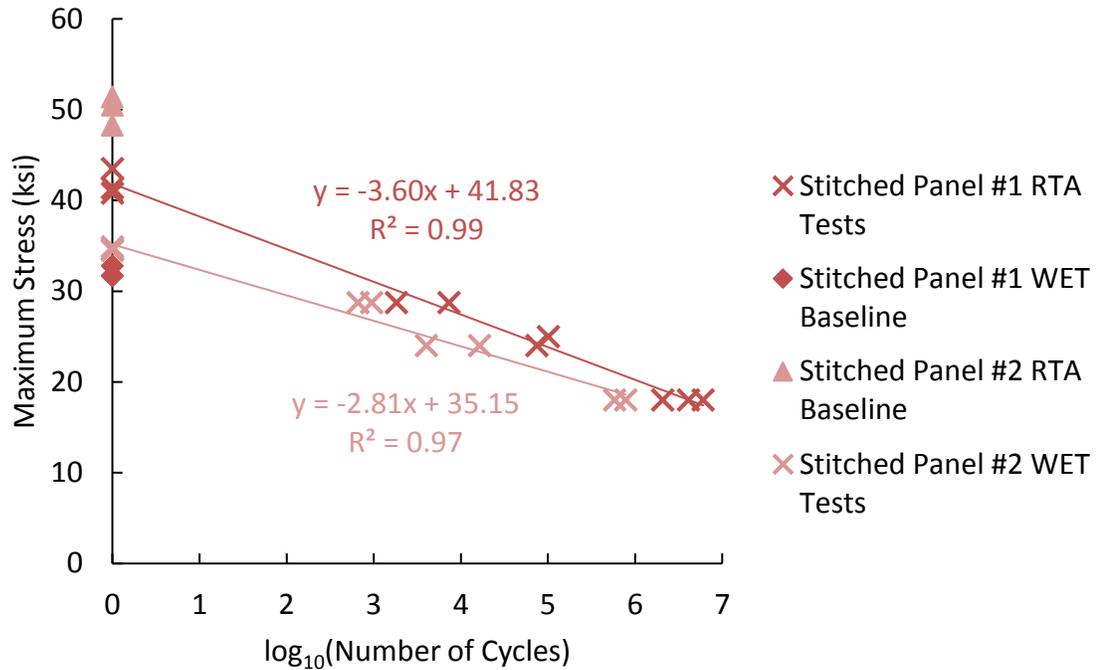
Figure 6-16. S-N curve for the two stitched panels including quasi-static strength data in both RTA and WET conditions and color-coded trendlines

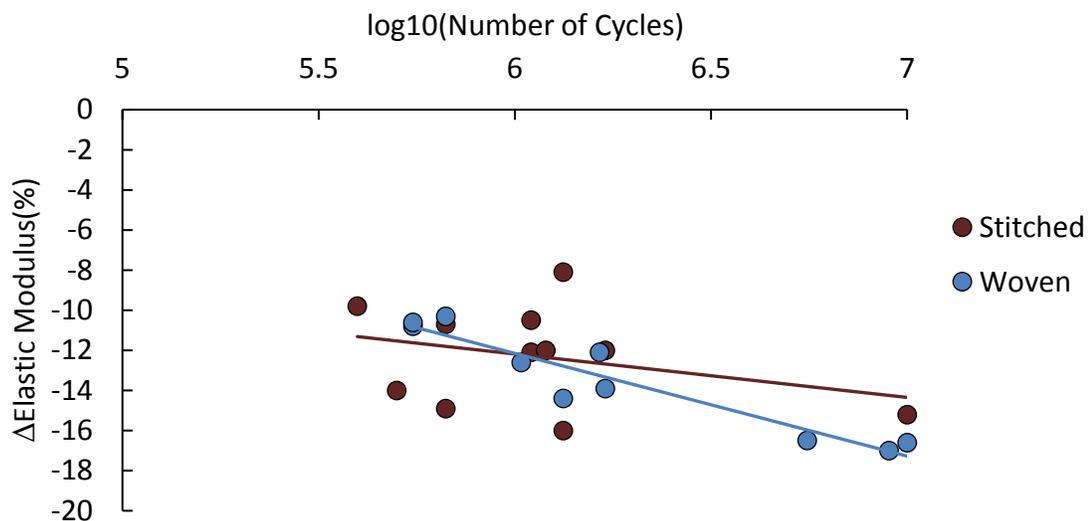
Figure 6-17. Quantification of damage through plotting number of cycles vs. modulus reduction for RTA woven and stitched samples tested at 13.75 ksi maximum (includes linear trendlines)

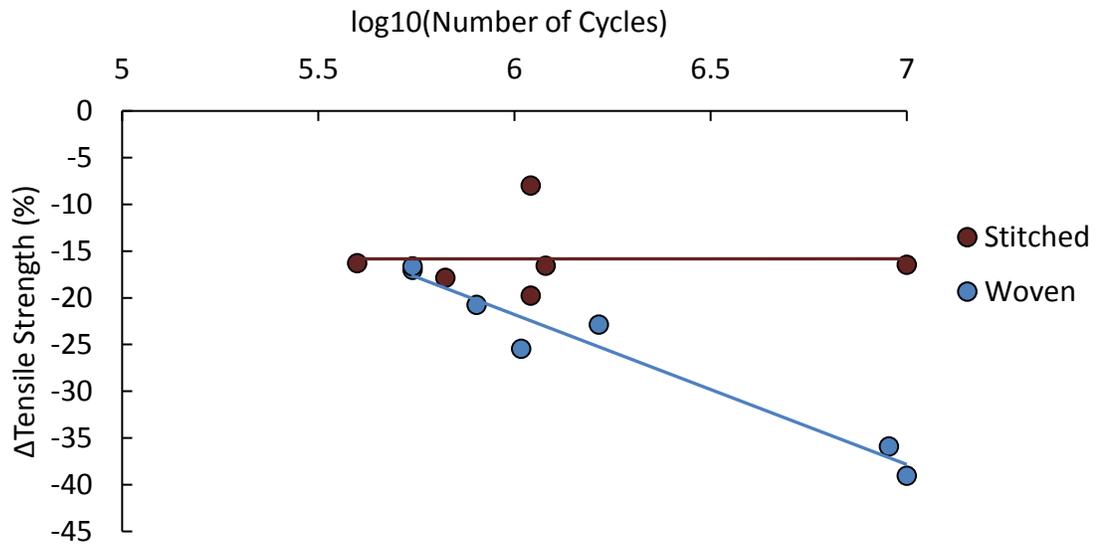
Figure 6-18. Quantification of damage through plotting number of cycles vs. change in tensile strength for RTA woven and stitched samples tested at 13.75 ksi maximum (includes linear trendlines)

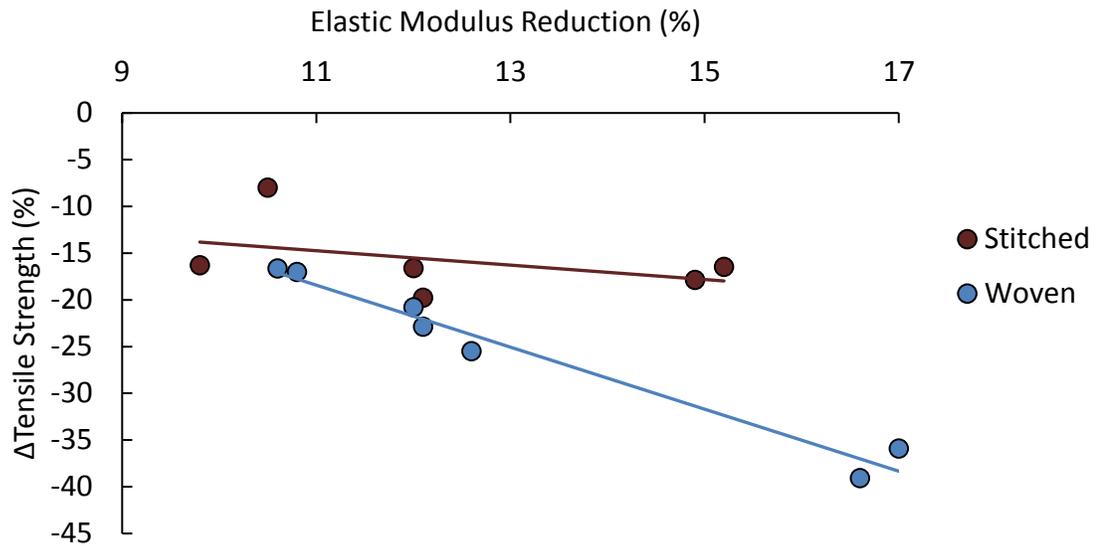
Figure 6-19. Quantification of damage through plotting modulus reduction vs. change in tensile strength for RTA woven and stitched samples tested at 13.75 ksi maximum (includes linear trendlines)

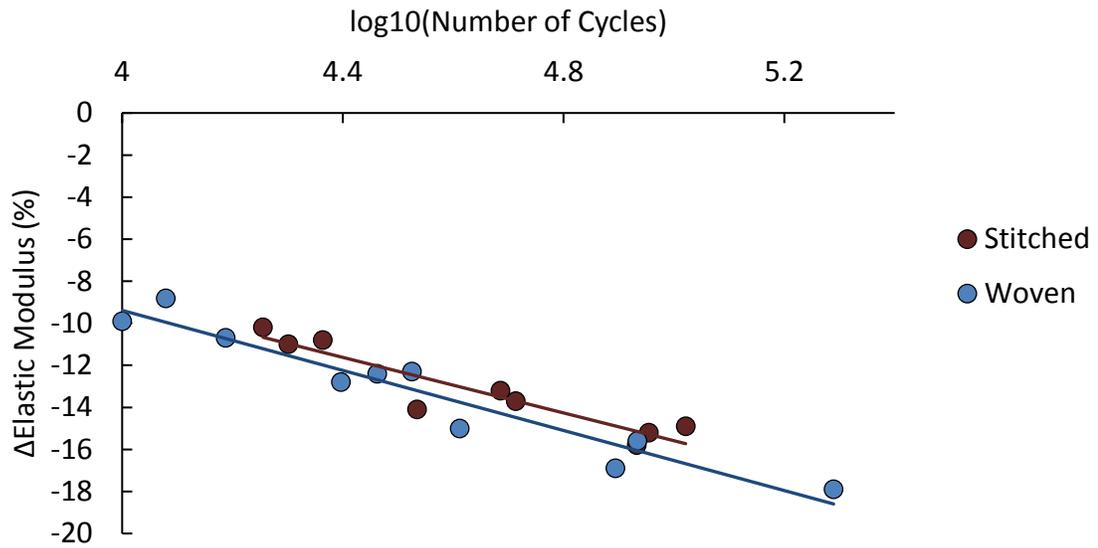
Figure 6-20. Quantification of damage through plotting number of cycles vs. modulus reduction for RTA woven and stitched samples tested at 18 ksi maximum (includes linear trendlines)
