The Pennsylvania State University

**MECHANICAL RESPONSE OF OUT-OF-AUTOCLAVE COMPLEX FIBER  
ARCHITECTURE COMPOSITES FOR MARINE STRUCTURES**

A Thesis in

Master of Science

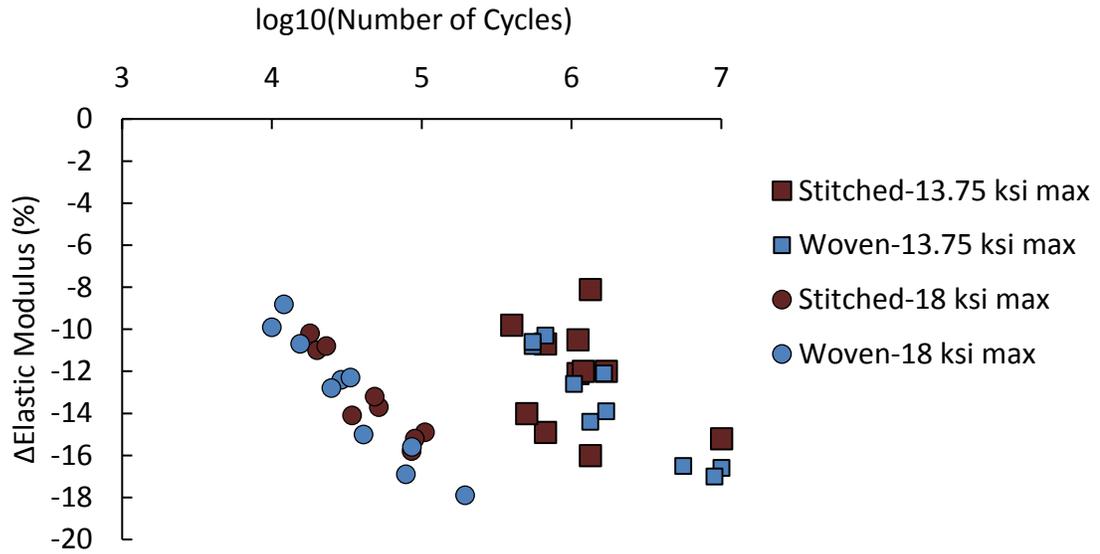
Figure 6-21. Comparison of damage accumulation within 13.75 ksi maximum and 18 ksi maximum woven and stitched RTA specimens through plot of number of cycles vs. modulus reduction

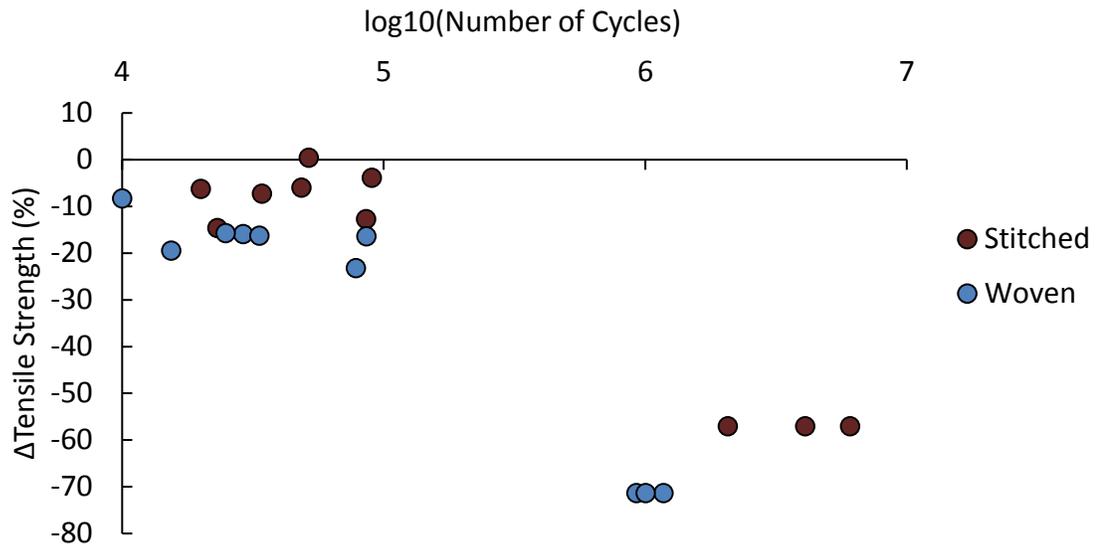
Figure 6-22. Quantification of damage through plotting modulus reduction vs. change in tensile strength for RTA woven and stitched samples tested at 18 ksi maximum (includes linear trendlines)

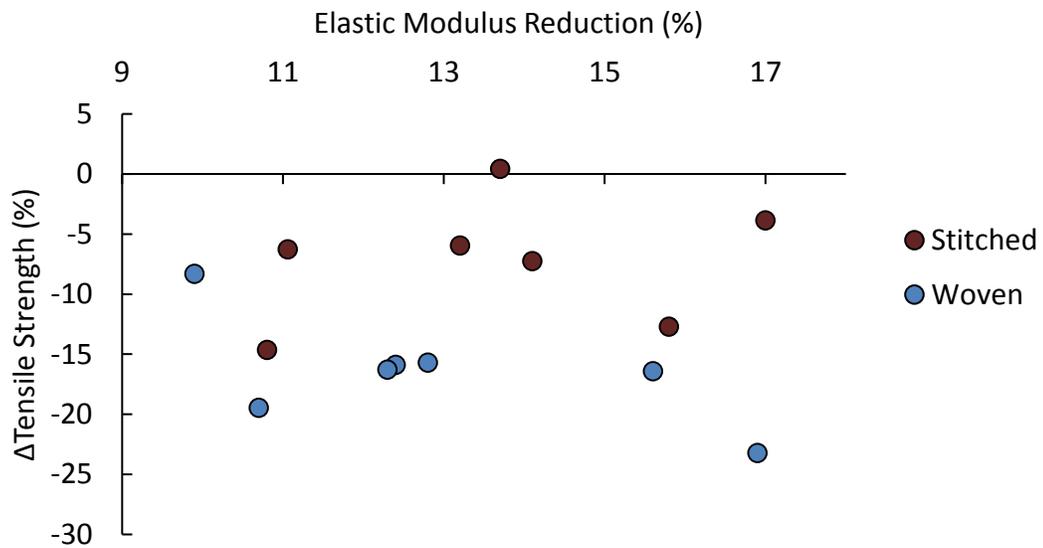
Figure 6-23. Quantification of damage through plotting modulus reduction vs. change in tensile strength for RTA woven and stitched samples tested at 18 ksi maximum (includes linear trendlines)

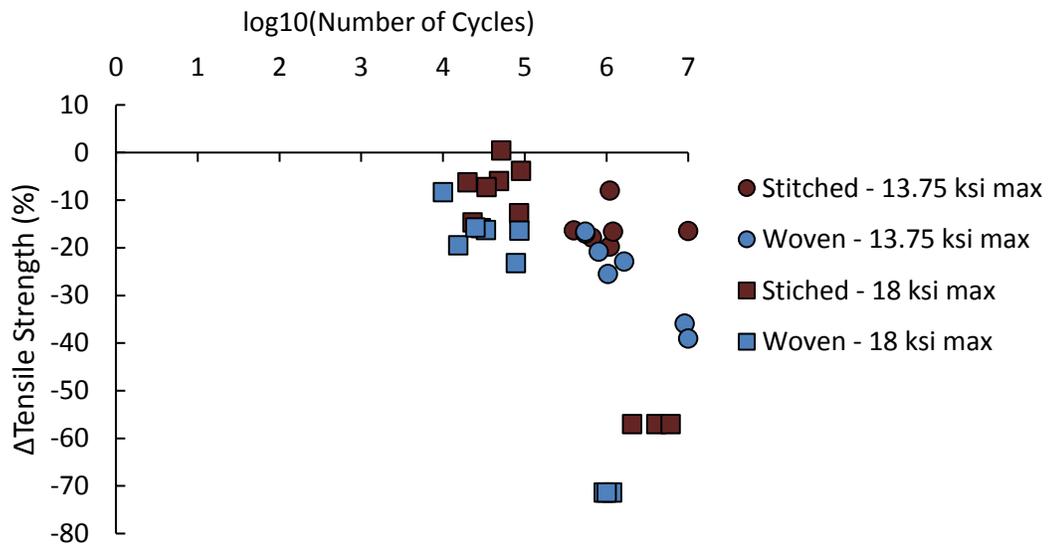
Figure 6-24. Comparison of damage accumulation within 13.75 ksi maximum and 18 ksi maximum woven and stitched RTA specimens through plot of number of cycles vs. change in tensile strength

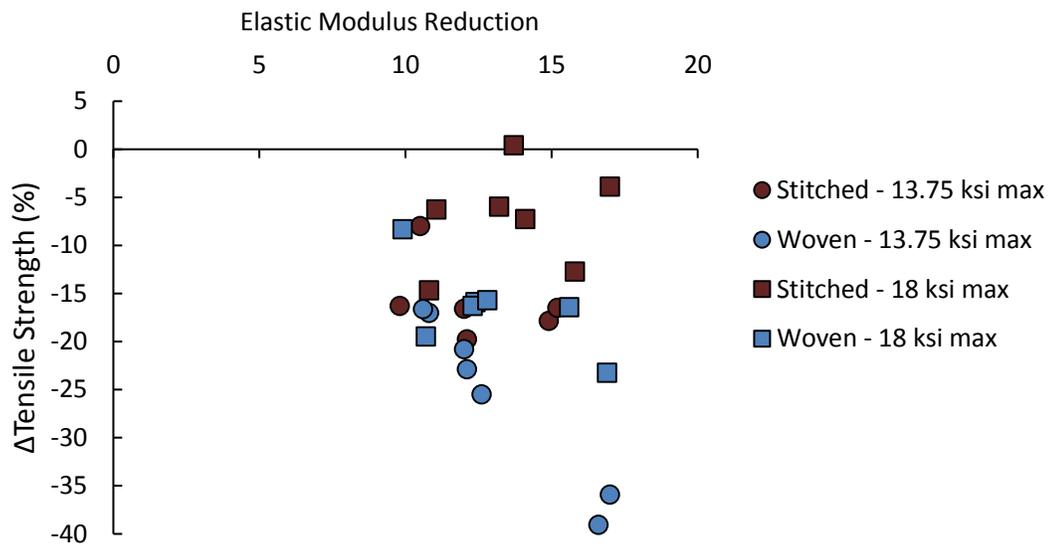
Figure 6-25. Comparison of damage accumulation within 13.75 ksi maximum and 18 ksi maximum woven and stitched RTA specimens through plot of elastic modulus reduction vs. change in tensile strength

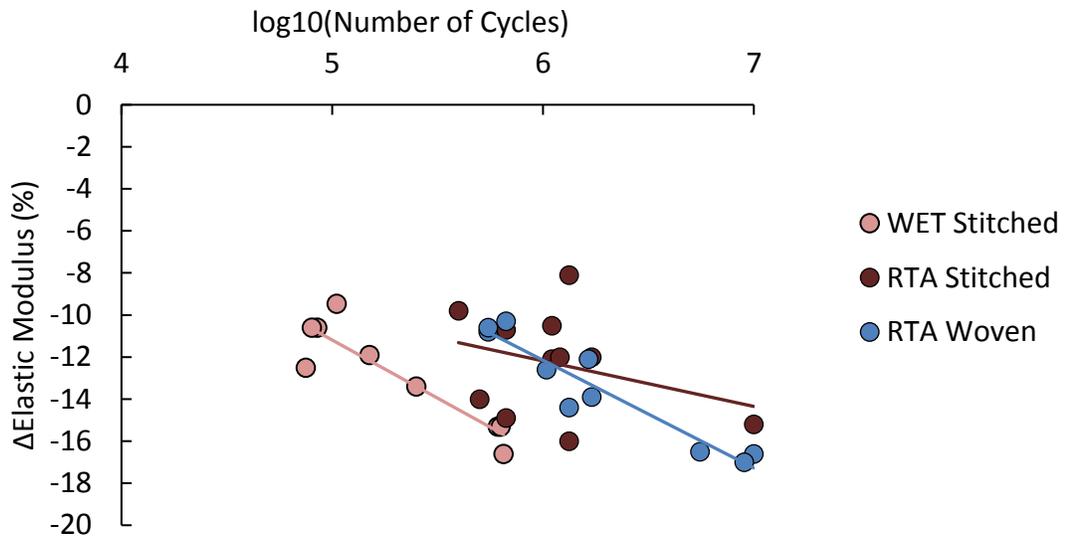
Figure 6-26. Quantification of damage through plotting number of cycles vs. modulus reduction for RTA and WET samples tested at 13.75 ksi maximum (includes linear trendlines)

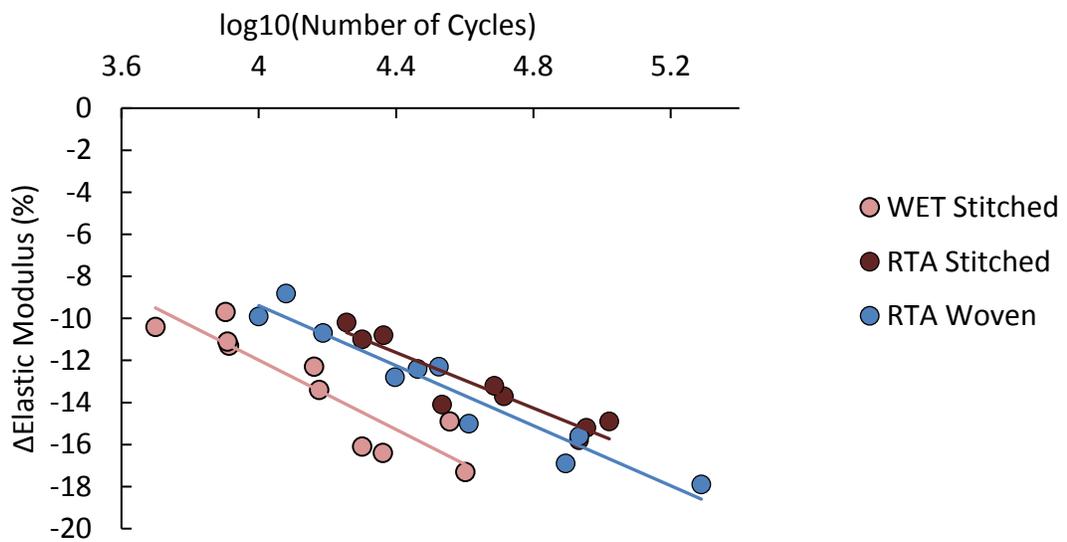
Figure 6-27. Quantification of damage through plotting number of cycles vs. modulus reduction for RTA and WET samples tested at 18 ksi maximum (includes linear trendlines)

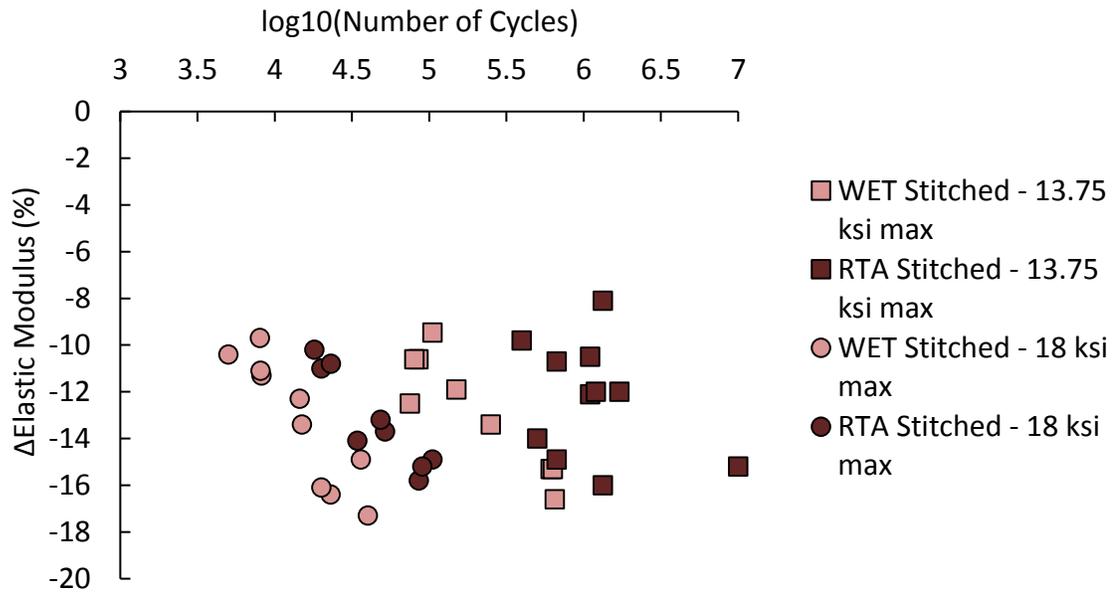
Figure 6-28. Quantification of damage through plotting number of cycles vs. modulus reduction for RTA and WET samples tested at 13.75 and 18 ksi maximum (includes linear trendlines)

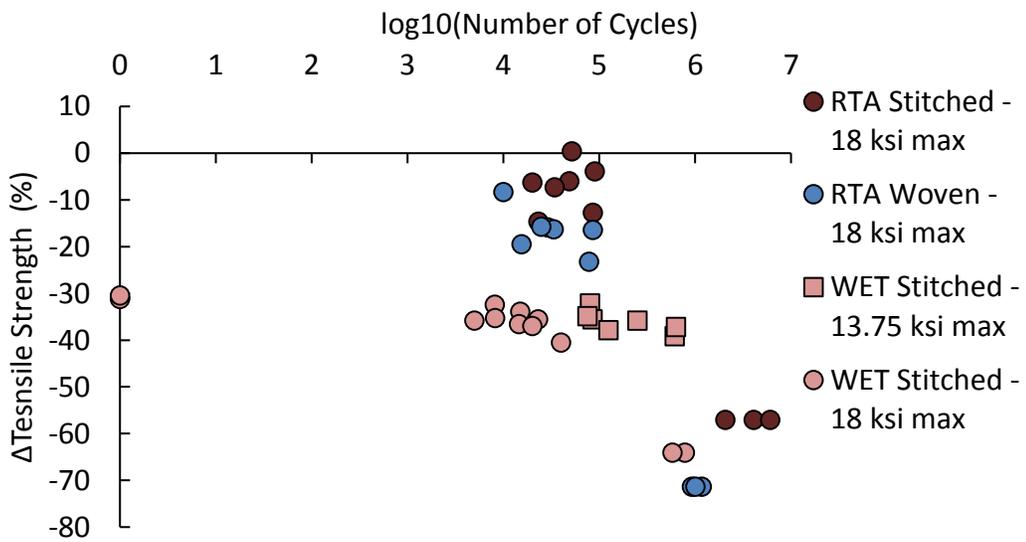
Figure 6-29. Quantification of damage through plotting number of cycles vs. change in tensile strength for RTA and WET samples tested at 13.75 and 18 ksi maximum

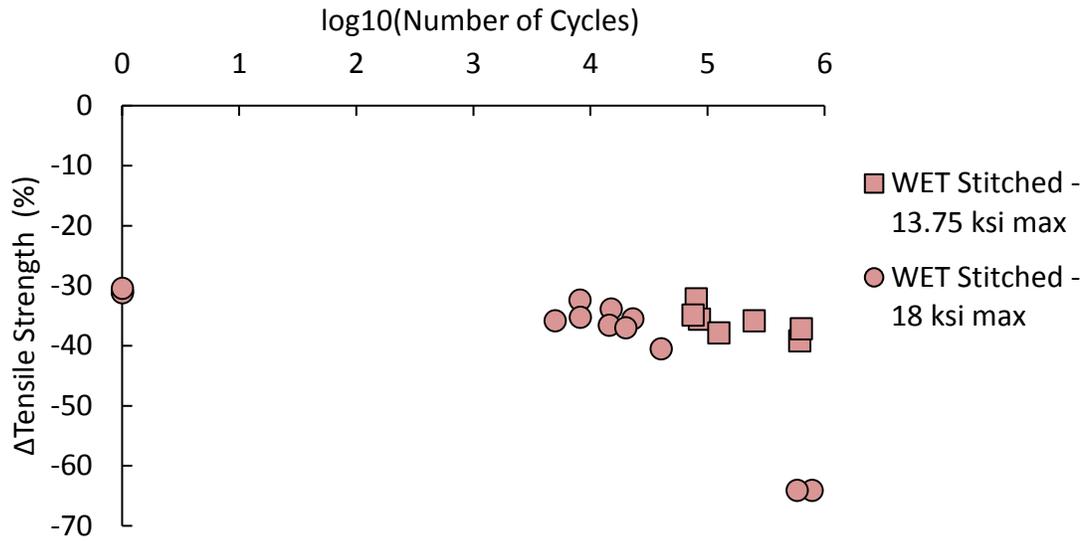
Figure 6-30. Residual Strength change over time for all WET stitched samples; far left baseline strengths apply to both data sets

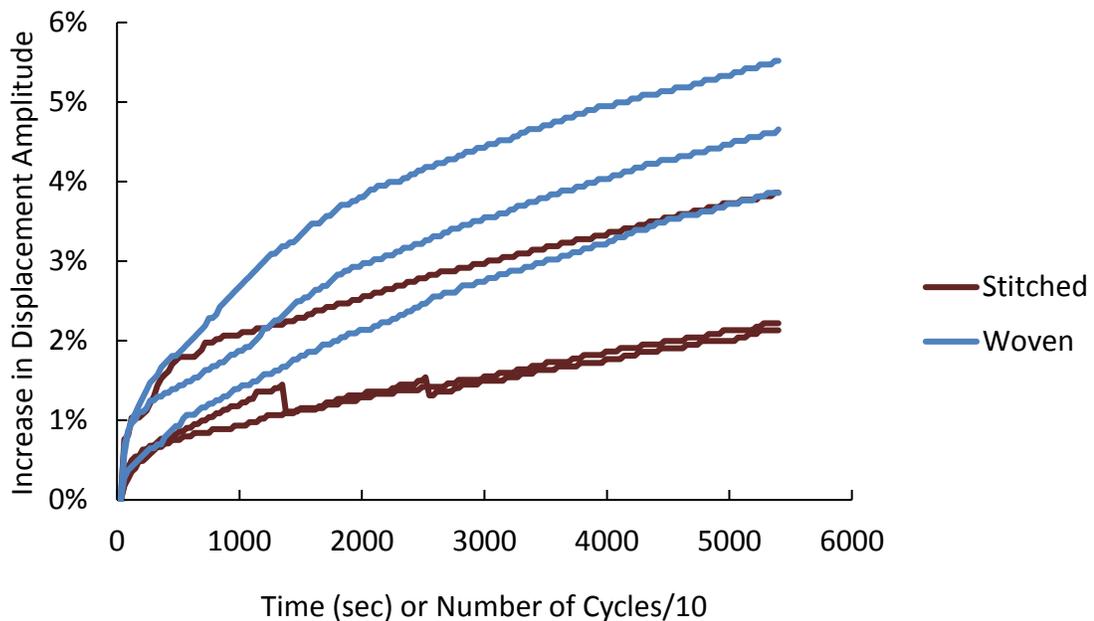
Figure 6-31. Initial increase in extensometer-measured displacement amplitude for RTA woven and stitched data at 13.75 ksi maximum fatigue load

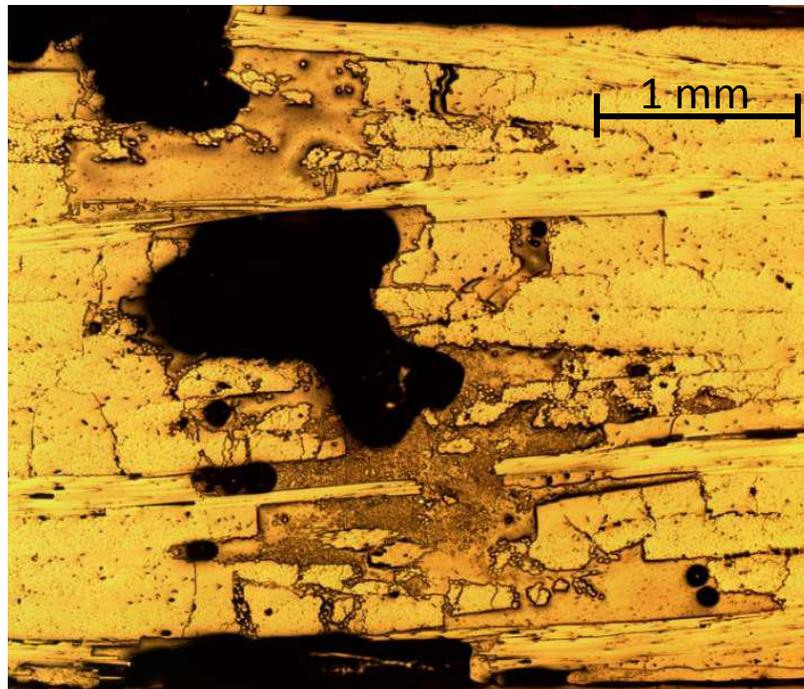
Figure 6-40. Critical flaw in failed 18 ksi maximum woven sample surrounded by intralaminar cracks and delaminations

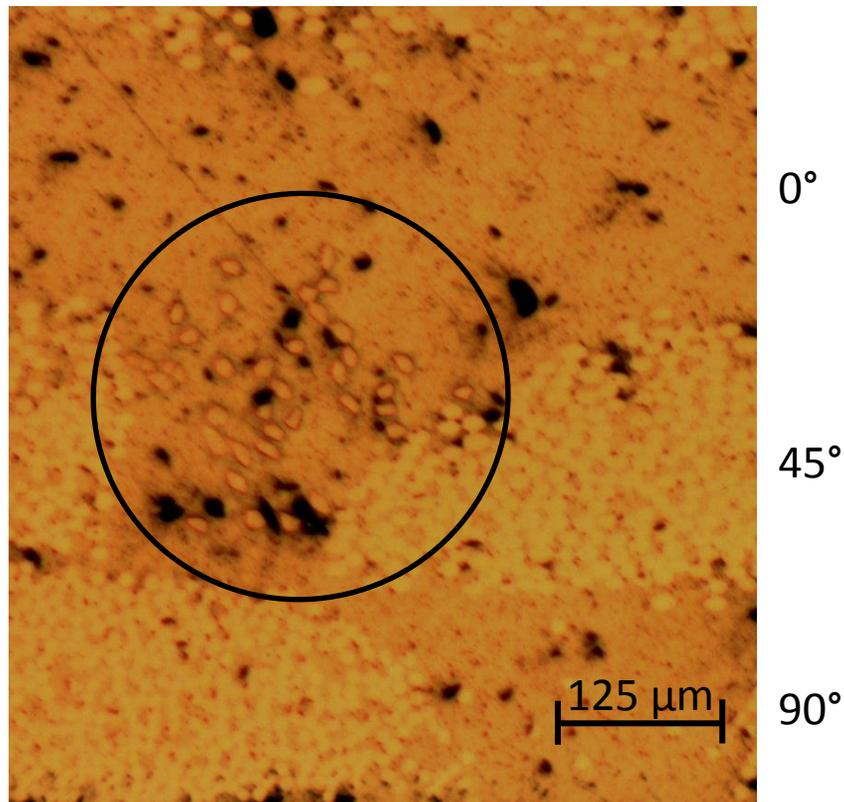
Figure 6-43. Virgin stitched RTA sample highlighting stitches found in micrograph without cracks

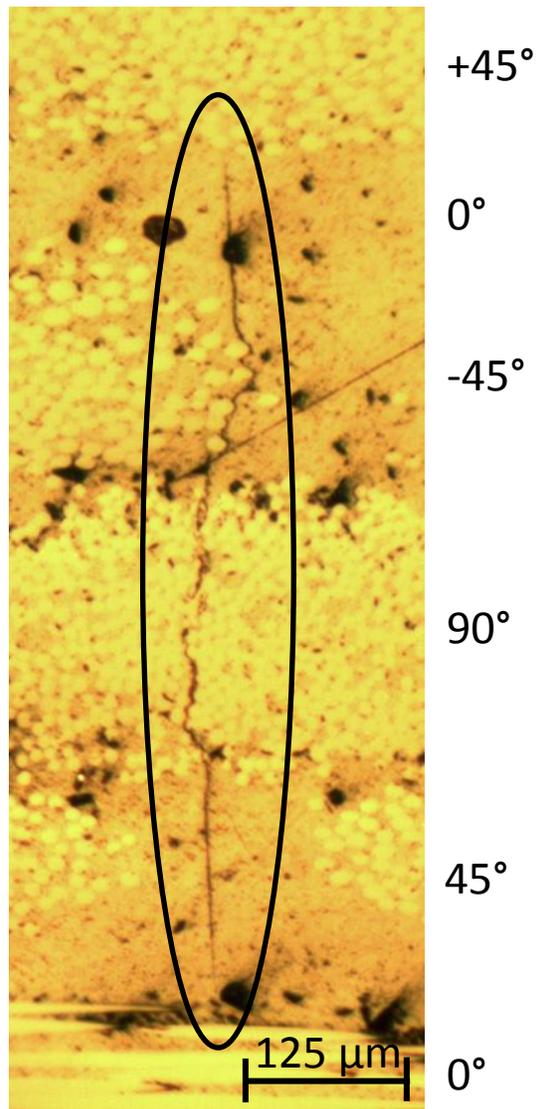
Figure 6-44. Stitched RTA sample loaded at 13.75 ksi maximum to 10% modulus reduction featuring an intralaminar crack in a 90° ply

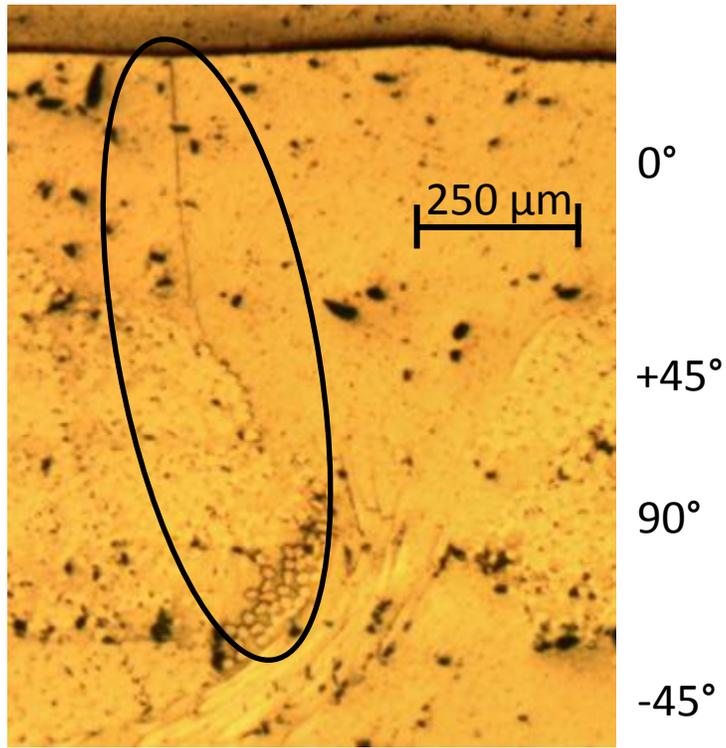
Figure 6-45. Multi-laminar crack involving the specimen edge and internal stitches in 13.75 ksi maximum 16% modulus reduction stitched sample

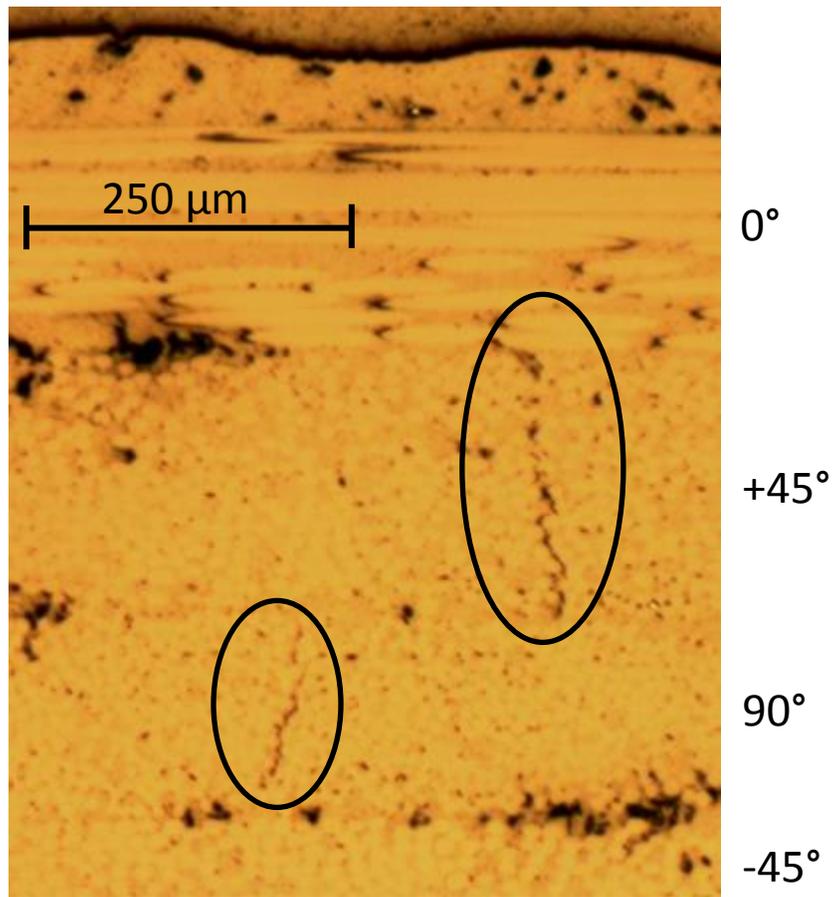
Figure 6-47. Stitched RTA sample loaded at 18 ksi maximum to 10% modulus reduction featuring intralaminar cracks in a 45 and 90° ply

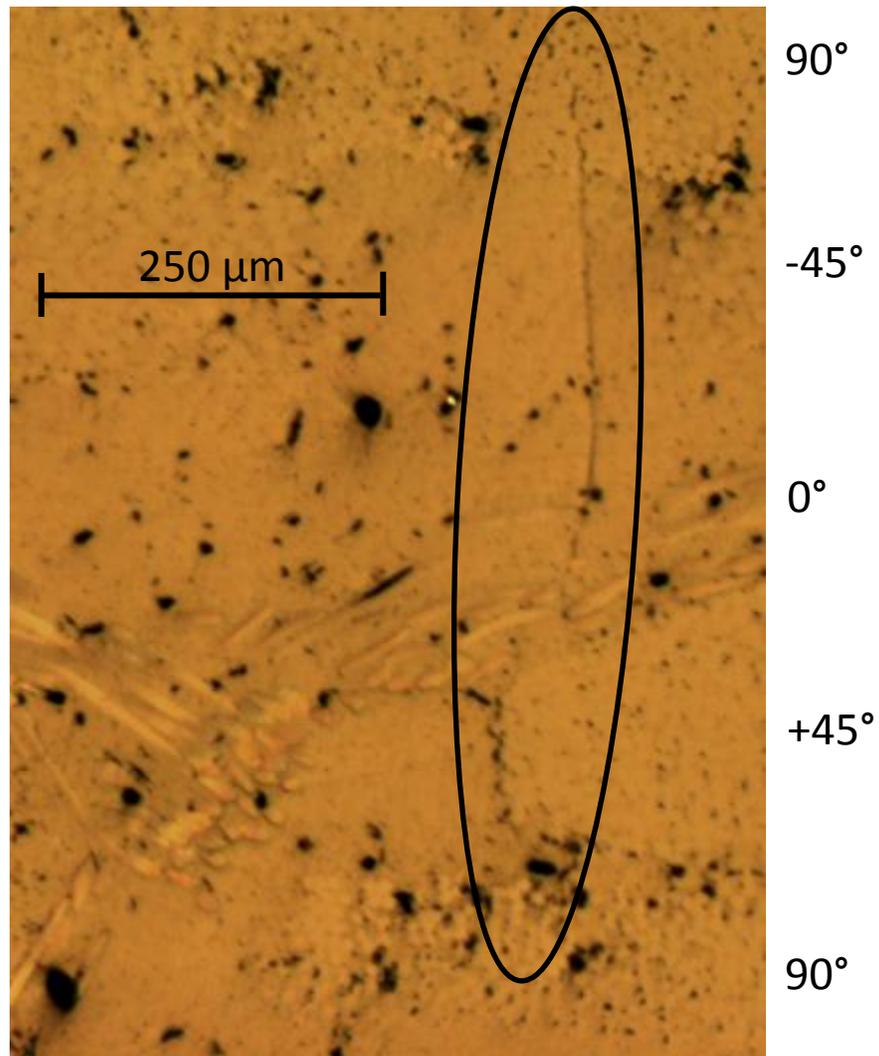
Figure 6-48. Long crack found in resin-rich area around stitches within an 18 ksi maximum stitched sample at 10% modulus reduction

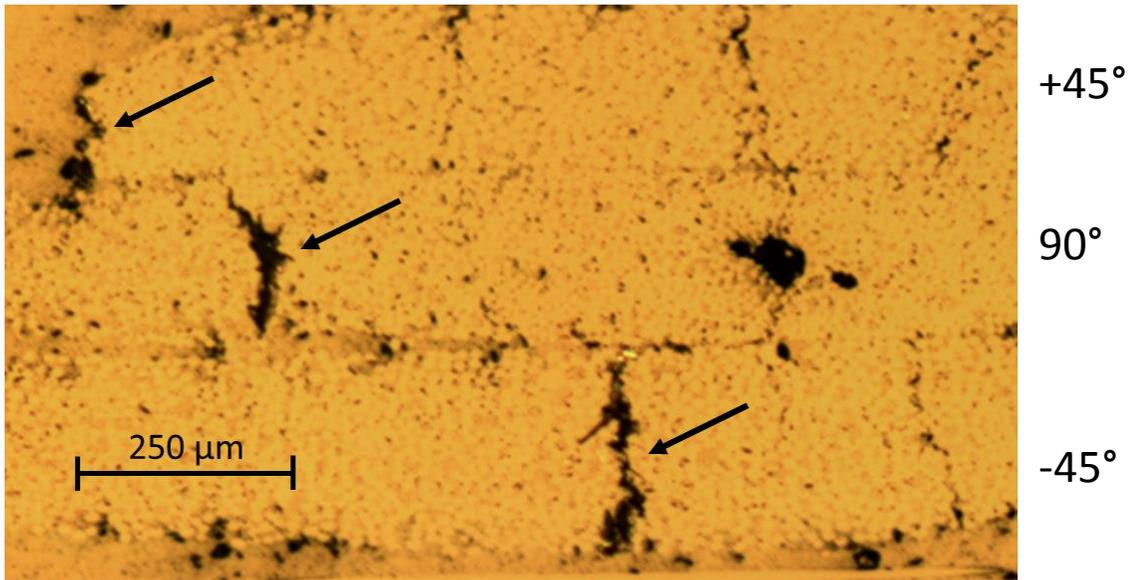
Figure 6-49. Copious wide intralaminar cracks within stitched 18 ksi maximum 16% modulus reduction specimen.

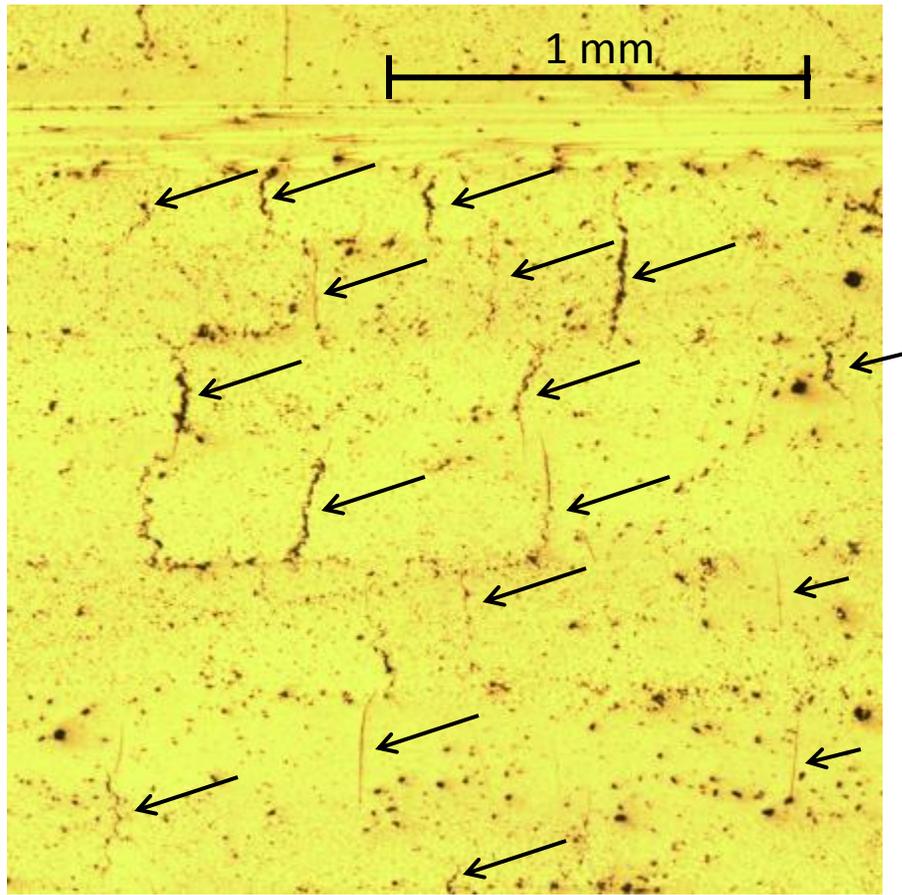
Figure 6-50. Numerous intralaminar cracks within 16 plies of a failed 18 ksi maximum stitched sample (non-critical cross-section)

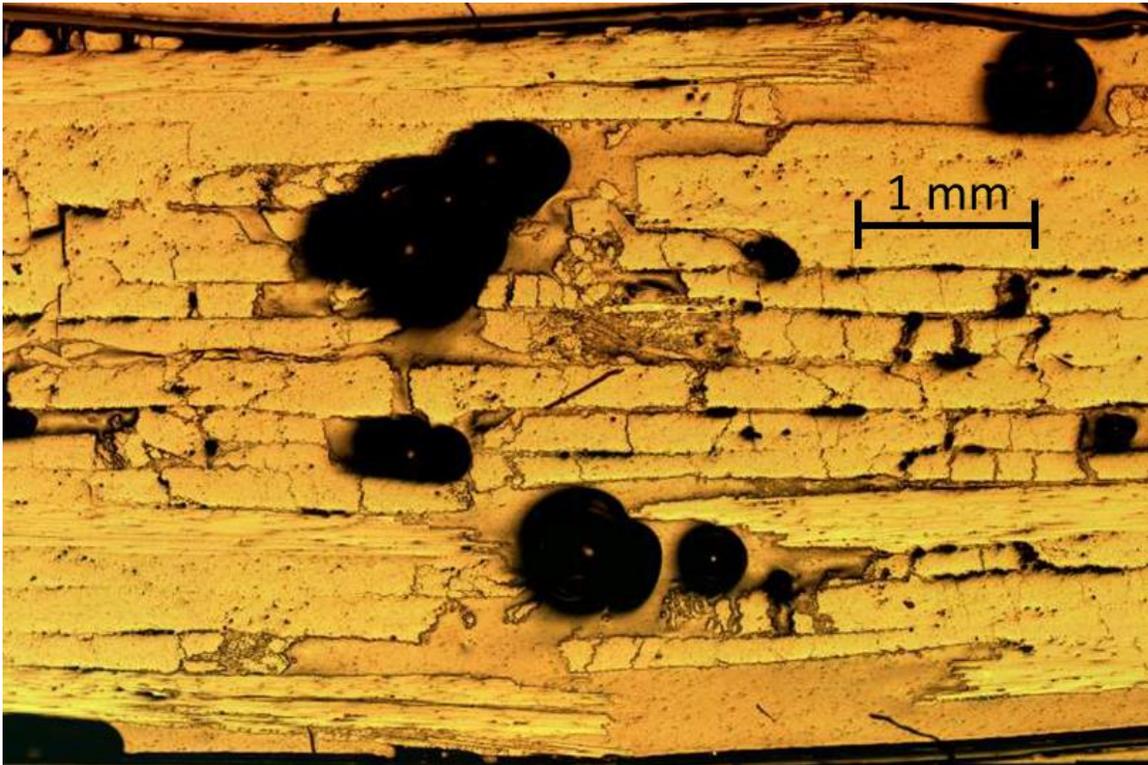
Figure 6-52. Critical flaw within 18 ksi maximum failed sample complete with delaminations of nearly every ply and numerous interlaminar cracks

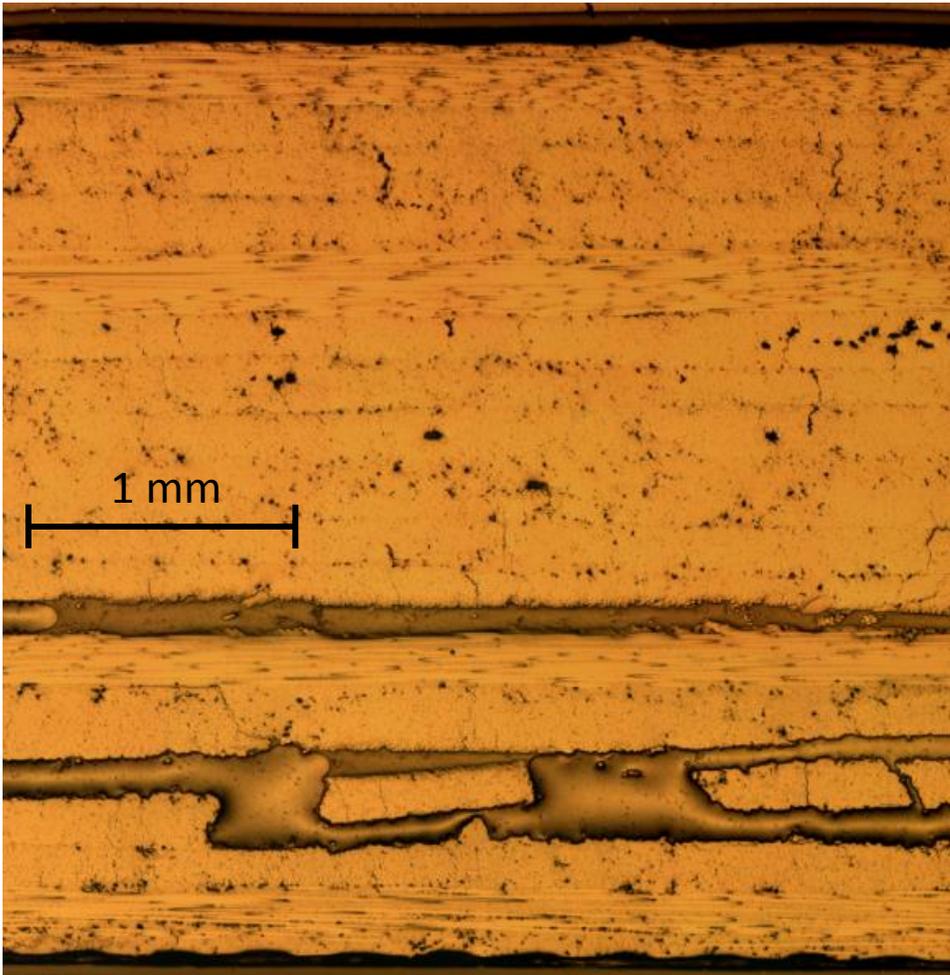
Figure 6-53. Few intralaminar cracks with predominantly interlaminar failure in failed 24 ksi maximum stitched sample

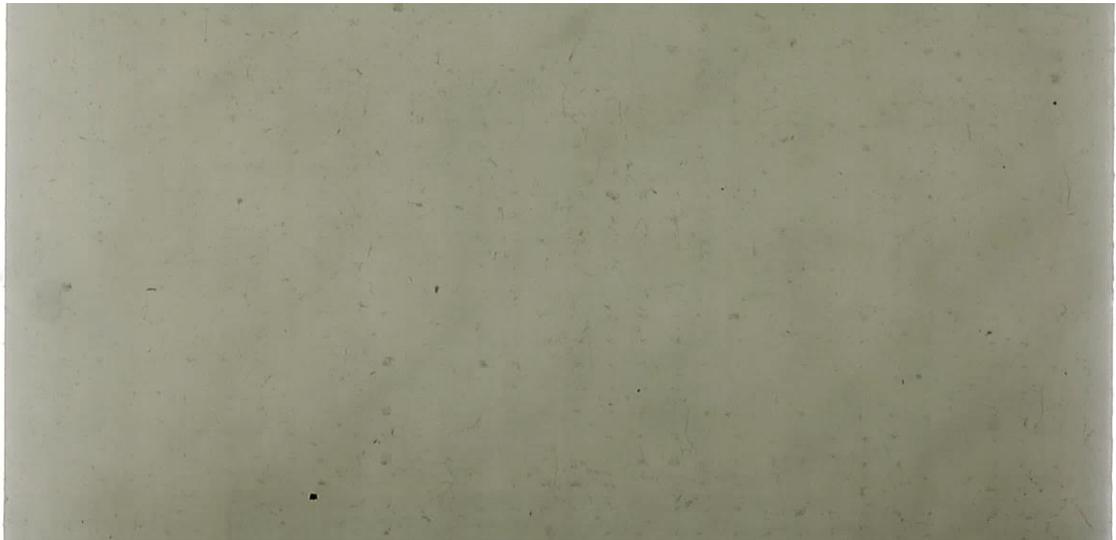
Figure 6-54. Scan of woven virgin sample showing a baseline for comparison with damaged samples.

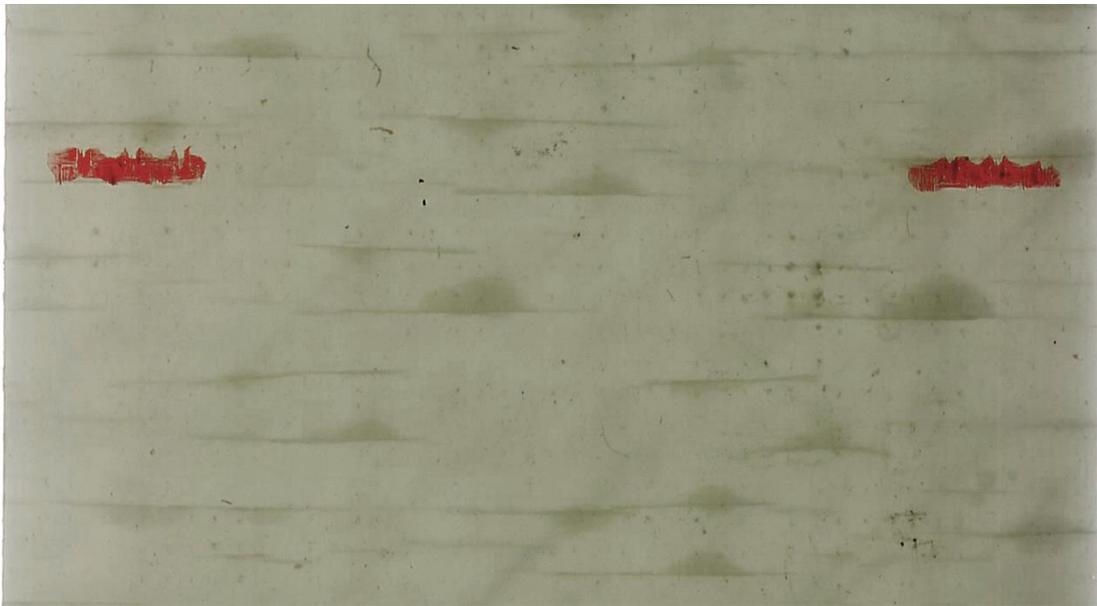
Figure 6-55. Scan of 13.75 ksi maximum woven sample at nearly 10% modulus reduction

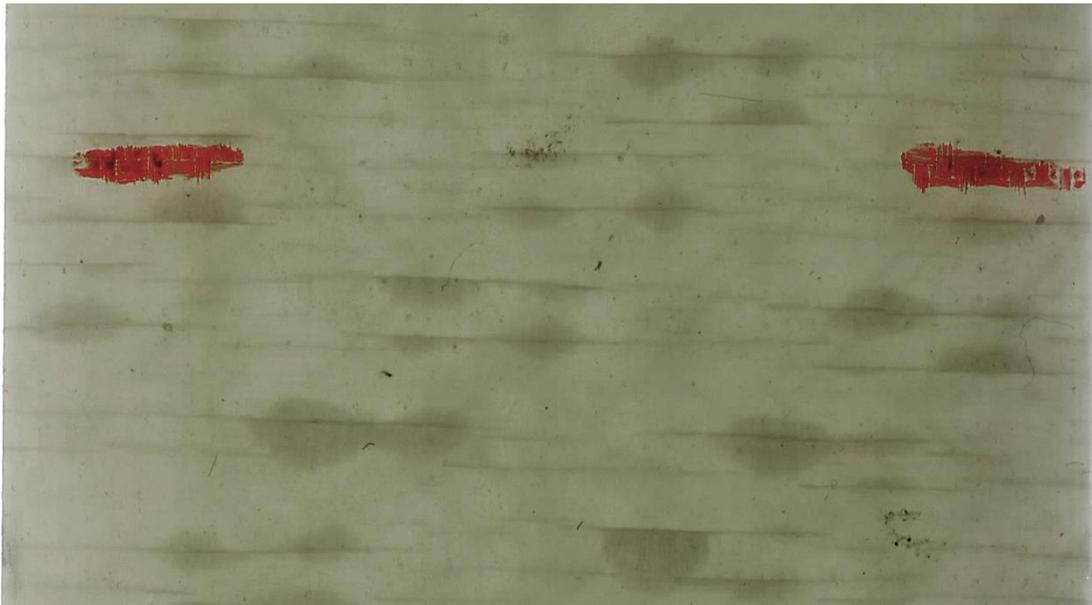
Figure 6-57. Scan of 13.75 ksi maximum woven sample at nearly 16% modulus reduction

Figure 6-55 through Figure 6-57 shows the progression of macro-scale damage within the woven specimens loaded at 13.75 ksi maximum. The red lines that appear in the scans are magic marker marks present from specimen manufacturing where the approximate middle of the specimen was marked to aid in the later attachment of the extensometer to the specimen. As is shown in the figures, the development of tensile cracks form in a 45° pattern on the specimen's surface. Additionally, the density of these tensile cracks increases with higher reductions in elastic modulus. Further, dark blotches around the tensile cracks, which are most likely areas of delamination, tend to grow in size with higher reductions in elastic modulus.

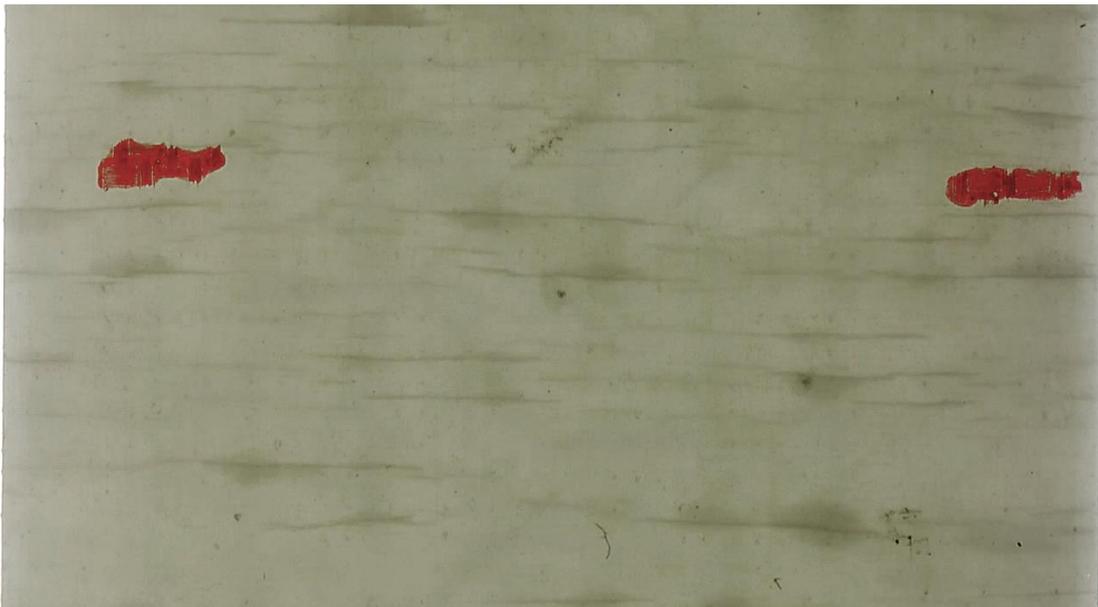
Figure 6-58. Scan of 18 ksi maximum woven sample at nearly 13% modulus reduction

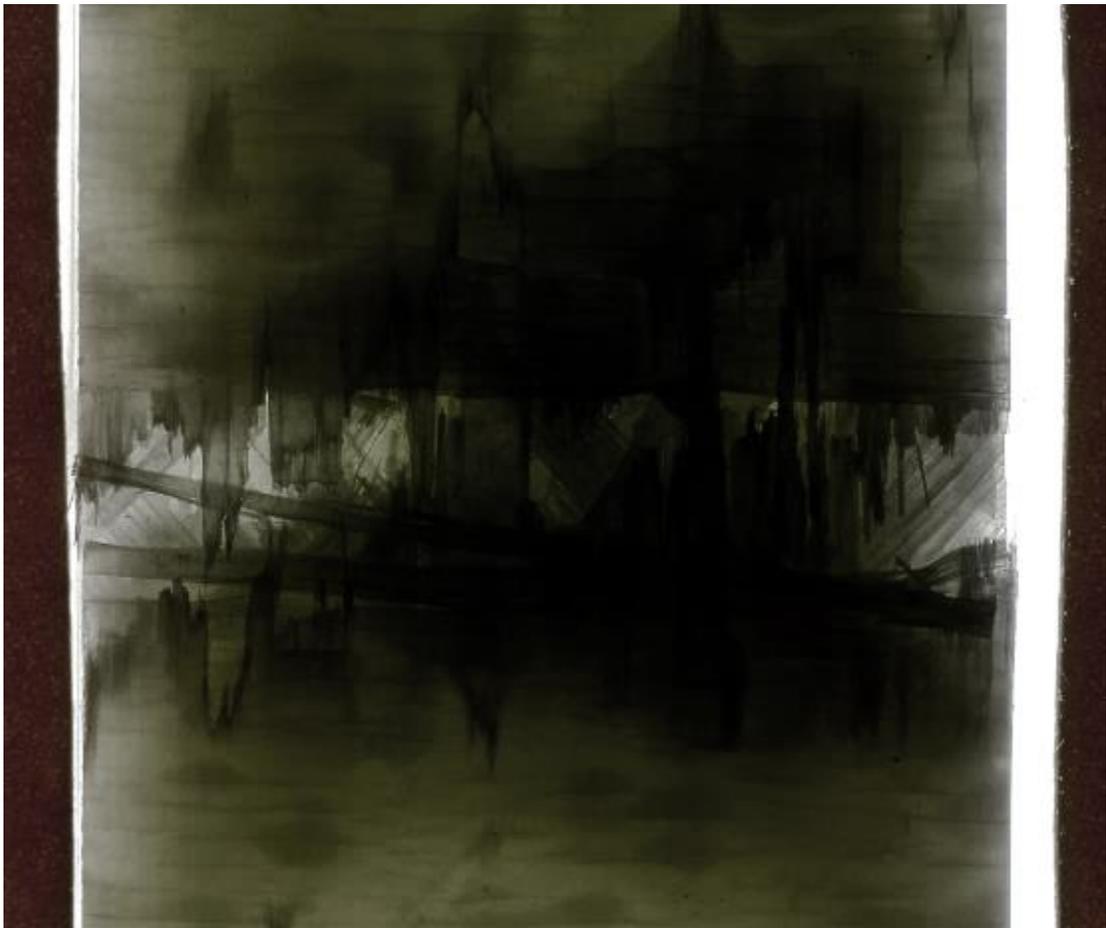
Figure 6-59. Scan of critical crack of woven sample failed at 28.75 ksi maximum fatigue stress

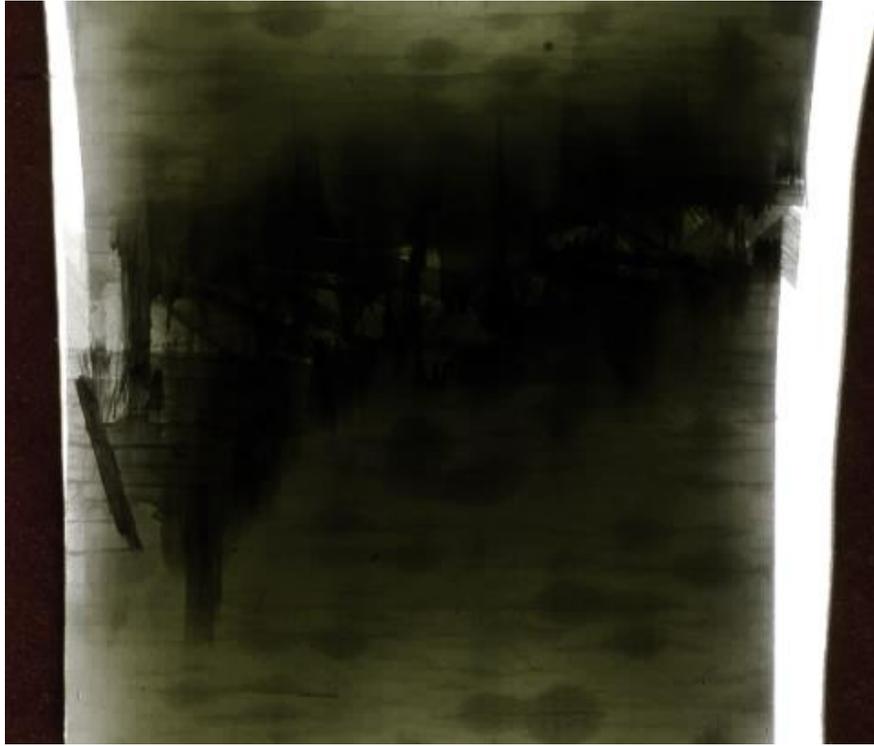
Figure 6-60. Scan of critical crack of woven sample failed at 24 ksi maximum fatigue stress

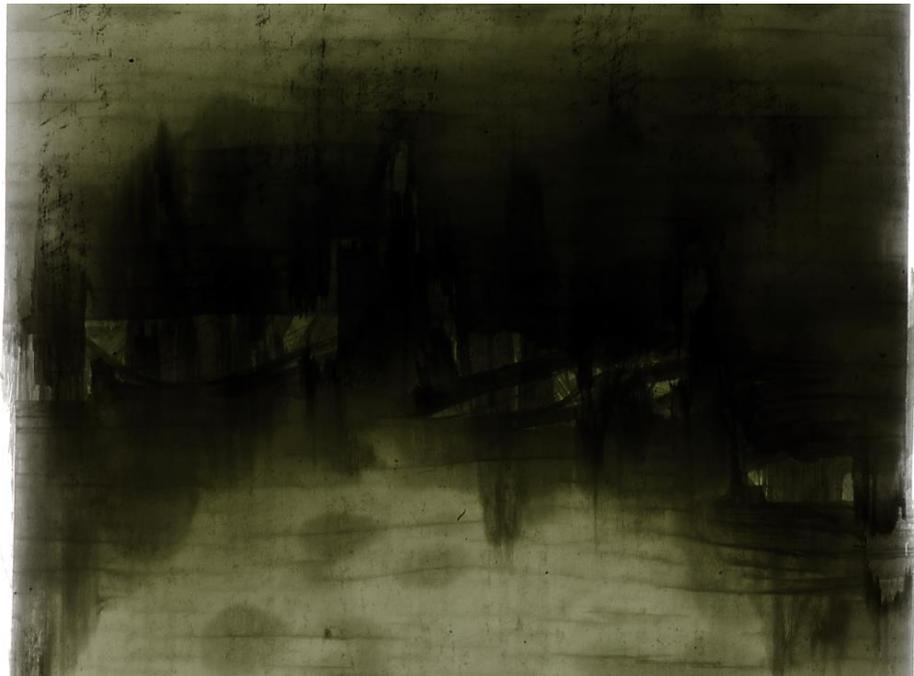
Figure 6-61. Scan of critical crack of woven sample failed at 18 ksi maximum fatigue stress

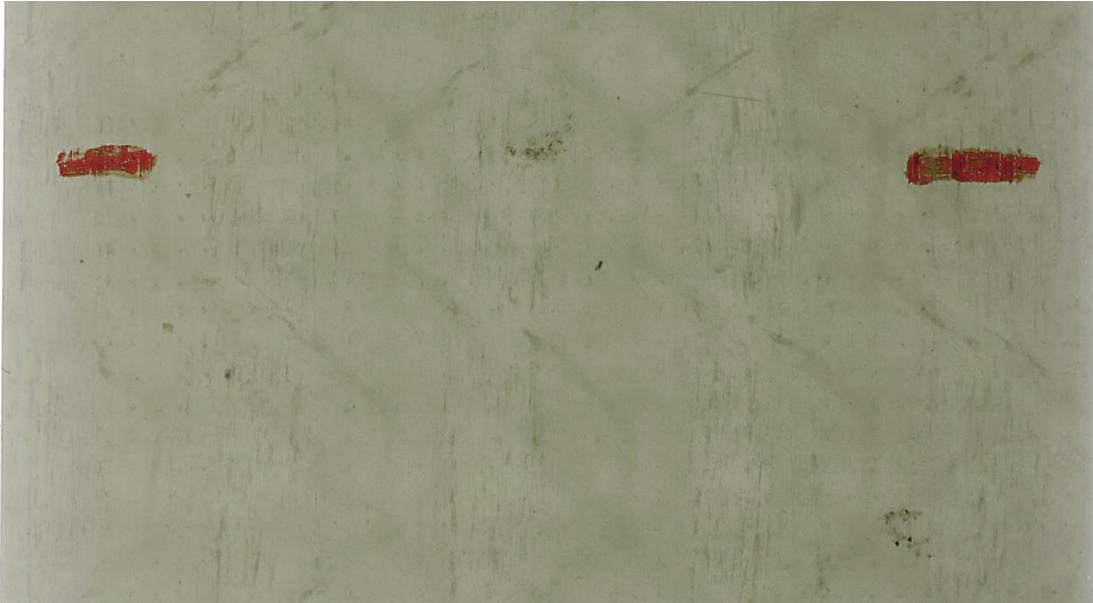
Figure 6-62. Virgin stitched sample for comparison to damaged samples

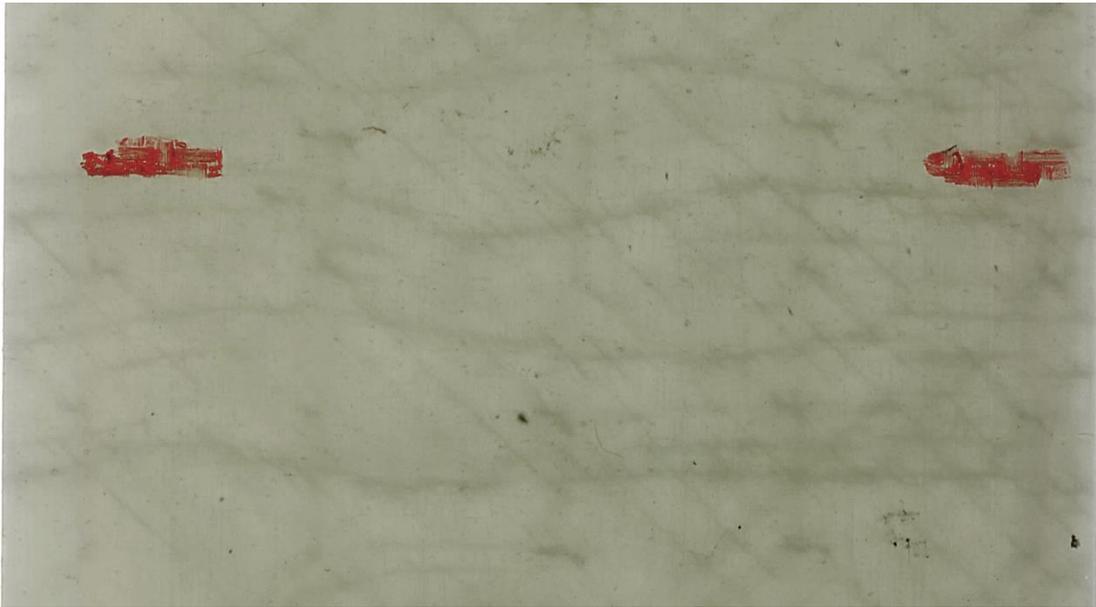
Figure 6-63. Scan of 13.75 ksi maximum stitched sample at nearly 10% modulus reduction

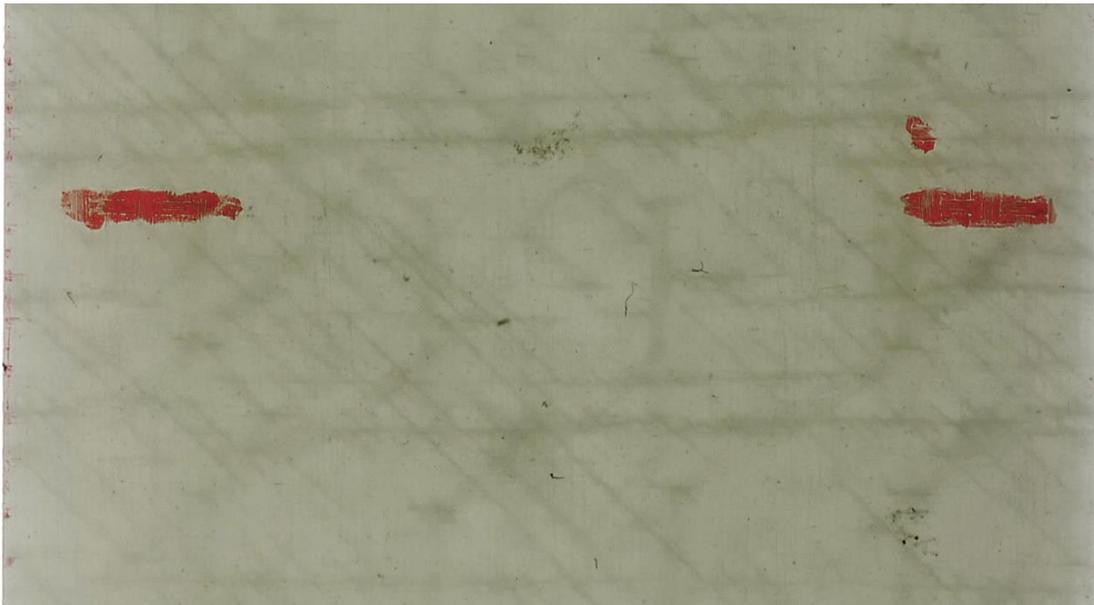
Figure 6-64. Scan of 13.75 ksi maximum stitched sample at nearly 13% modulus reduction

Damaged stitched samples tested at 13.75 ksi maximum are shown in Figure 6-63 to Figure 6-65, which range from 10% to 16% modulus reduction. Delaminations do not appear in these samples. In damaged stitched samples, numerous faint tensile cracks as well as fainter 45° cracks behind the 90° tensile matrix cracks. The density of both types of cracks increase for higher reductions in elastic modulus and the density of tensile cracks in the stitched specimens is higher than the density of tensile cracks in the woven specimens. However, just as the microscopy samples showed, there is no evidence of delaminations in the stitched samples within the scans of the 13.75 ksi maximum samples.

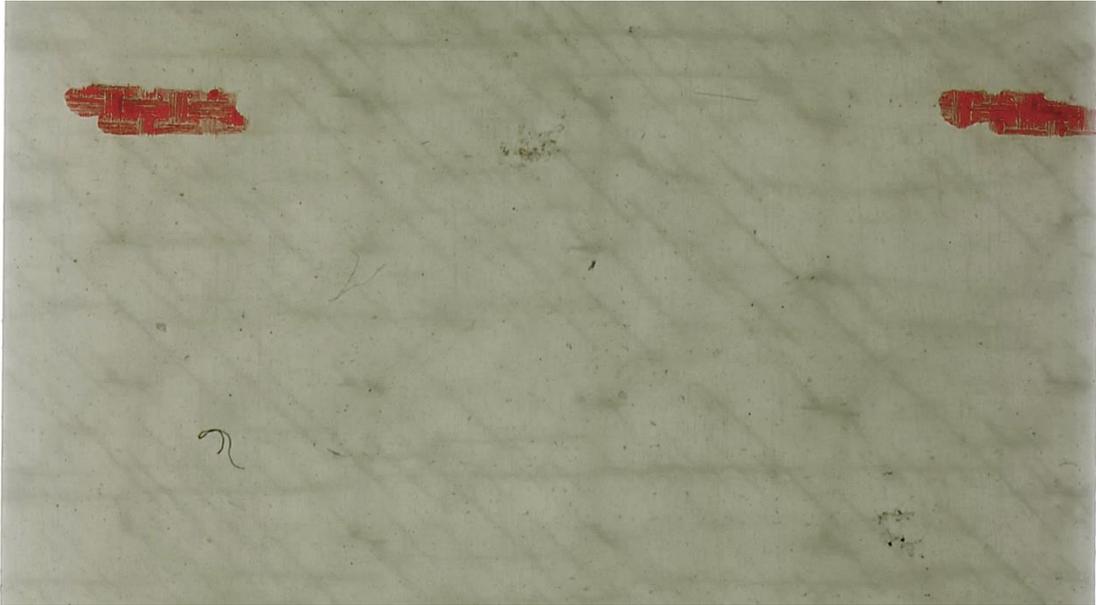
Figure 6-65. Scan of 13.75 ksi maximum stitched sample at nearly 16% modulus reduction
