The Pennsylvania State University

**MECHANICAL RESPONSE OF OUT-OF-AUTOCLAVE COMPLEX FIBER  
ARCHITECTURE COMPOSITES FOR MARINE STRUCTURES**

A Thesis in

Master of Science

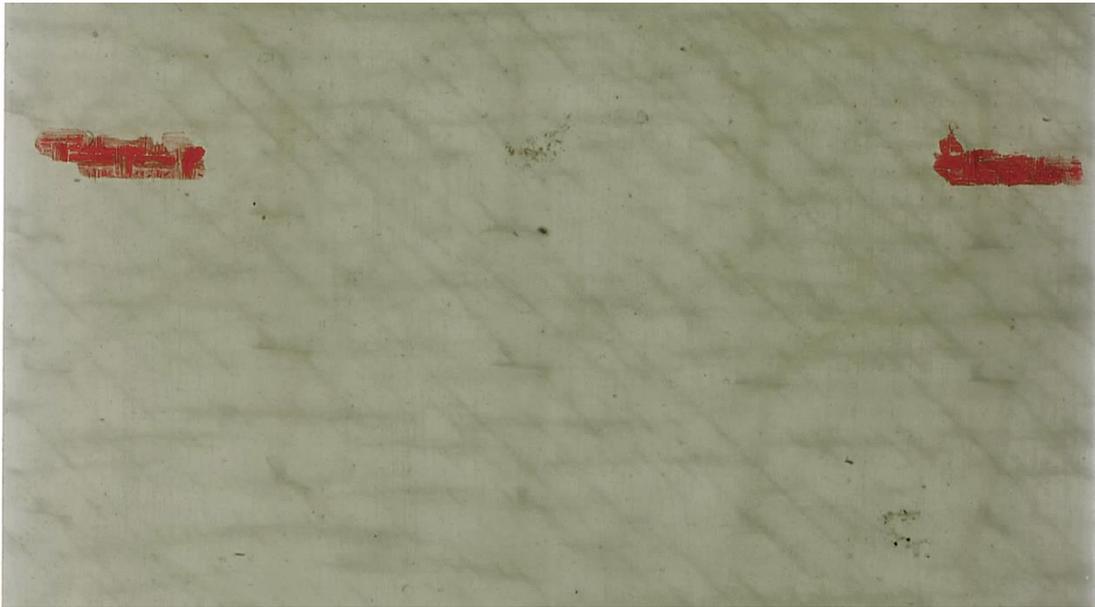
Figure 6-66. Scan of 18 ksi maximum stitched sample at nearly 13% modulus reduction

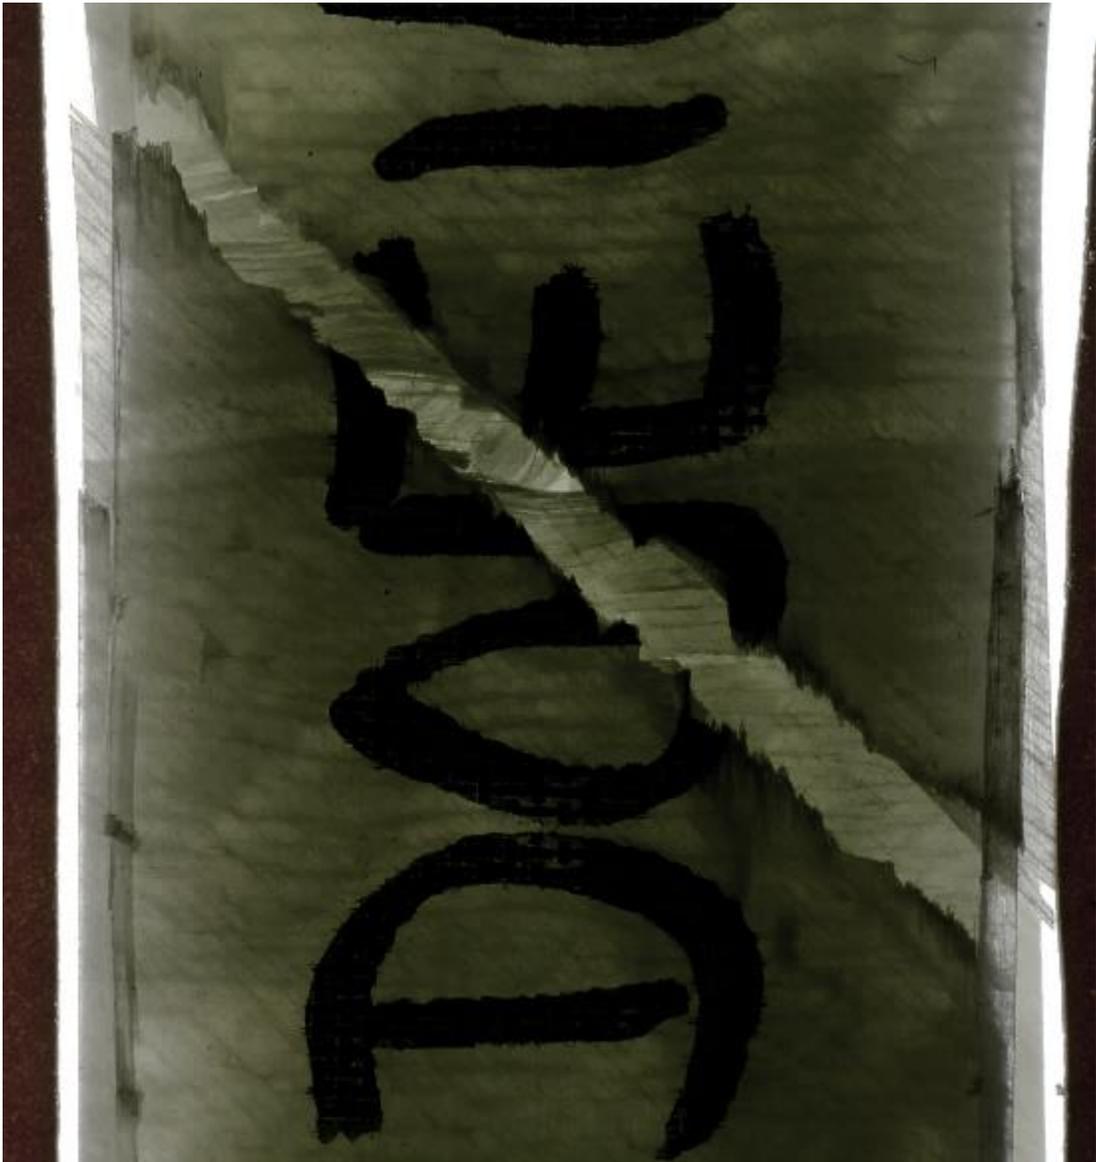
Figure 6-67. Scan of critical crack of stitched sample failed at 28.75 ksi maximum fatigue stress

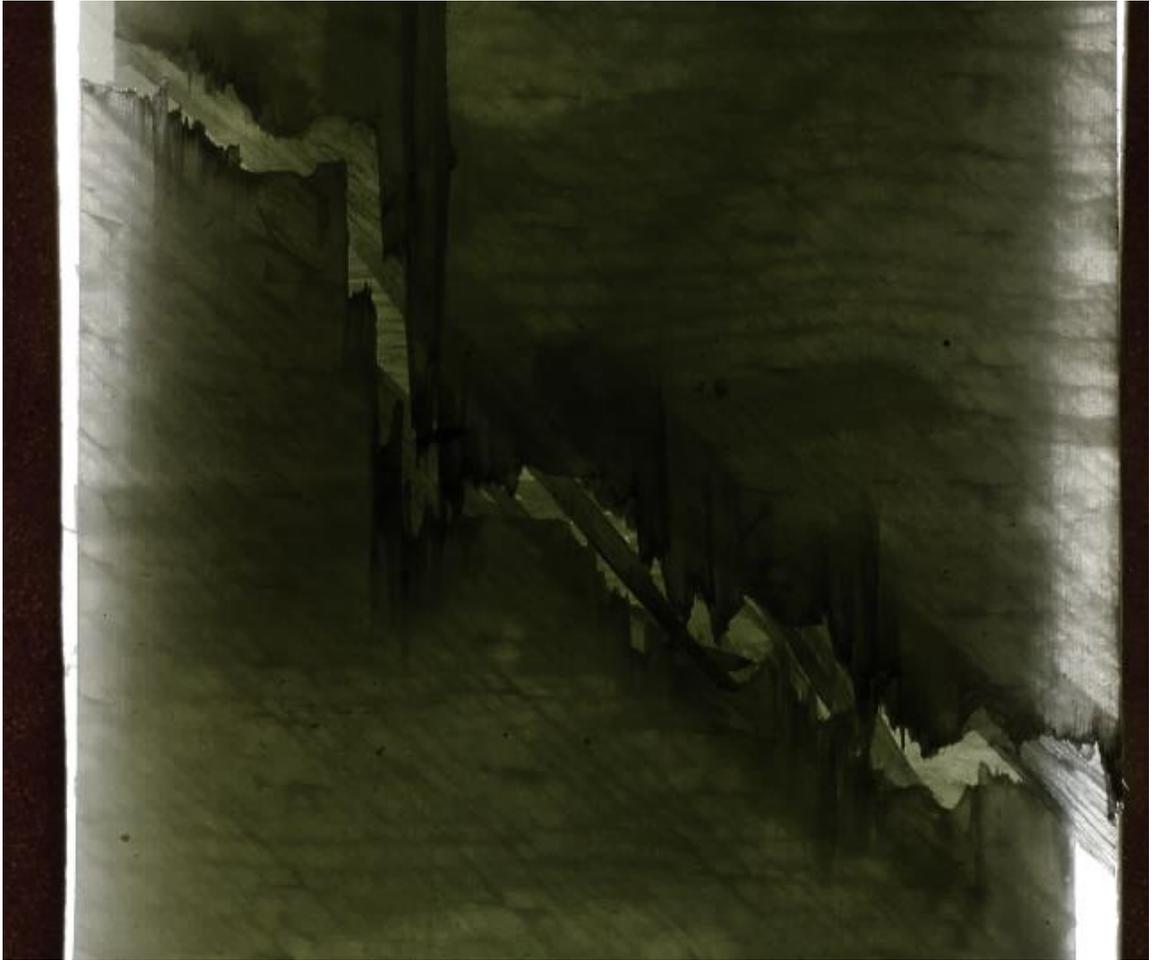
Figure 6-68. Scan of critical crack of stitched sample failed at 24 ksi maximum fatigue stress

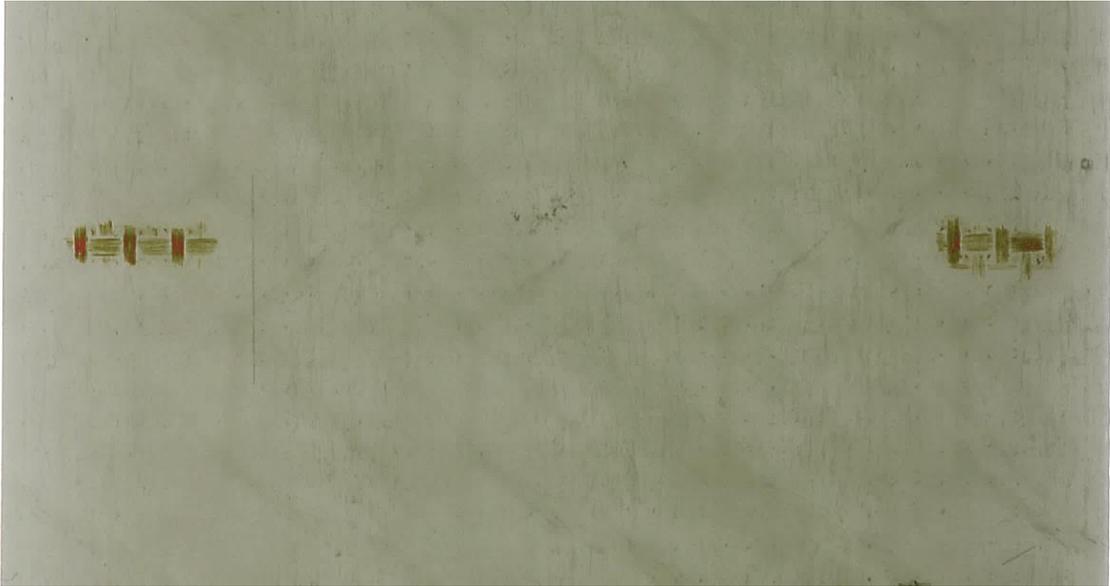
Figure 6-70. Scan of WET conditioned, but unloaded stitched sample without polysulfide edge seals

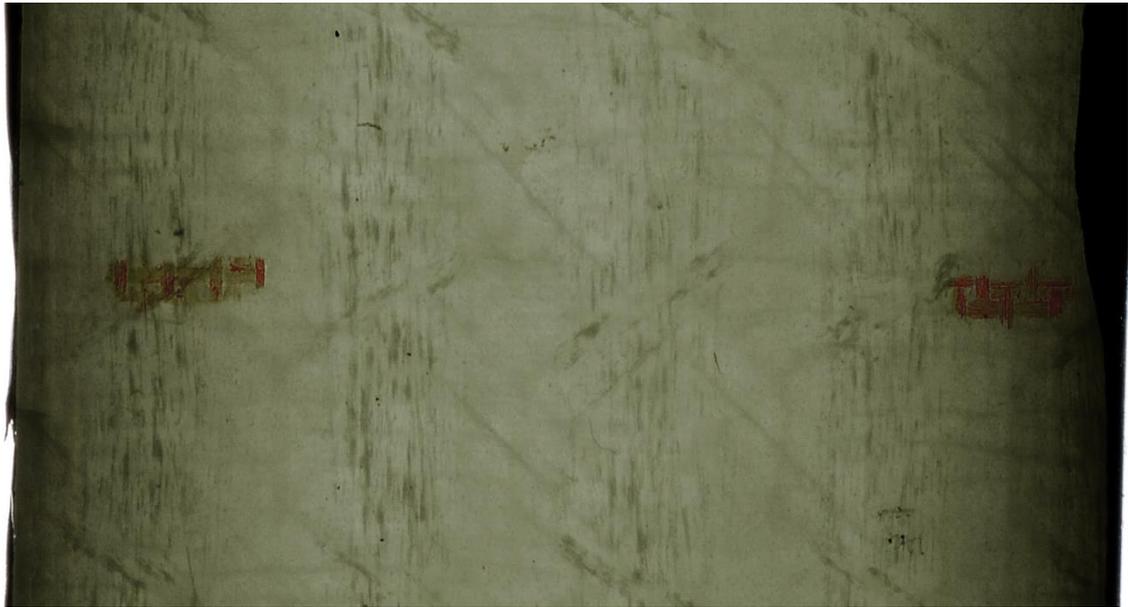
Figure 6-71. Scan of WET stitched sample tested to 10% modulus reduction at 13.75 ksi maximum

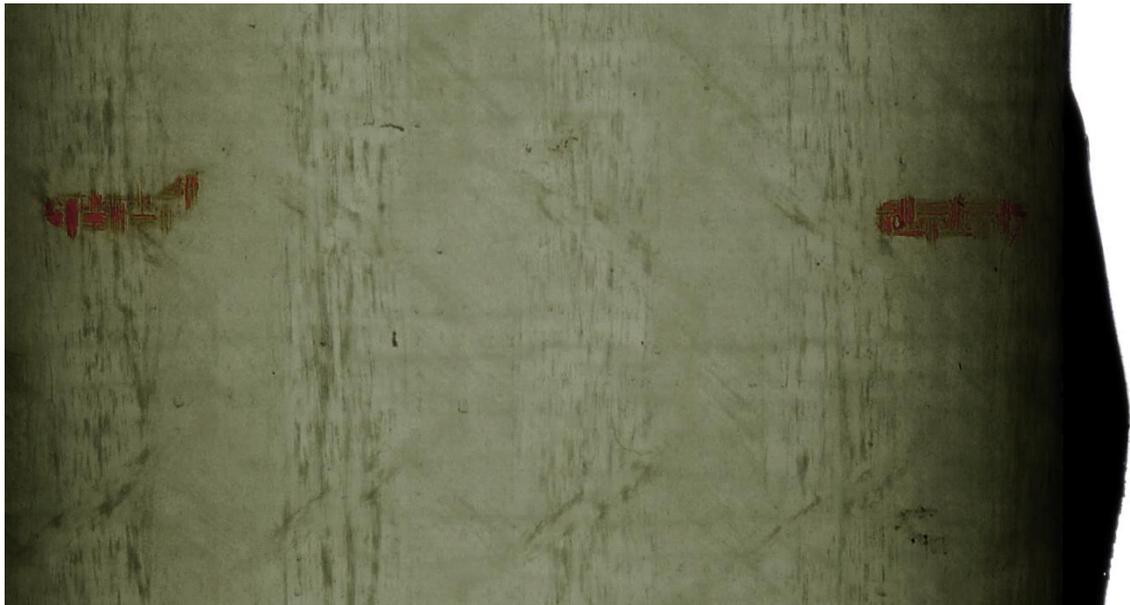
Figure 6-72. Scan of WET stitched sample tested to 13% modulus reduction at 13.75 ksi maximum

Images Figure 6-71 to Figure 6-73 show damage within the 13.75 ksi maximum WET samples tested to 10 to 16% modulus reduction. While faint 90° and 45° cracks are apparent, the polysulfide edge seal and the specimen's loss in transparency makes determining the state of damage within the composite difficult. Additionally, some 0° tows show through the surface, and without microscopy, it is difficult to note whether there is damage within the tow. The same description can be made for the 18 ksi maximum WET samples shown in Figure 6-74 and Figure 6-75. Microscopy could be performed on sectioned WET samples at a later time, but were not as part of this investigation.

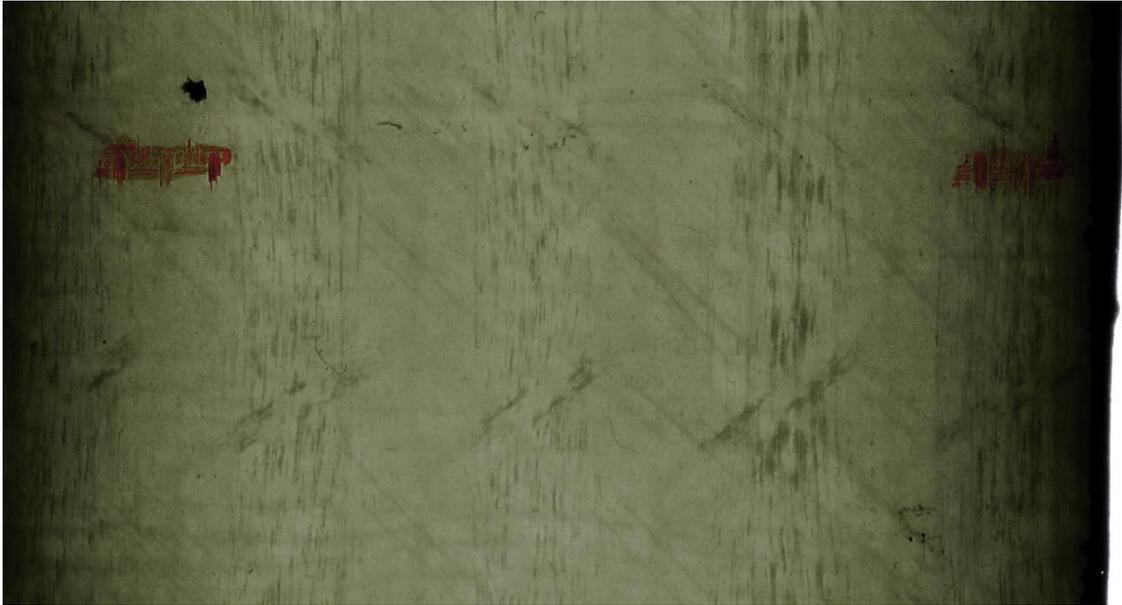
Figure 6-73. Scan of WET stitched sample tested to 16% modulus reduction at 13.75 ksi maximum

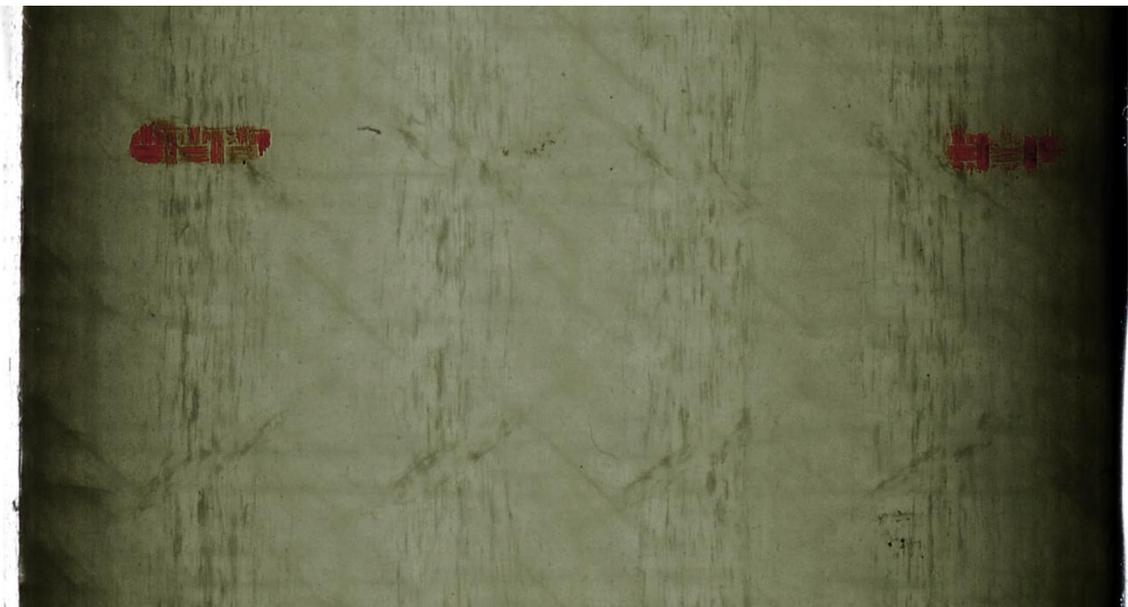
Figure 6-74. Scan of WET stitched sample tested to 10% modulus reduction at 18 ksi maximum

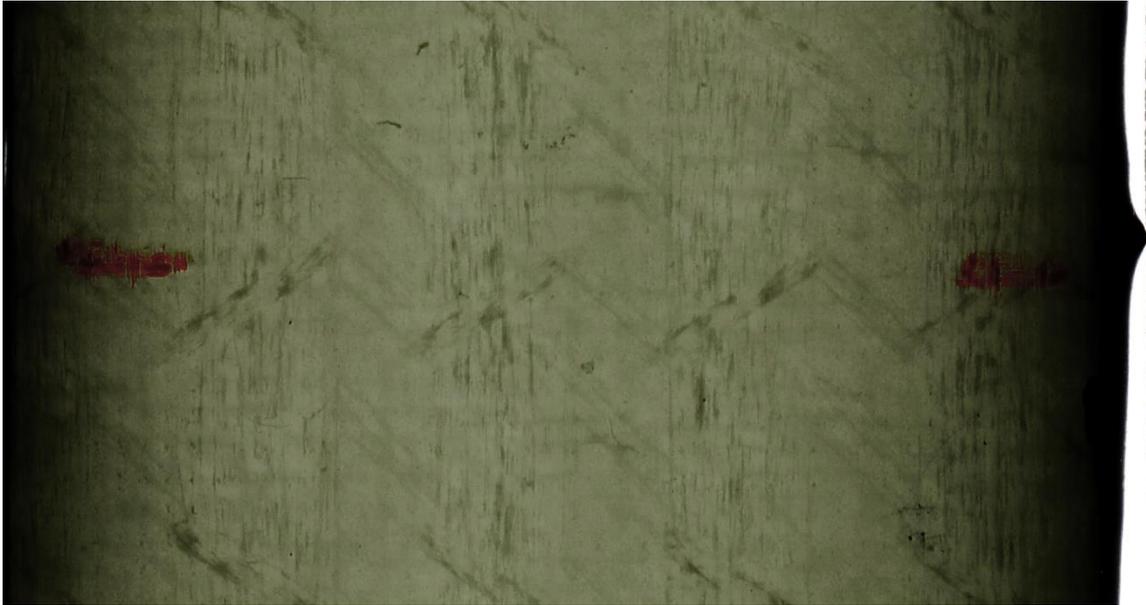
Figure 6-75. Scan of WET stitched sample tested to 16% modulus reduction at 13.75 ksi maximum

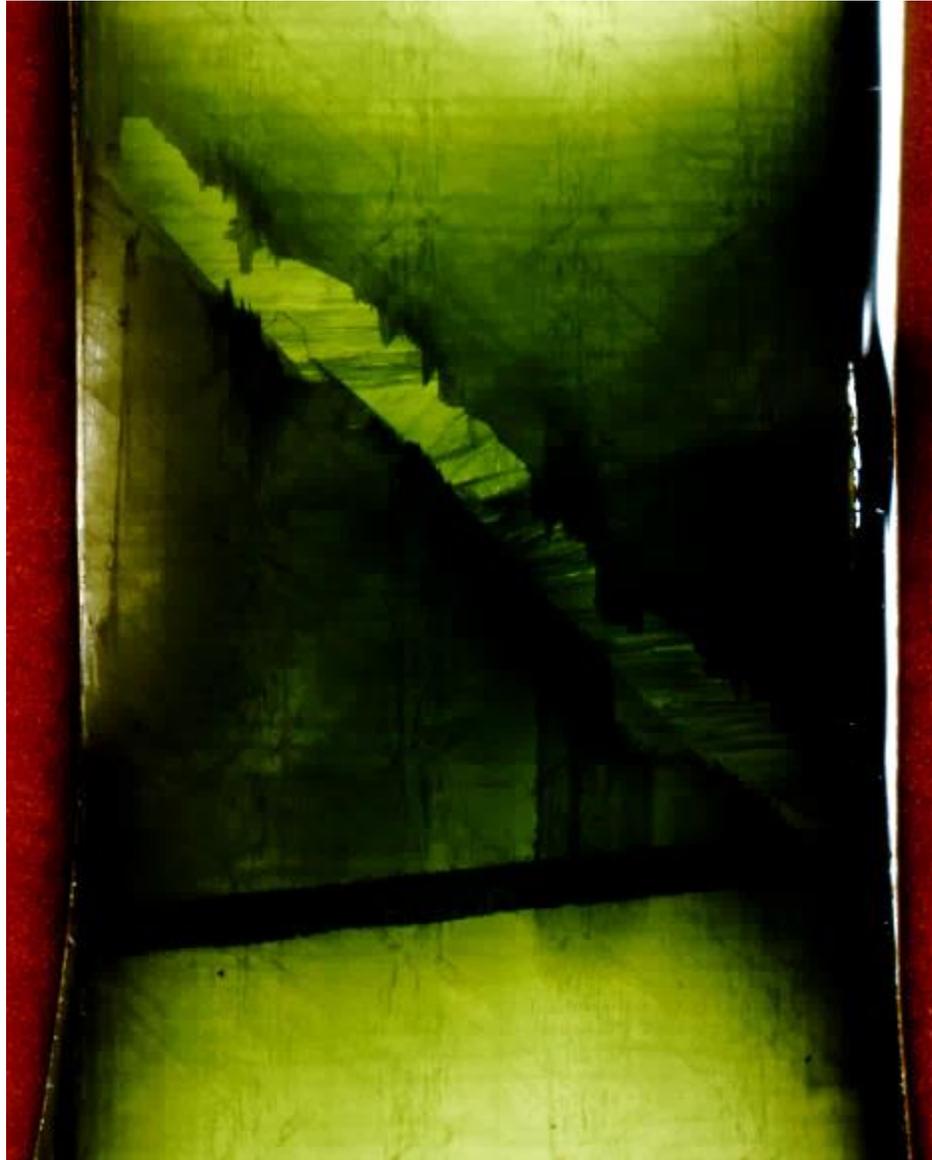
Figure 6-76. Scan of critical crack of WET stitched sample failed at 28.75 ksi maximum fatigue stress

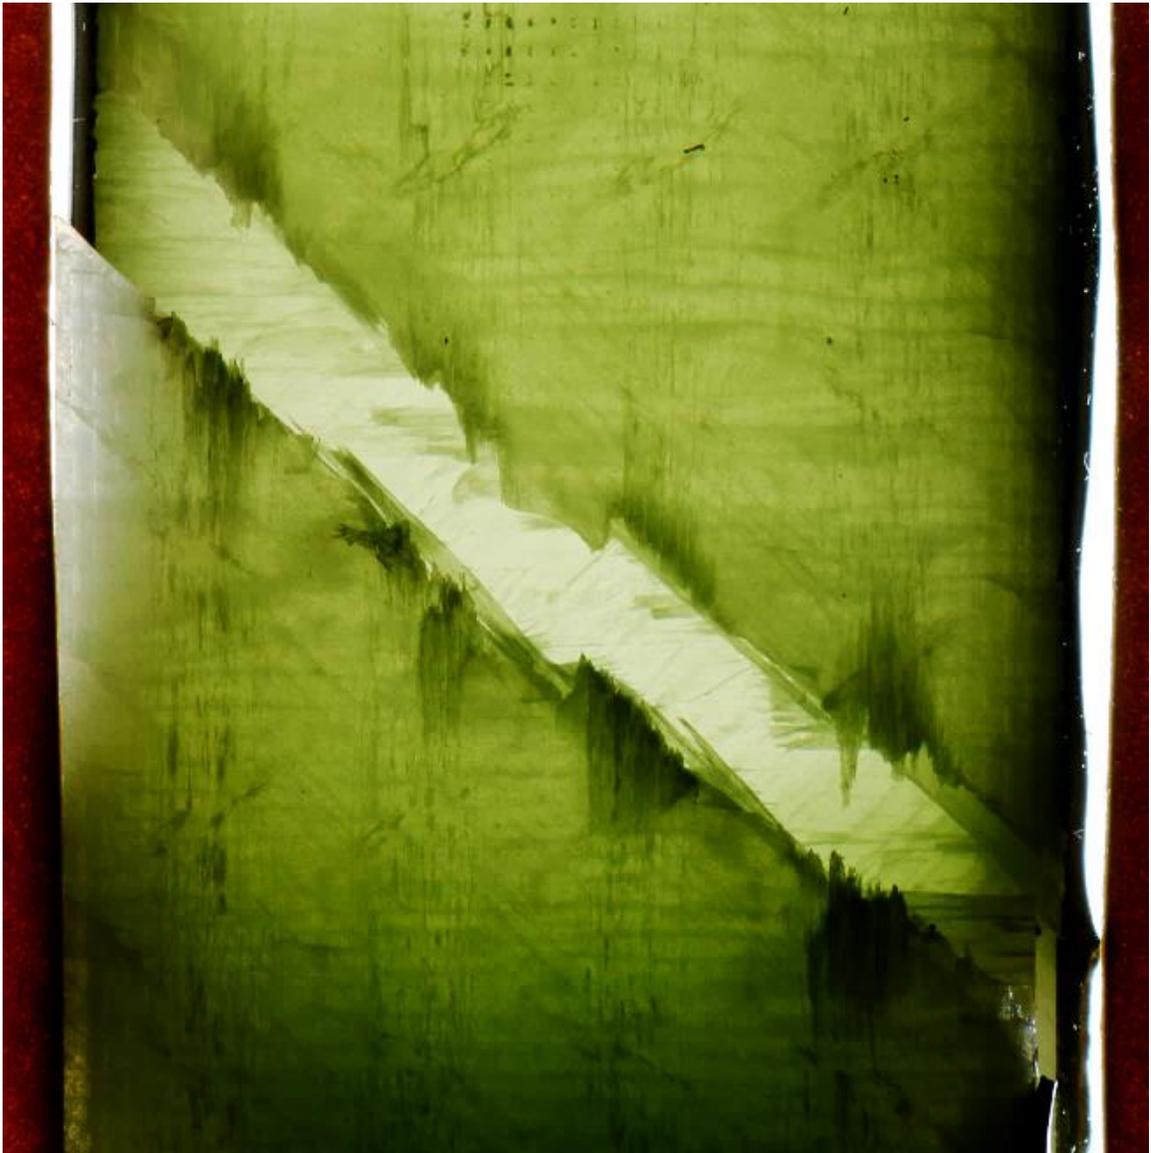
Figure 6-77. Scan of critical crack of WET stitched sample failed at 24 ksi maximum fatigue stress

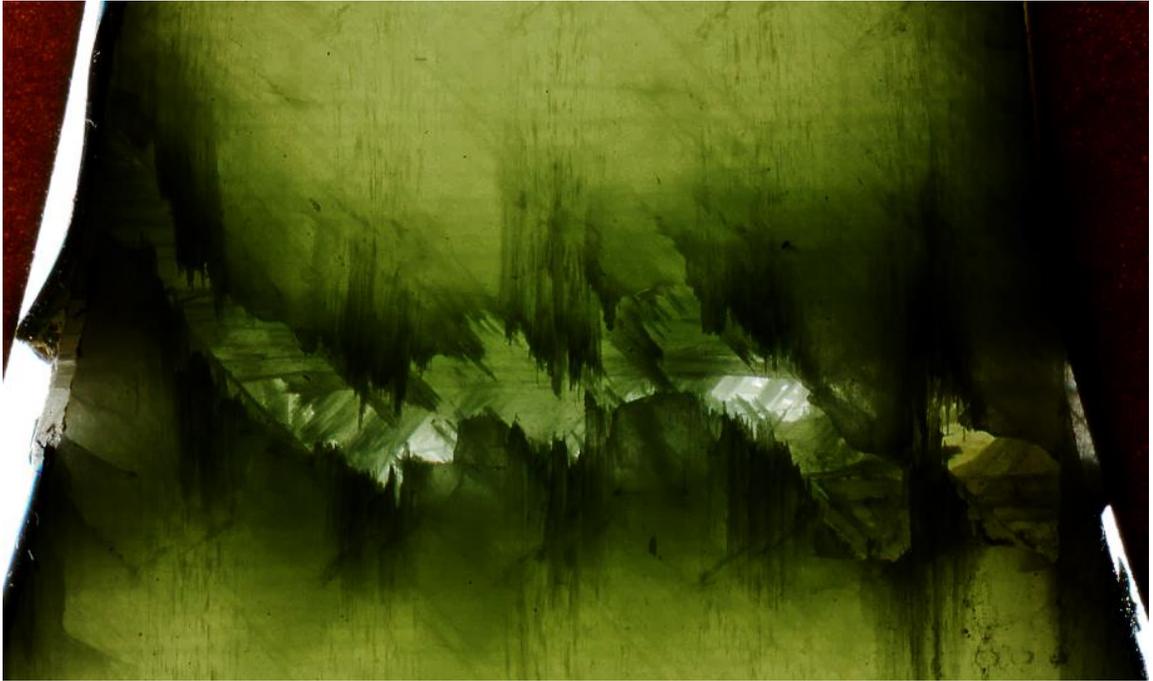
Figure 6-78. Scan of critical crack of WET stitched sample failed at 18 ksi maximum fatigue stress
