The Pennsylvania State University
The Graduate School
Department of Civil and Environmental Engineering

**THE VIABILITY OF PARTIALLY POST-TENSIONED CONCRETE MEMBERS
IN AN AGGRESSIVE ENVIRONMENT, INCLUDING CYCLIC LOADING**

A Dissertation in
Civil Engineering
by
Jeffery Scott Volz

December 2008

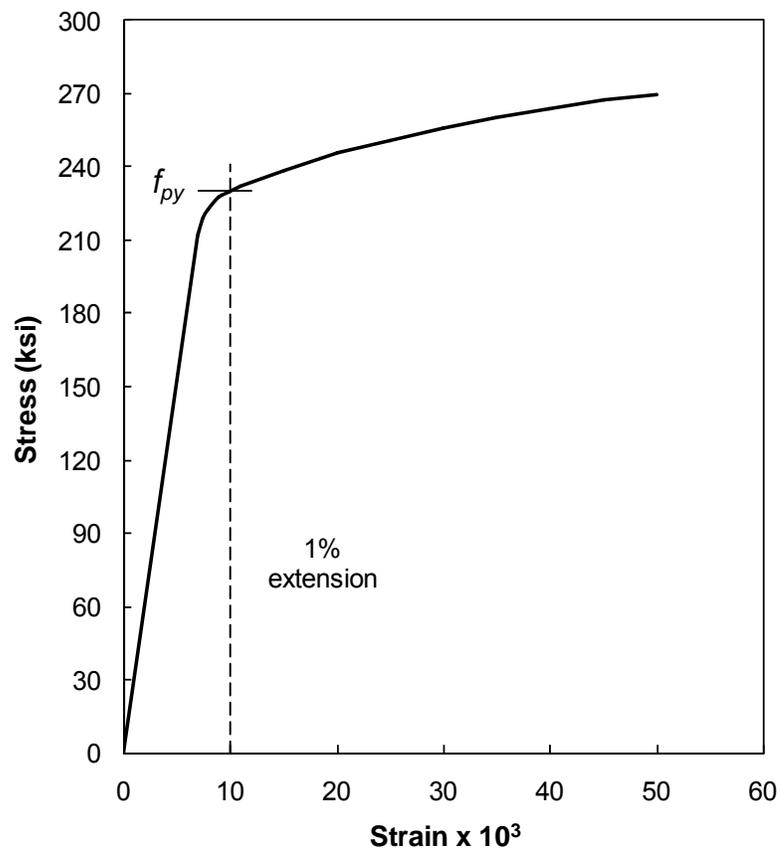
As a result of this production process, prestressing steel exhibits a stress-strain relationship significantly different than mild steel. A detailed stress-strain diagram for Grade 270 prestressing strand is shown in Figure 2-2 (*e.g.*, Lin and Burns 1981, Nilson 1987).

Figure 2-2: Stress-Strain Curve for Grade 270 Prestressing Strand

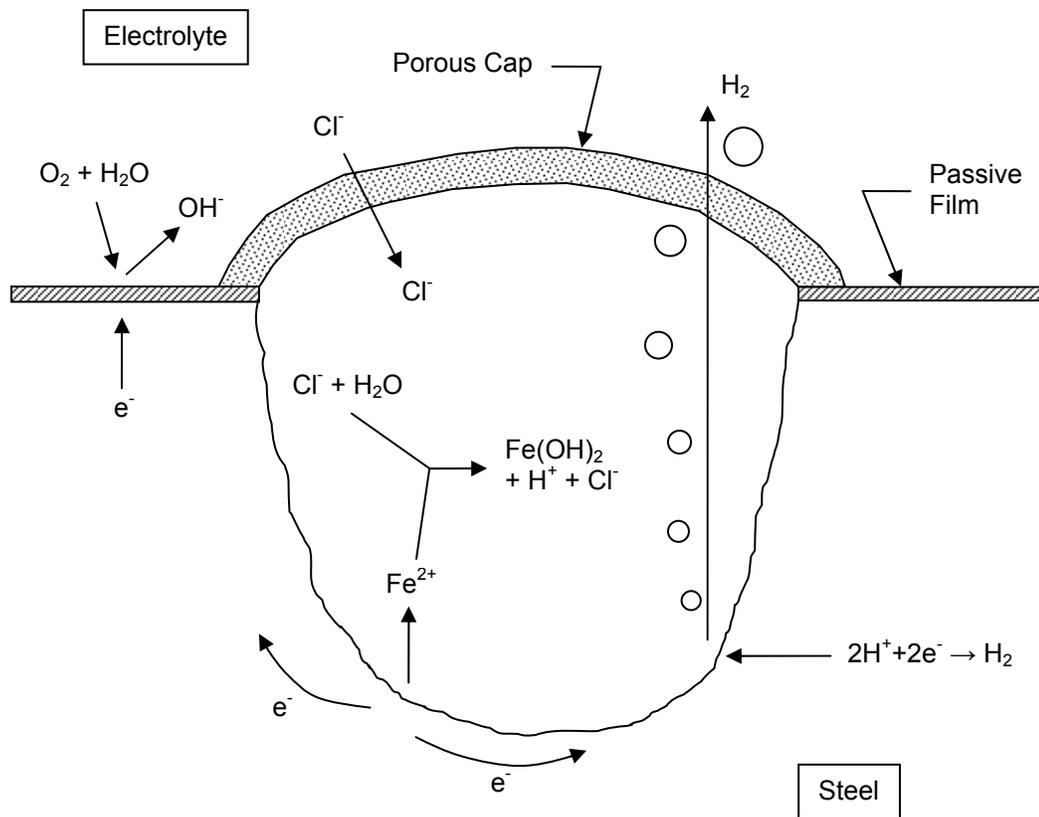
Some of the ferrous ions migrate from the pit and oxidize at the pit mouth to form an insoluble, porous cap as shown in Figure 2-3. This cap reduces the further escape of dissolved iron but allows the smaller chloride ions to penetrate to the pit interior (Jones 1996). The chloride ions sustain the acid solution within the pit and result in the continued dissolution of iron (Jones 1996). The anodic reaction within the pit couples with a cathodic reaction on the strand surface, where oxygen is reduced to form hydroxyl ions, which increases the pH at these cathodic sites (Jones 1996).

Figure 2-3: Schematic of Corrosion Pit Propagation in Steel

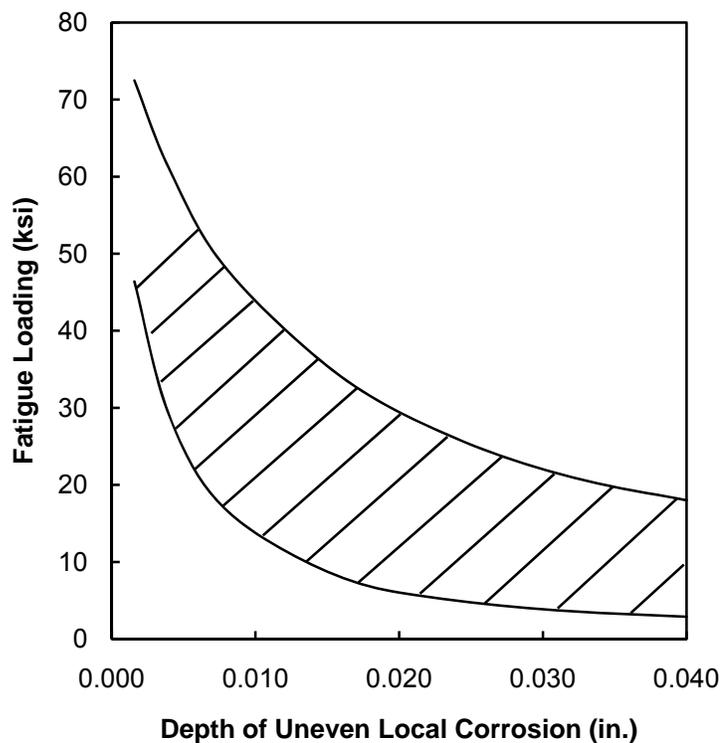
and mechanisms of corrosion, methods of preventing corrosion, and the results of corrosion on the behavior of prestressing strand. Nürnberger concludes that local corrosion is the most detrimental form of corrosion experienced by prestressing strand. Figure 2-4 is a plot from Nürnberger that shows the degradation in fatigue capacity of cold drawn prestressing wire as a function of pitting corrosion (based on 2,000,000 cycles).

Figure 2-4: Fatigue Capacity of Prestressing Wire as a Function of Pitting Corrosion. Nürnberger (2002) Reproduced with Permission.

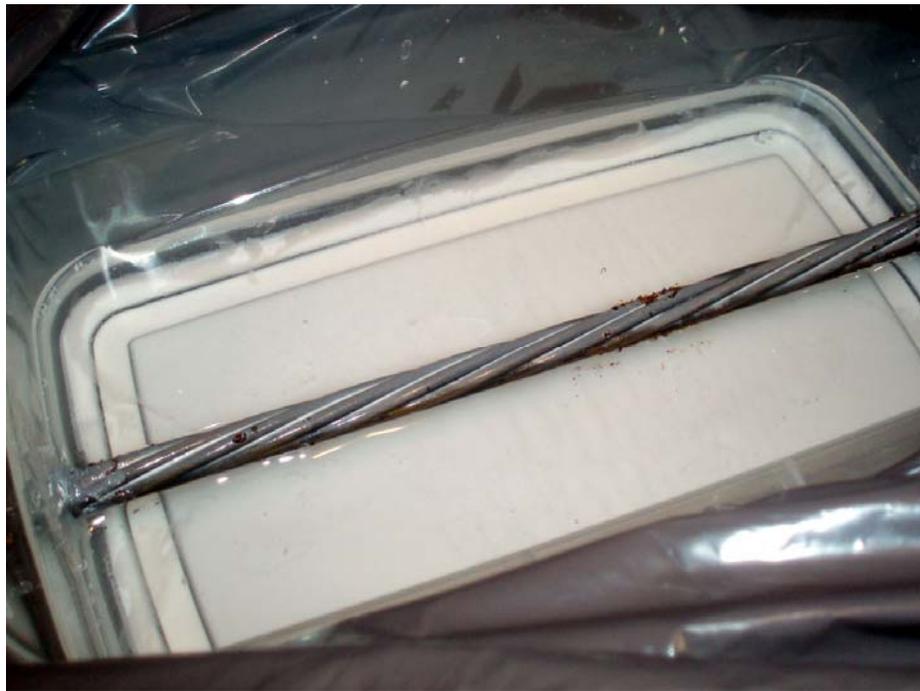
The author placed the strand samples within the above solution and allowed them to corrode at their own natural pace, as shown in Figure 3-1. (Initial testing accelerated the degradation process by applying an electrode potential to the strand sample. However, as discussed in Appendix A, this method was subsequently abandoned.) A plastic container measuring 26.5"x 15.8"x 6.5" was used to contain the pore water and NaCl salt solution. A 1/2" diameter hole was drilled in the short sides of the container through which the strand sample was placed. These holes were subsequently sealed with a rubber-silicone caulk. This arrangement was used to limit the exposed portion of the strand to the center two-thirds, eliminating corrosion within the vicinity of the attachment points to the fatigue frame.

Figure 3-1: Non-Accelerated Corrosion Setup

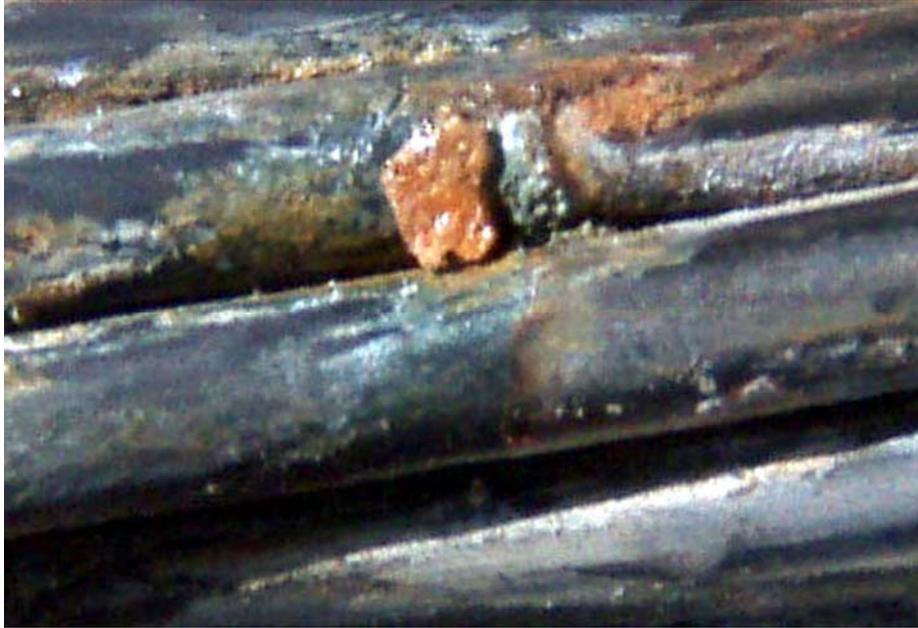
Figure 3-2: Pitting Corrosion Attack

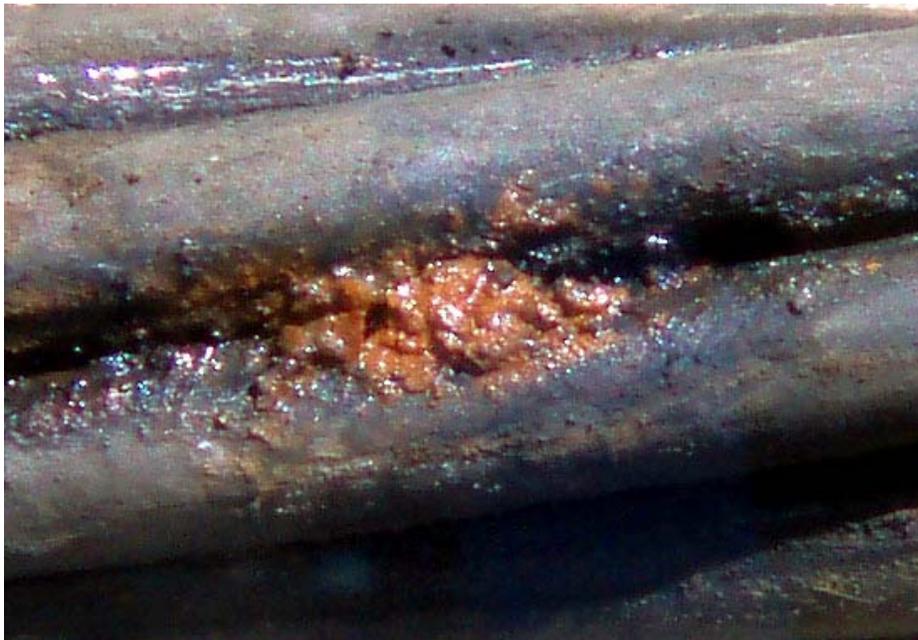
Figure 3-3: Crevice Corrosion Attack

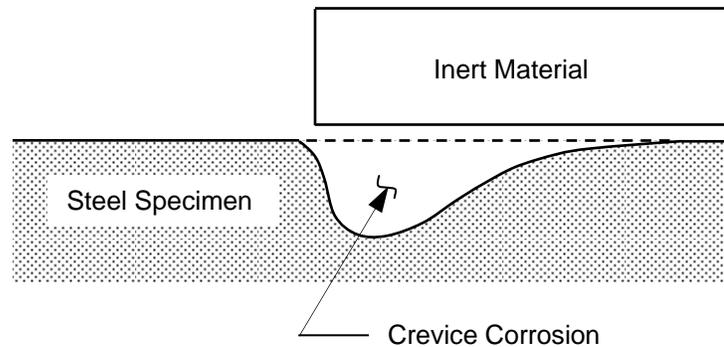
The morphology of classic crevice corrosion is shown in Figure 3-4 (Jones 1996). The shape of the section loss within the crevice follows the shape of the active and passive regions of the anodic polarization curve (Pickering 2003). However, studies have shown that pitting can form near the mouth of very tight crevices (Jones 1996), such as those that occur between adjacent wires of the strand. Furthermore, research has shown that the presence of chlorides in the electrolyte can promote the formation of pitting near the mouth of a crevice (Cho and Pickering 1991).

Figure 3-4: Schematic of Typical Crevice Corrosion Attack

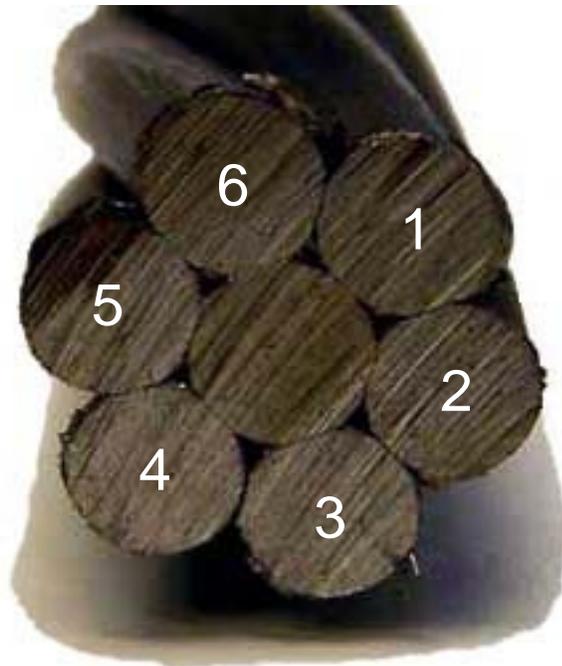
Figure 3-5: Wire Numbering Convention for Recording Corrosion Data in Table 3-1

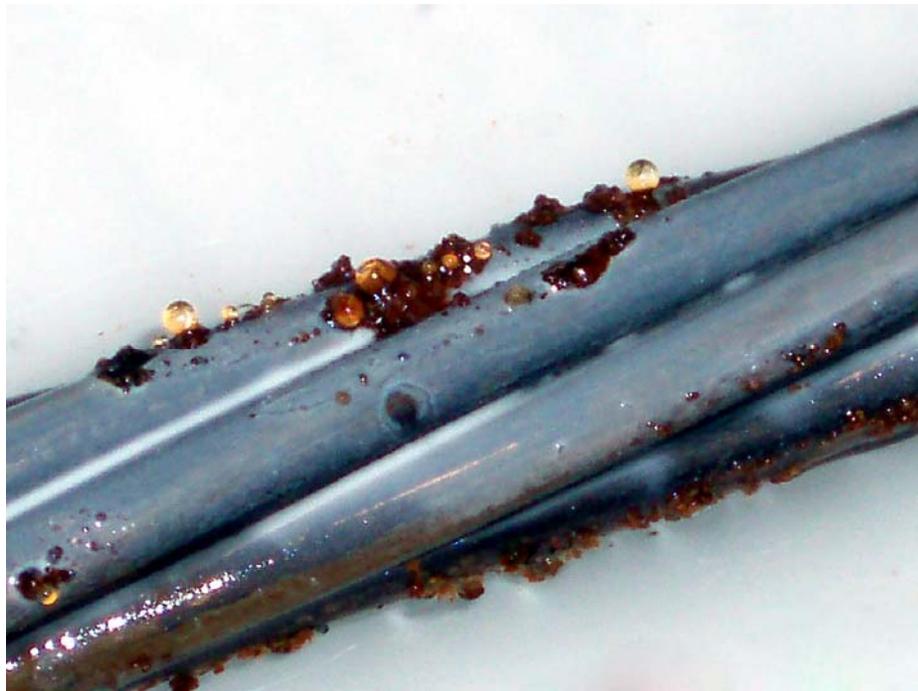
active pitting and, based on the mass spectrometry, support the theory put forth by numerous researchers (*e.g.*, Novokshchenov 1994, Bentur *et al.* 1997, Broomfield 1997) concerning hydrogen formation within a corrosion pit.

Figure 3-6: Hydrogen Evolution During Localized Corrosion Attack

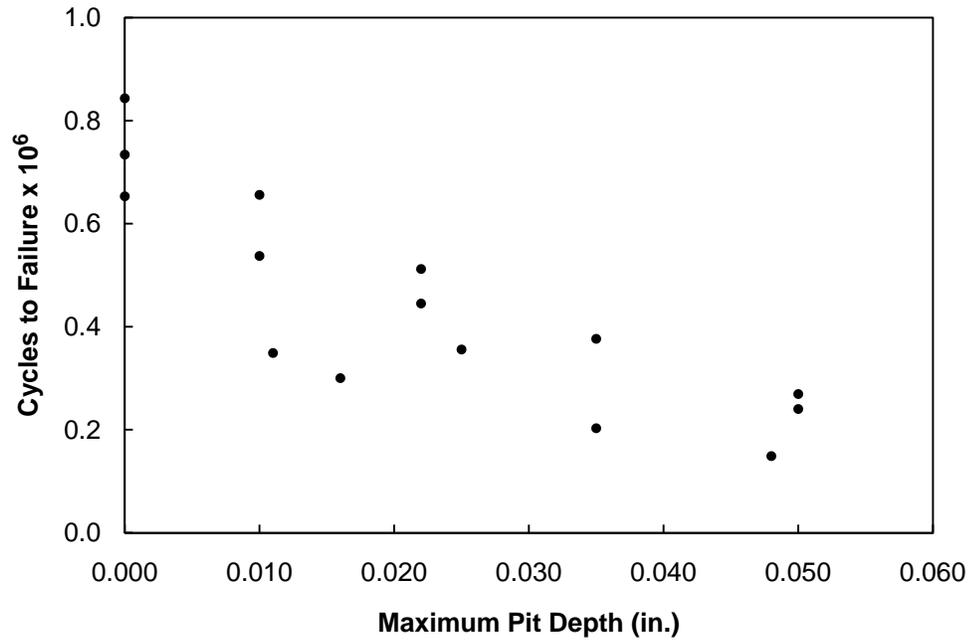
The strand test results are presented in Figures 3-10 through 3-14. The independent variables are maximum pit depth, average pit depth, percentage loss of strand area, percentage of corroded strand surface, and percentage weight loss of strand, respectively. The dependent variable is number of cycles to failure. The data is contained in Tables 3-1 through 3-4. For the plot of average pit depth, Figure 3-11, the independent variable represents the numerical average of the pit depths recorded in Table 3-1 for a particular strand specimen. The data presented in Figures 3-10 through 3-14 was used as the basis for the LEFM and empirical studies that follow.

Figure 3-10: Cycles to Failure as a Function of Maximum Pit Depth

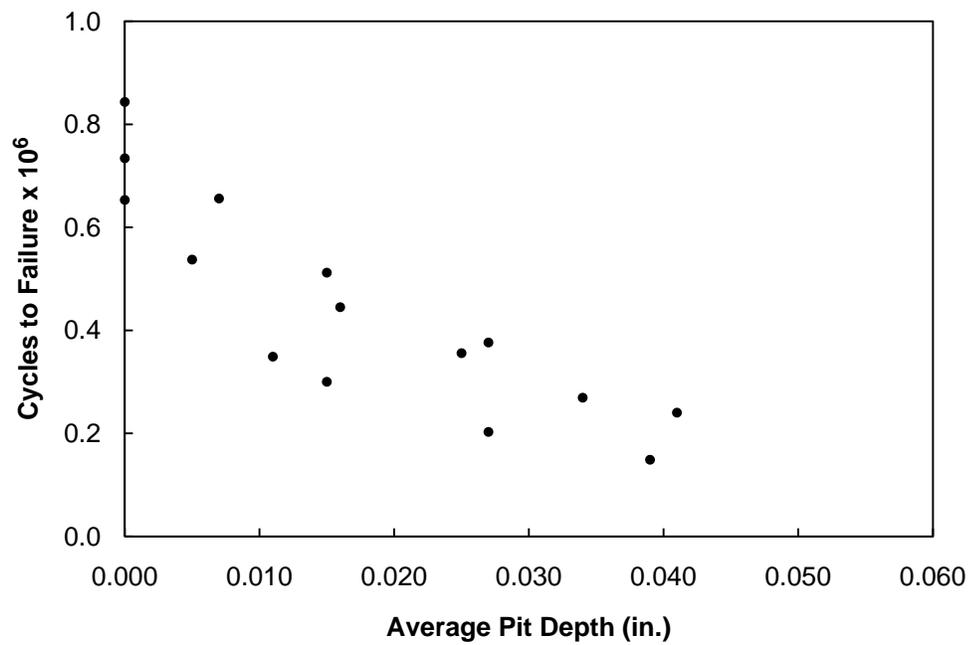
Figure 3-11: Cycles to Failure as a Function of Average Pit Depth

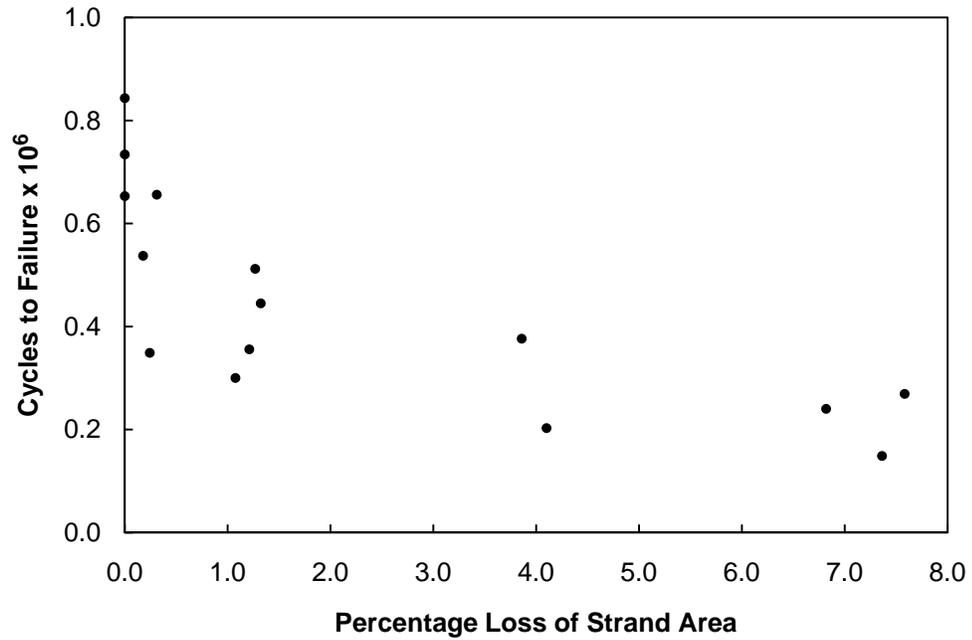
Figure 3-12: Cycles to Failure as a Function of Percentage Loss of Strand Area

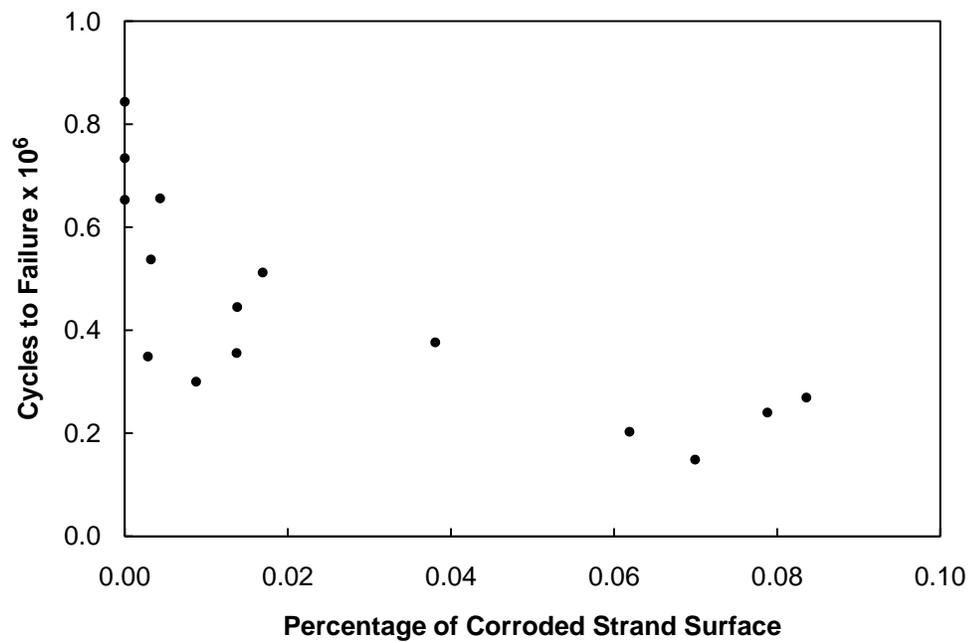
Figure 3-13: Cycles to Failure as a Function of Percentage of Corroded Strand Surface

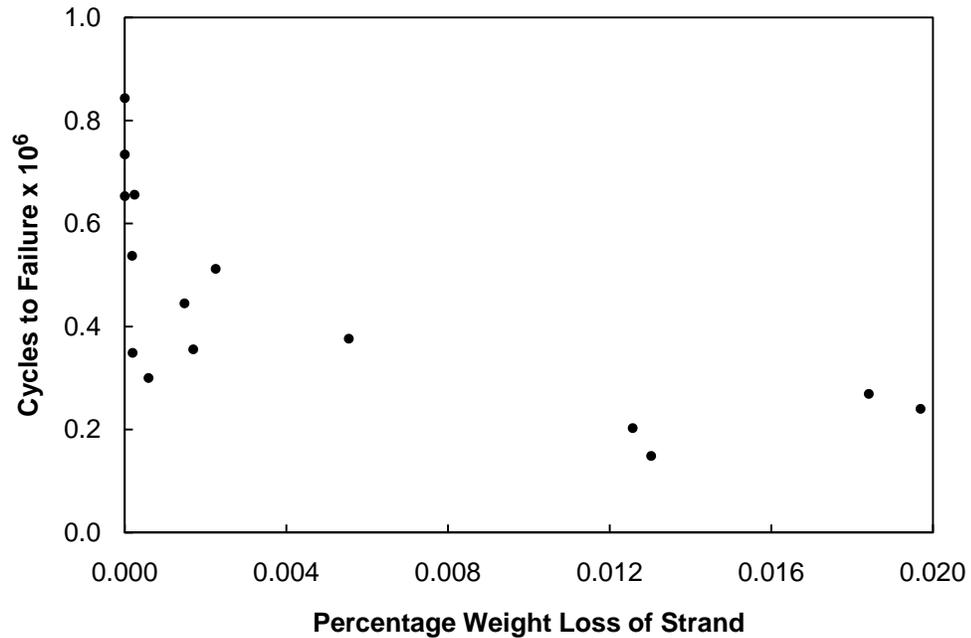
Figure 3-14: Cycles to Failure as a Function of Percentage Weight Loss of Strand

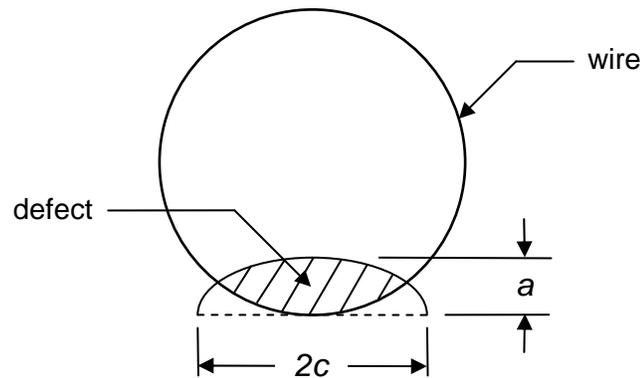
Equation 3.4 requires the empirical constants C and m as well as initial and final defect lengths, a_i and a_f , respectively. For cold drawn, eutectoid steel wires, Llorca and Sanchez-Galvez (1989) determined values of 1.107×10^{-11} for C and 2.417 for m . These values were based on units of m/cycle for da/dN and $\text{MPa}\sqrt{\text{m}}$ for ΔK . Llorca and Sanchez-Galvez also found that the cold drawing process resulted in surface flaws in the wires due to inclusions, cavities, and cracks associated with cavities. Although the flaws varied in profile, the most common defect had an aspect ratio, a/c , equal to 0.5, as shown in Figure 3-15, and a length, a_i , of 55 to 57 μm .

Figure 3-15: Cold Drawn Wire Defect Profile

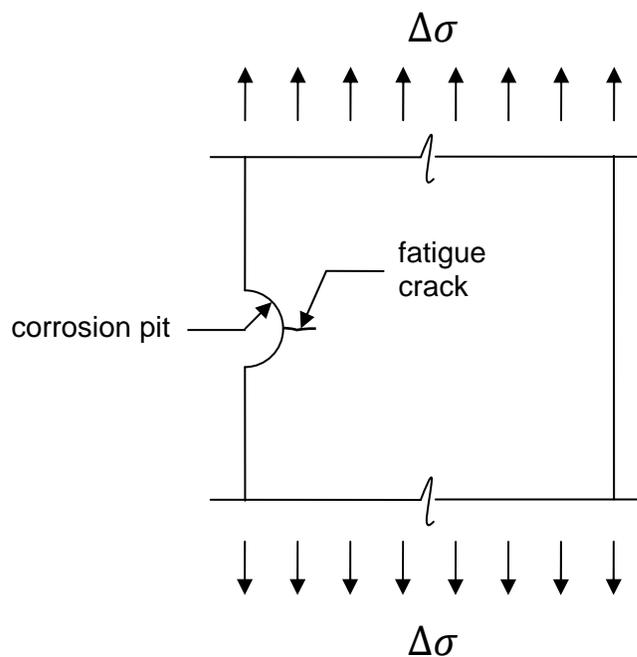
Figure 3-16: Fatigue Crack Emanating from the Base of a Corrosion Pit

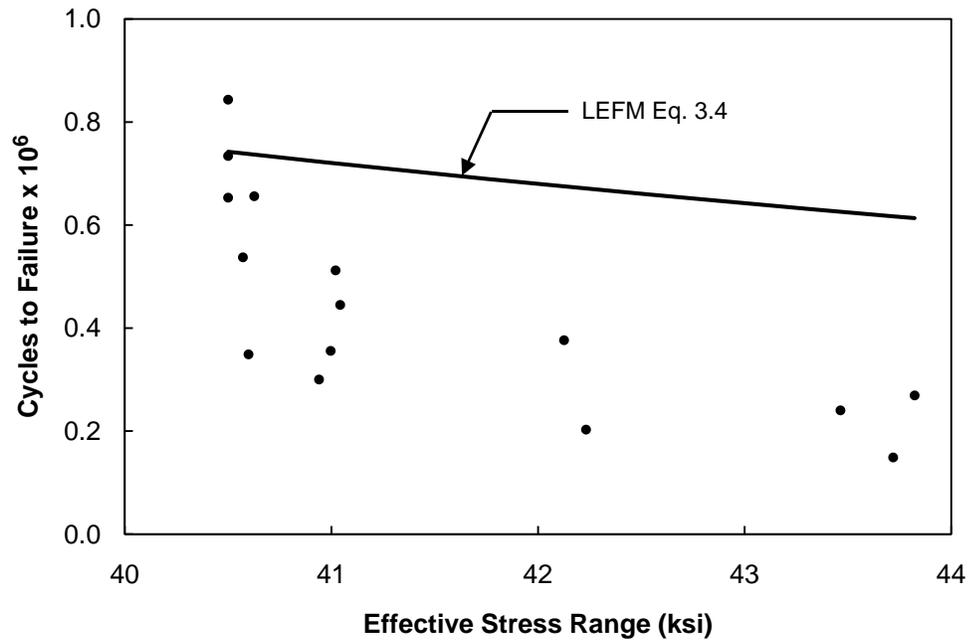
Figure 3-17: Cycles to Failure as a Function of Effective Stress Range

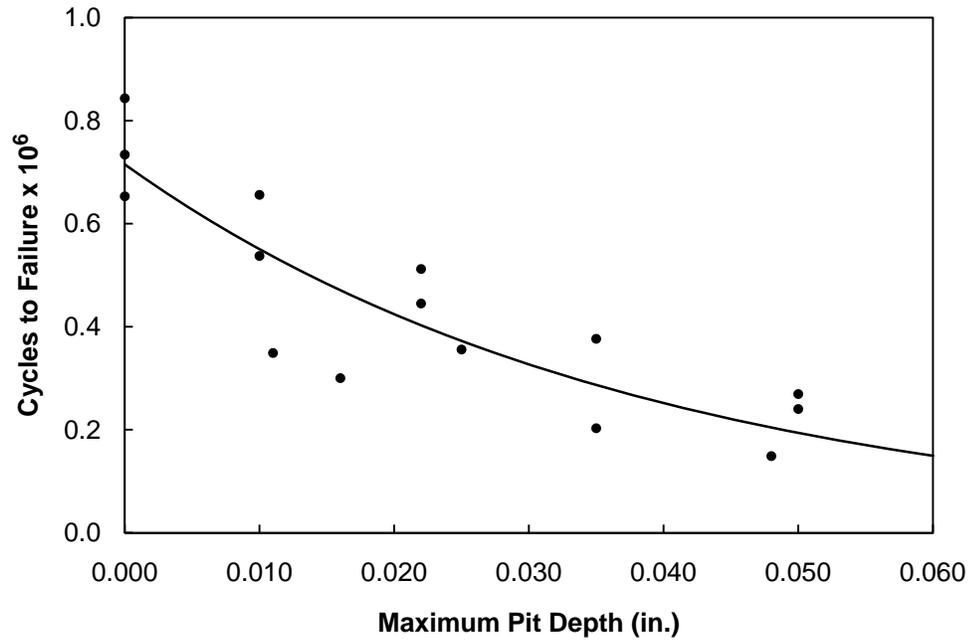
Figure 3-18: Cycles to Failure as a Function of Maximum Pit Depth

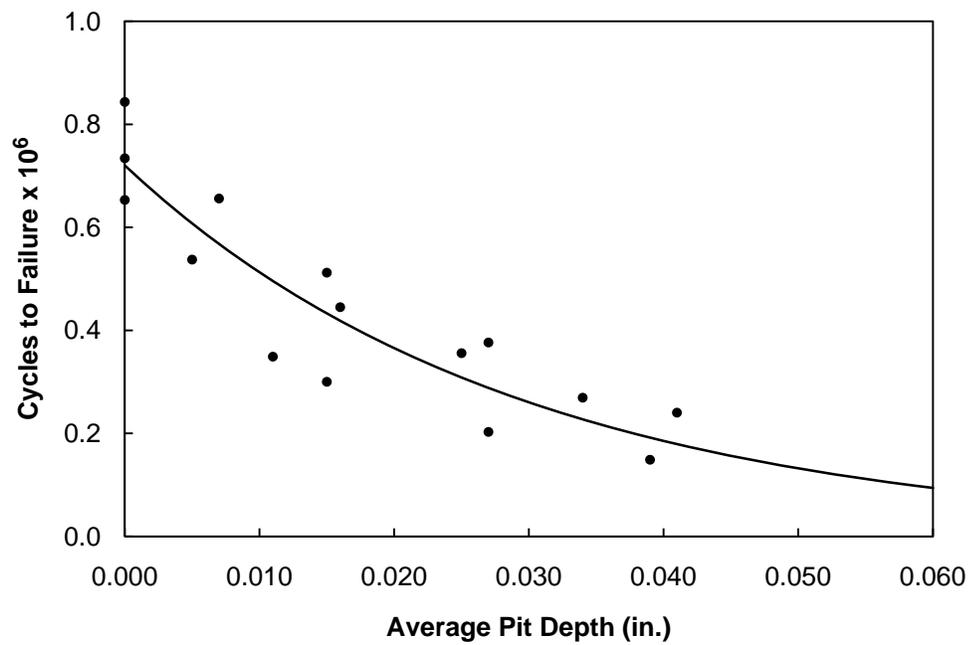
Figure 3-19: Cycles to Failure as a Function of Average Pit Depth

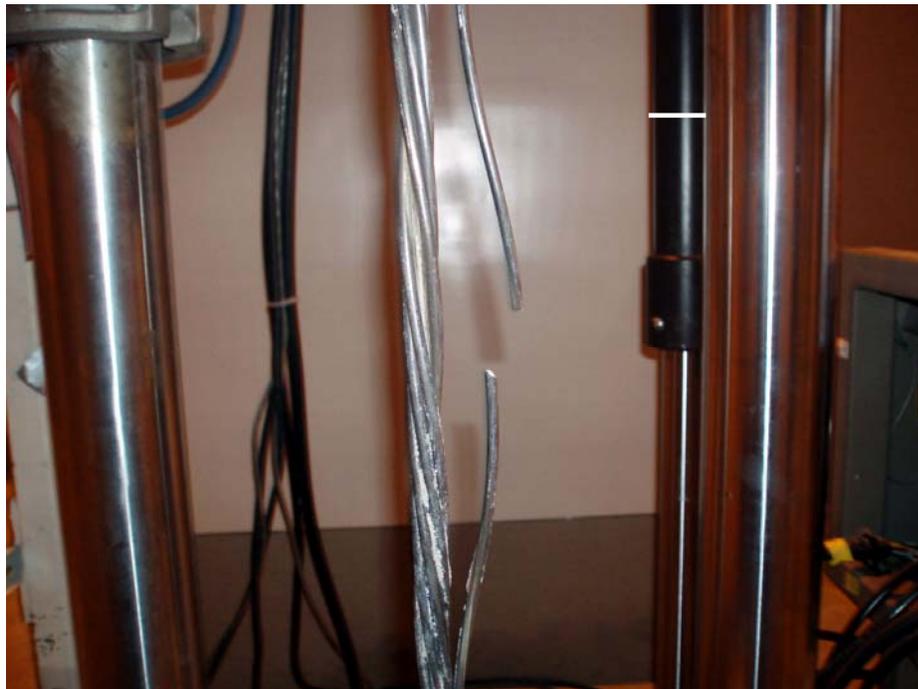
The number of cycles between failure of the first wire and complete failure of the strand can be significant. Figure 3-20 is an example of a strand specimen where the first wire failed due to fatigue and the remaining six wires carried the cyclic test load for an additional 129,608 cycles until complete failure of the strand. Approximately 18 percent of the total specimen fatigue life occurred after the first wire break.

Figure 3-20: Individual Wire Break During Fatigue Testing

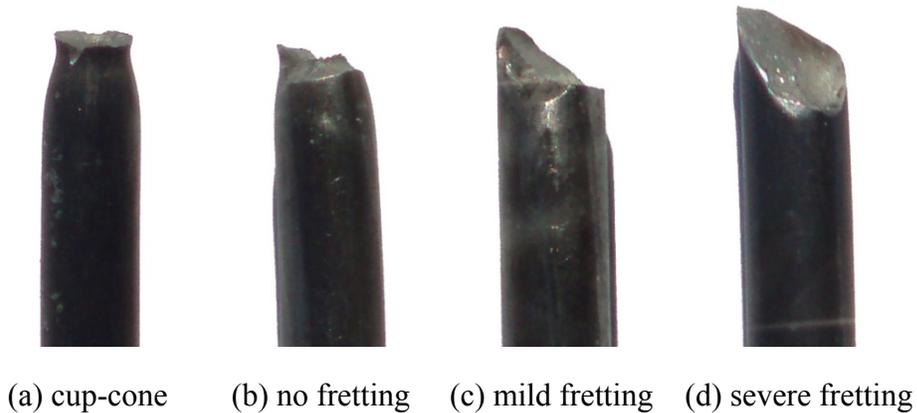
Figure 3-21: Wire Fracture Surfaces Observed During Fatigue Testing

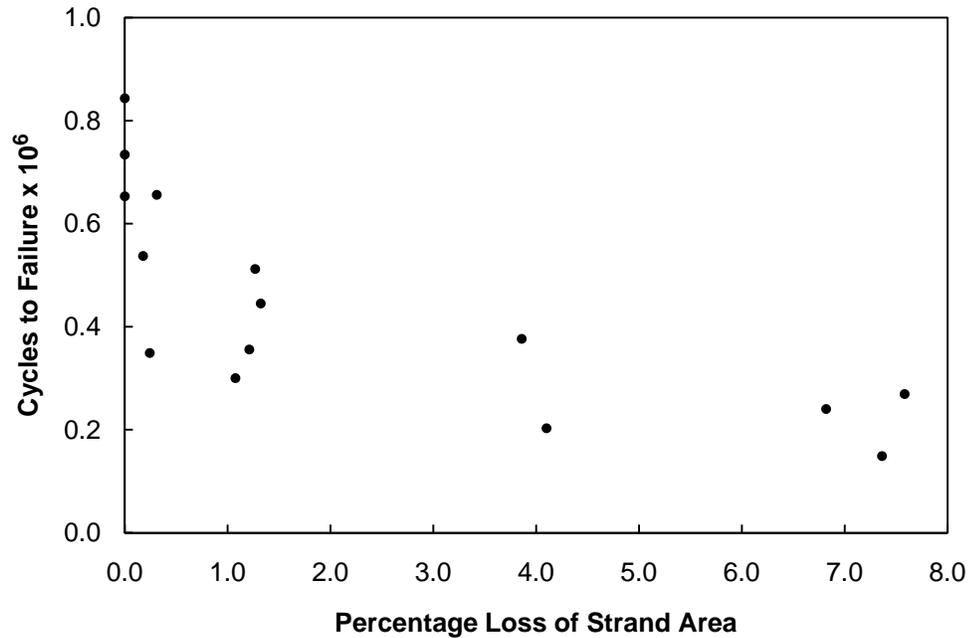
This trend is evident in Figure 3-22, which is a plot of number of cycles to failure as a function of percentage loss of strand area. Although not at the exact same percentage loss, there are definite groupings of the data for which the vertical spread decreases at increasing loss in strand area. The vertical spread of the data points clustered near 0.2 percent (3 data points), 1.3 percent (4 data points), 4.0 percent (2 data points), and 7.3 percent (3 data points), is 307,137 cycles, 212,060 cycles, 173,630 cycles, and 120,372 cycles. What this means is that as the pit sizes increase, they begin to override the inherent defects in the steel and thus dominate the response. However, at “smaller” pit depths, both the corrosion pits and the inherent defects play an equal role in the fatigue failure of the prestressing strand.

Figure 3-22: Cycles to Failure as a Function of Percentage Loss of Strand Area

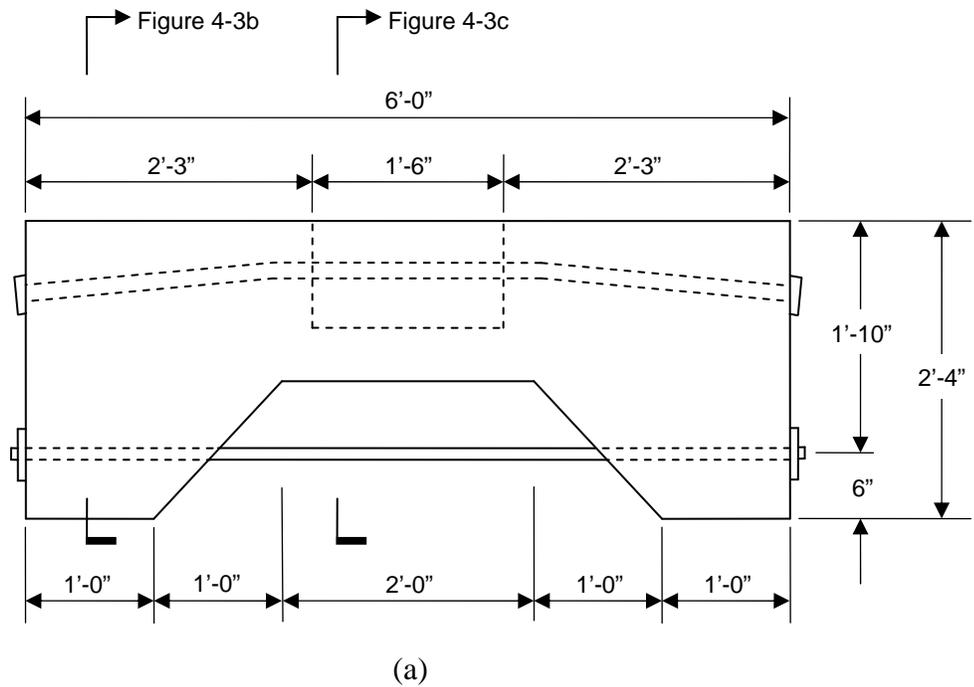
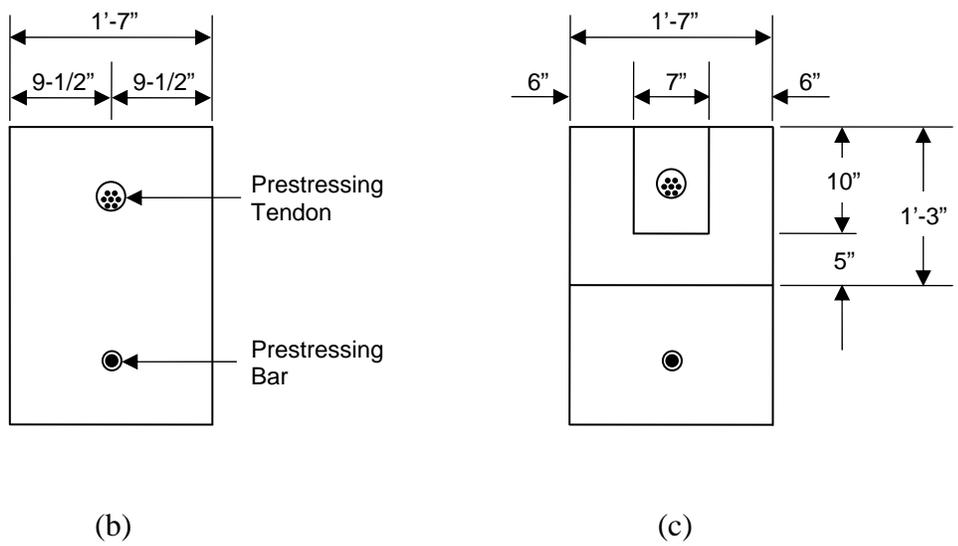
Figure 4-3: Beam Specimen Design

The finite element model is shown in Figure 5-8. Due to symmetry, the author constructed only a quarter-model of the beam specimen. Along the two planes of symmetry, the boundary conditions allowed displacement parallel to the plane but restricted displacement perpendicular to the plane. To complete the boundary conditions, displacement was restricted in the y-direction along the bottom edge of the corbel. Loading was applied as a pressure over the same area as the test equipment actuator head, with the centroid located 6” above the edge of the corbel to match the specimen design as shown in Figure 4-3.

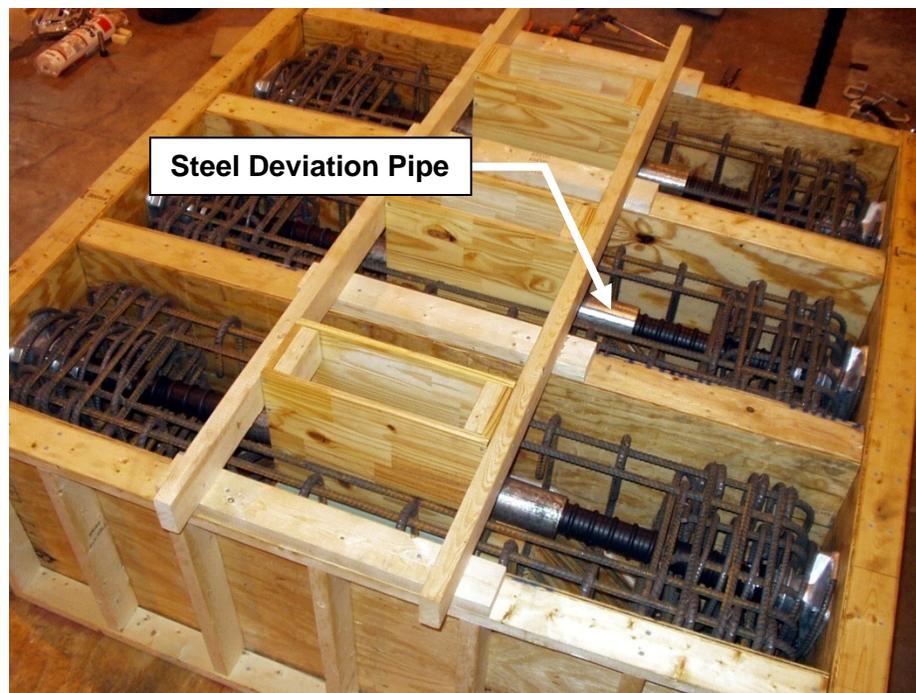
In accordance with AASHTO requirements, the author installed a steel pipe at the tendon deviation point, as shown in Figure 4-5, which also coincided with the transition from internal to external tendon. The plastic duct of the tendon, with a maximum outside diameter of 2-7/8" at the ribs, passes through the steel pipe, which has an internal diameter of 3-1/8". The pipe measures 6" in length and was curved to a 20'-0" radius, the minimum value allowed by AASHTO. The steel pipe conforms to the requirements of ASTM A53, Type E, Grade B with a nominal wall thickness not less than 0.125" as specified by AASHTO.

Figure 4-5: Photograph Showing Location of Steel Deviation Pipe

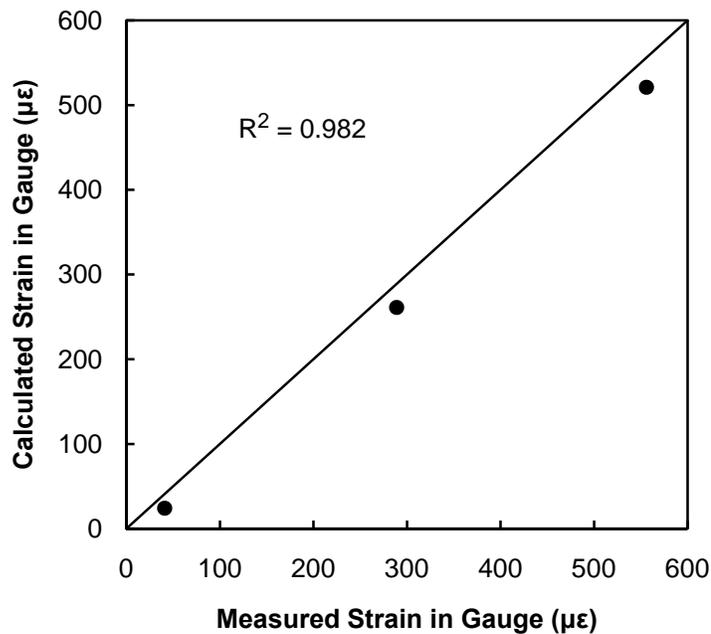
Figure 5-3: Beam Specimen AZ-1 Measured versus Calculated Concrete Strains During Jacking Operation

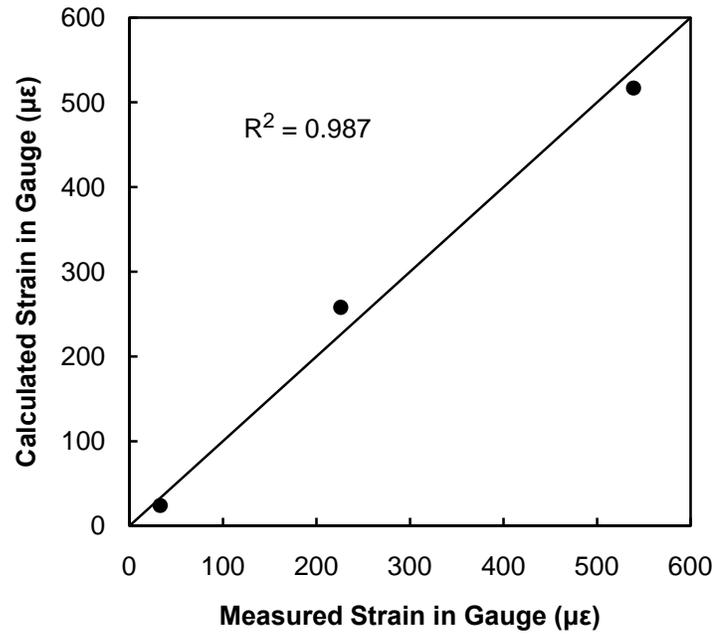
Figure 5-4: Beam Specimen AZC-1 Measured versus Calculated Concrete Strains During Jacking Operation

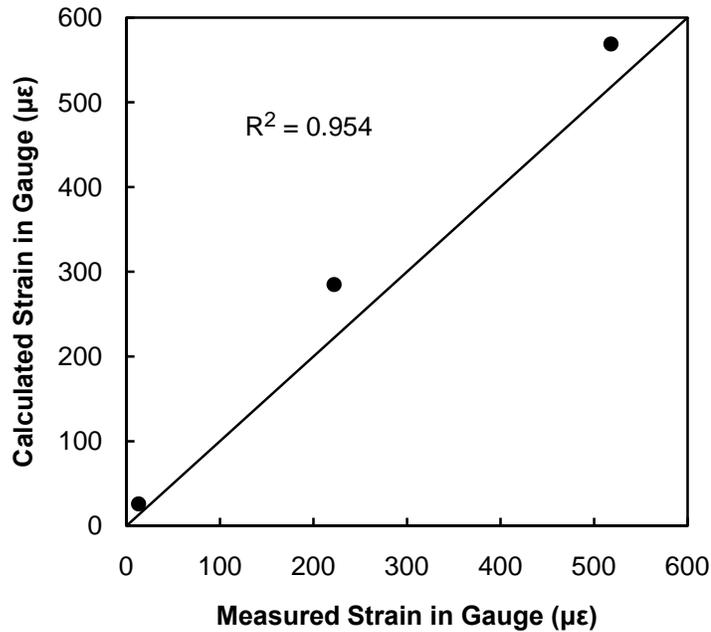
Figure 5-5: Beam Specimen GVC-1 Measured versus Calculated Concrete Strains During Jacking Operation

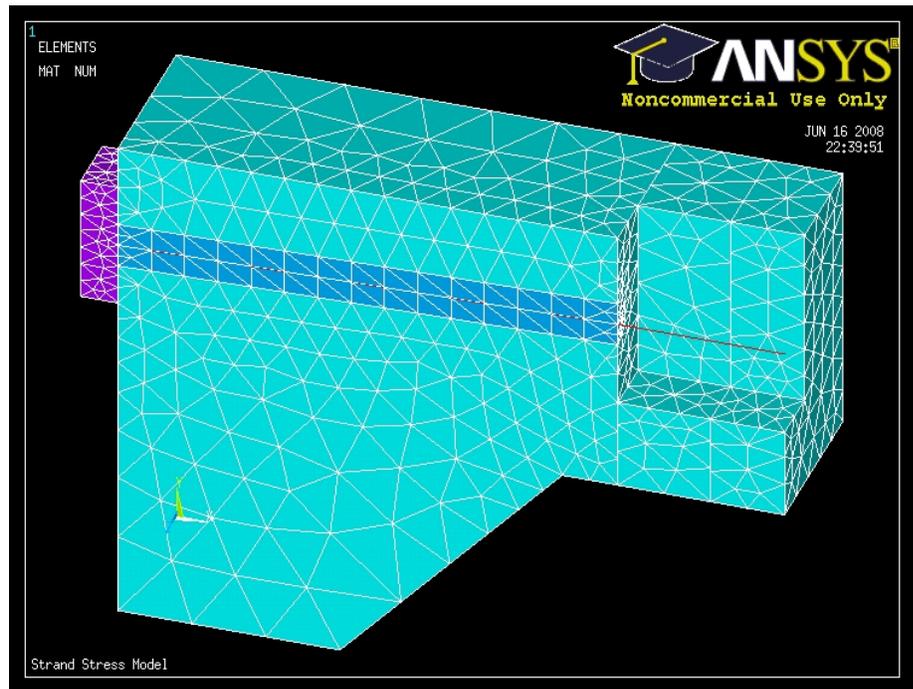
Figure 5-8: Finite Element Model for Determining Strand Stress During Fatigue Testing

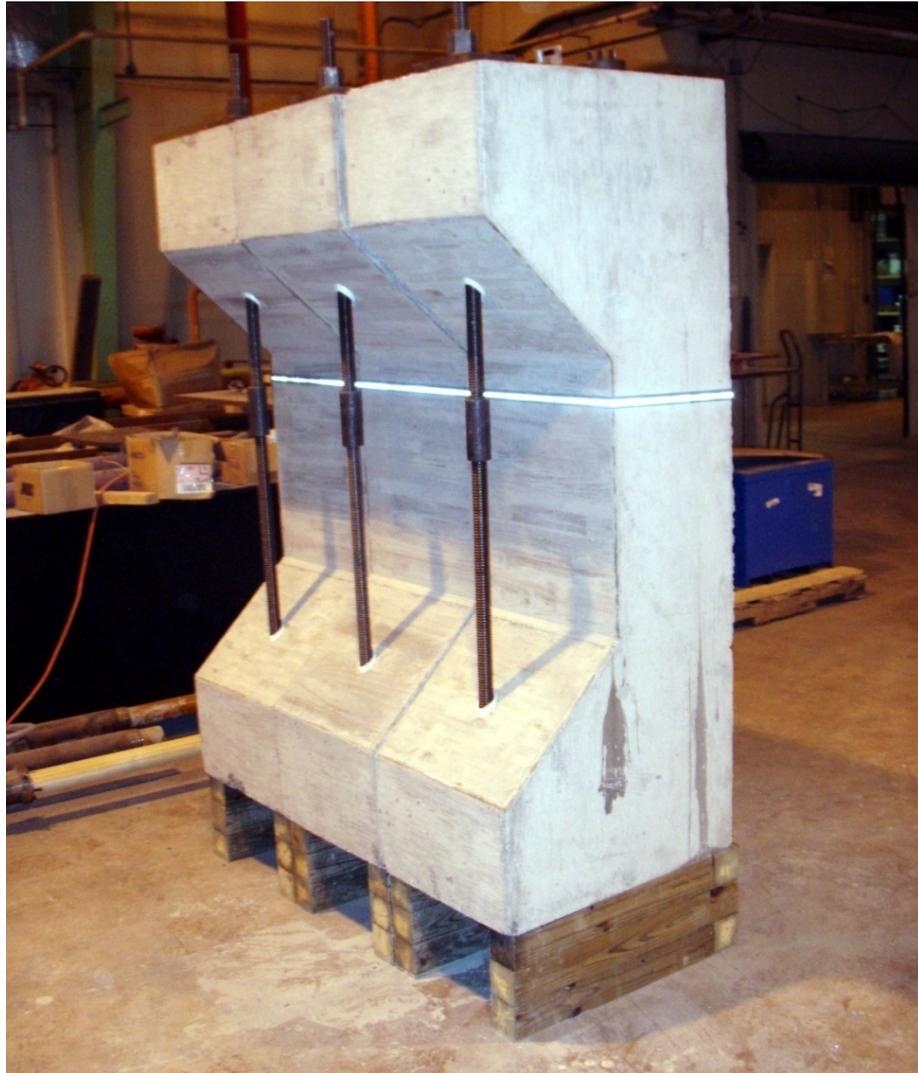
Due to physical constraints, it was impossible to monitor the corrosion that occurred in the void behind the anchor head for the AZC specimens. Consequently, the author placed four-inch-long sections of strand into the empty holes of the anchor head. These small, unattached sections could be easily removed and periodically examined for signs of corrosion.

Figure 5-9: Anchor Zone Grout Void Corrosion Specimens Undergoing Exposure Testing

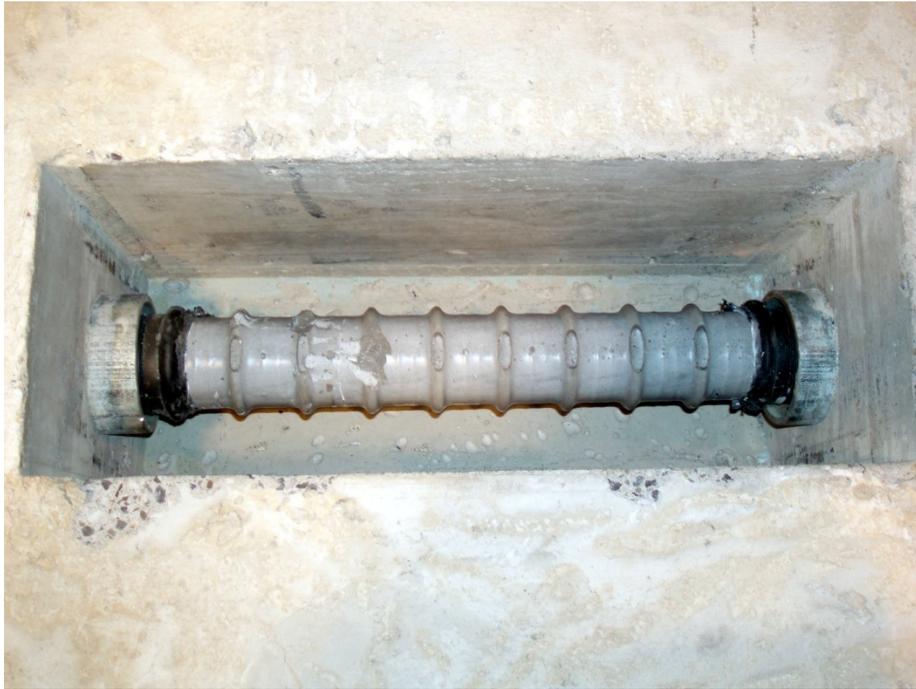
Immediately after removing the plastic duct, the author observed that the grout was cracked. Both longitudinal and circumferential cracks were observed in the grout for all three specimens. Whether the cracks occurred due to shrinkage of the grout or during the initial 10,000 cycle fatigue testing is unknown. Nonetheless, these cracks reduced the ability of the grout to protect the strand. Crack maps, including crack width measurements where sufficient access existed for the crack scope, are shown in Figures 5-11 through 5-13 for the exposed portion of the grouted tendons.

Figure 5-10: Exposed Grouted Tendon After Plastic Duct Removal

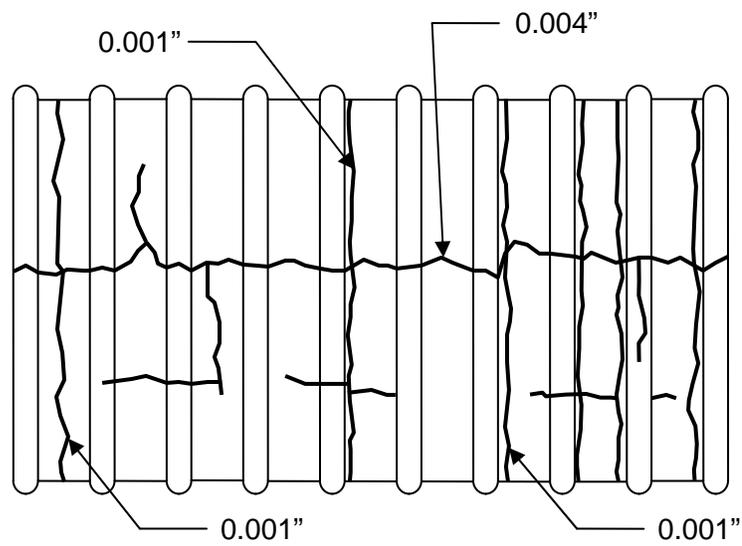
Figure 5-11: GVC-1 Grout Crack Map

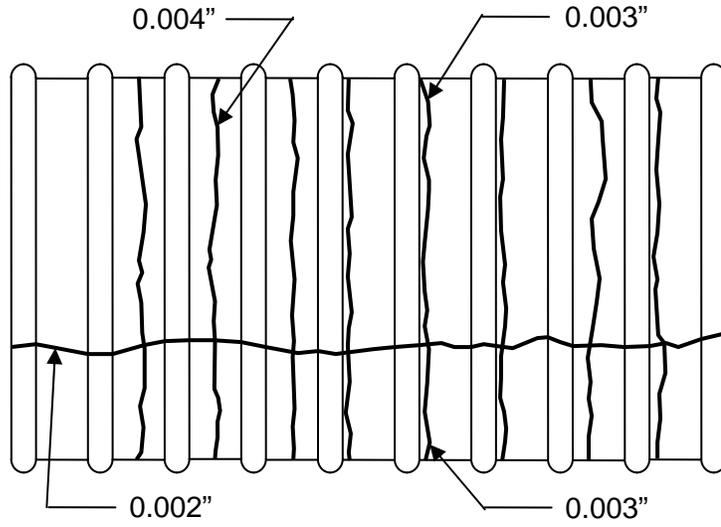
Figure 5-12: GVC-2 Grout Crack Map

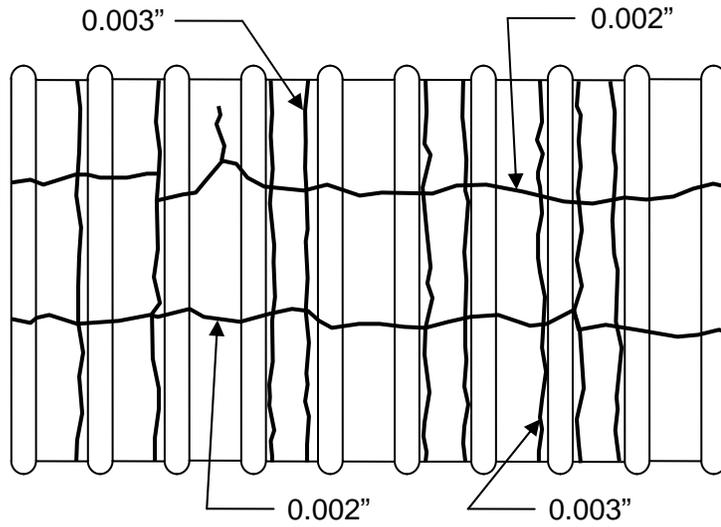
Figure 5-13: GVC-3 Grout Crack Map

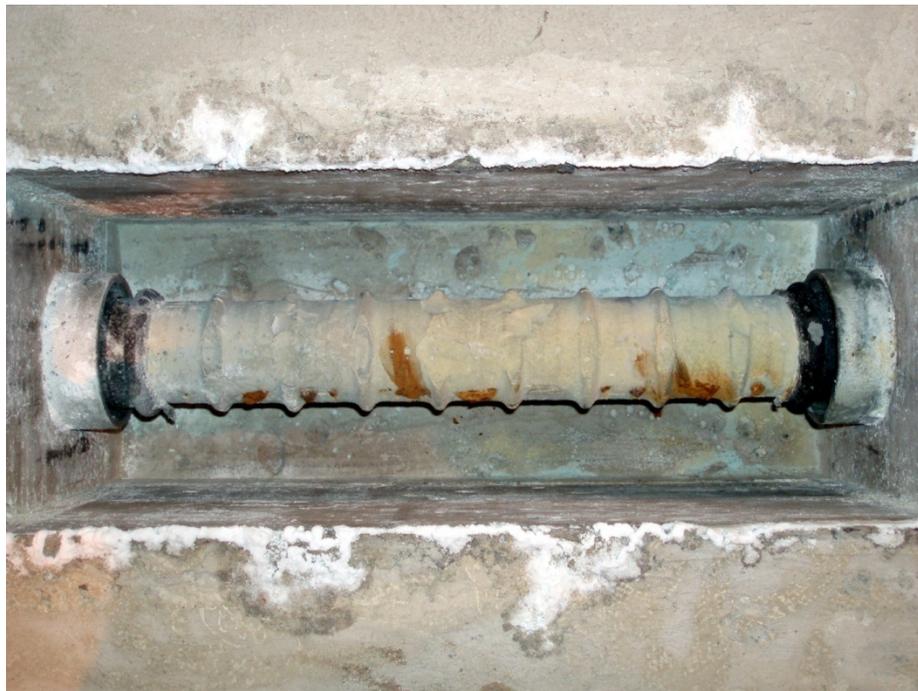
All three GVC specimens showed signs of corrosion at some point during the six months of chloride exposure. However, the amount and locations of corrosion varied between each of the three specimens, with no apparent pattern revealing itself. Beam Specimen GVC-1 showed signs of corrosion after only one two-week cycle of saltwater exposure, as shown in Figure 5-14. The corrosion shown in Figure 5-14 occurred at the crack locations identified in Figure 5-11. This finding is very important, as it shows that the ability of the grout to protect the strand is independent of the level of prestress, which is also consistent with the fact that the grout is not precompressed because it is installed after the tensioning operation.

Figure 5-14: Exposed Grouted Tendon for GVC-1 Showing Signs of Corrosion
