The Pennsylvania State University
The Graduate School
Department of Civil and Environmental Engineering

**THE VIABILITY OF PARTIALLY POST-TENSIONED CONCRETE MEMBERS
IN AN AGGRESSIVE ENVIRONMENT, INCLUDING CYCLIC LOADING**

A Dissertation in
Civil Engineering
by
Jeffery Scott Volz

December 2008

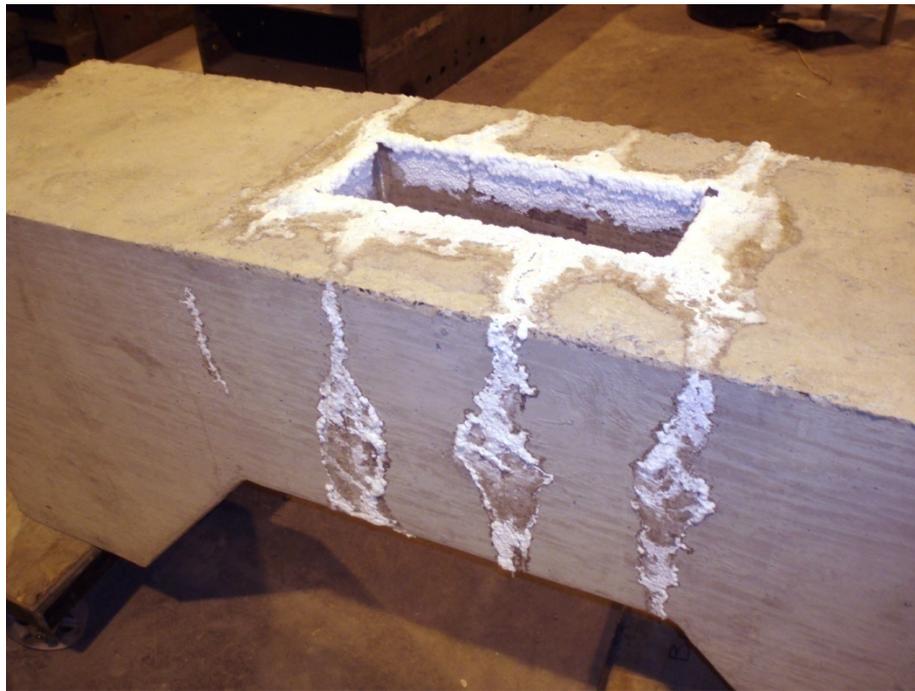
Figure 5-15 shows GVC-2, one of the partially prestressed specimens, just prior to fatigue testing. The most important aspect in the photograph is the extensive build-up of salt and calcium hydroxide on the outside surface of the specimen. The flexural cracks, which measured 0.006 to 0.009 inches in width, continued to leak saltwater throughout the six-month duration of the exposure testing. These crack widths are considered fine to very fine (ACI 224 2007), yet the saltwater continued to pass through the specimen, even after extensive build-up of salt and calcium hydroxide. This finding is very important in that it reaffirms that fine crack widths (those measuring less than 0.010 inches) can still act as transport mechanisms for chloride contamination. The same phenomenon occurred in Beam Specimen GVC-3, the other partially prestressed member.

Figure 5-15: Beam Specimen GVC-2 After Six-Month Duration of Exposure Testing

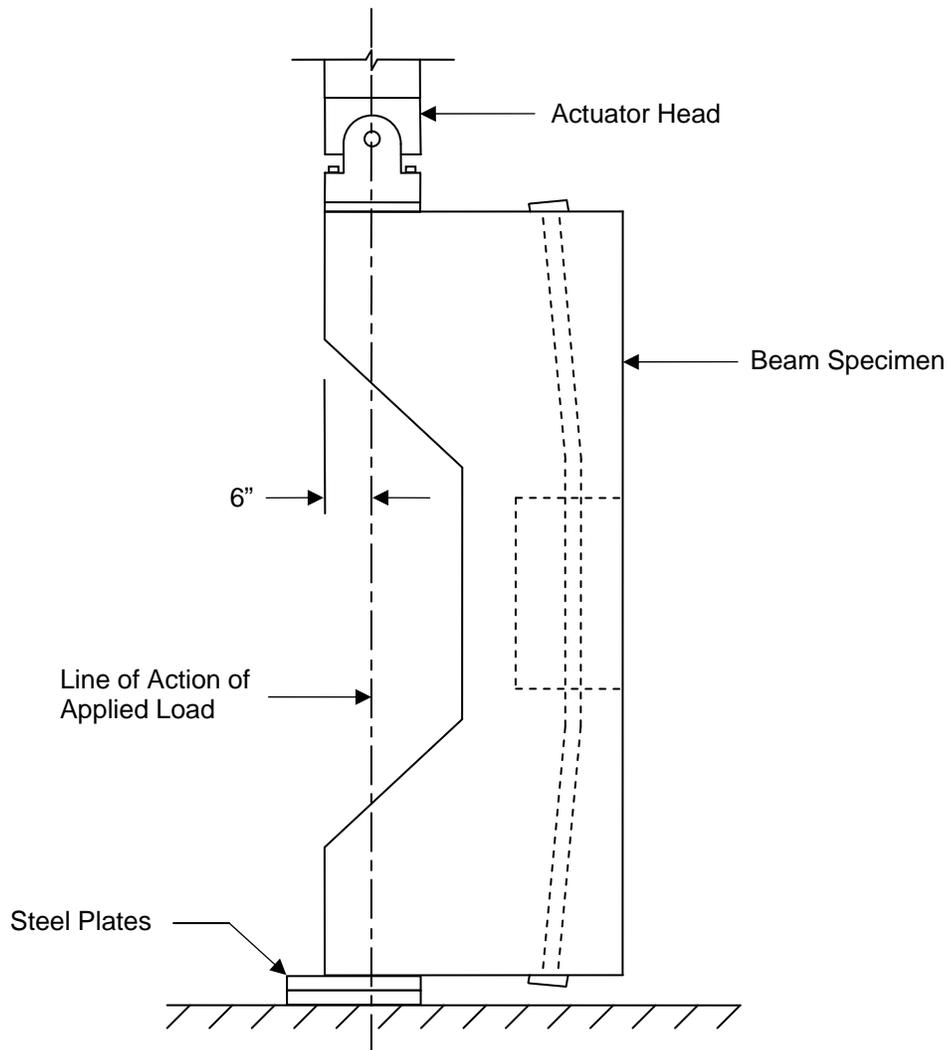
All twelve beam specimens completed the full 2,000,000 cycles of fatigue testing without a catastrophic failure of either the concrete or tendon. In regions of compressive stress, the concrete did not show any signs of distress (cracking, splitting, or spalling), even though the fatigue loading placed a maximum stress of $0.50f'_c$ in these areas for all twelve specimens. However, the concrete did suffer cracking at various locations, some of which was expected and some of which was not. For instance, in general, the fully prestressed specimens remained uncracked in the precompressed tensile zone, which was to be expected. The partially prestressed specimens, on the other hand, cracked in the precompressed tensile zone, which was also to be expected.

Figure 5-16: Beam Specimen Fatigue Test Setup

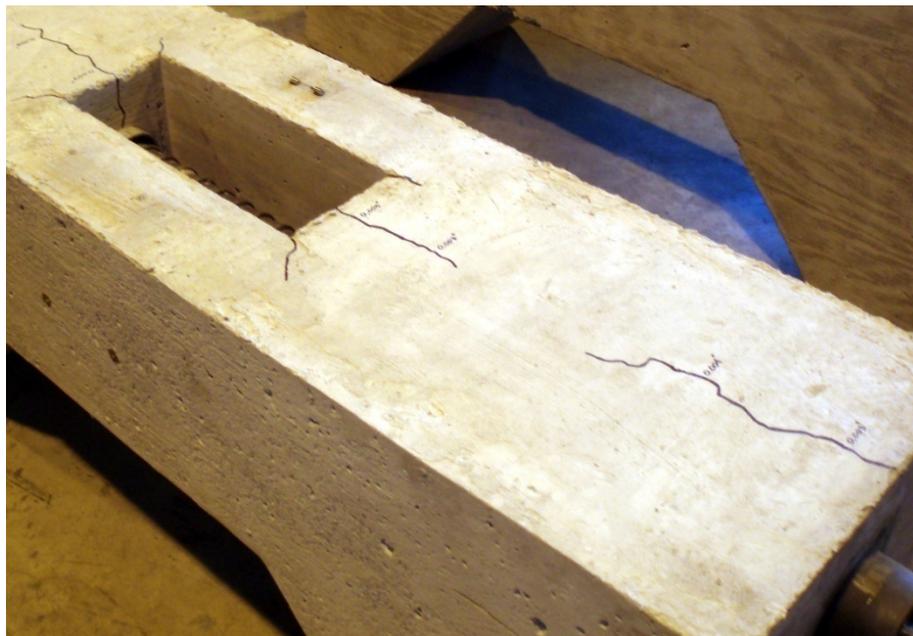
The second instance of unexpected cracking occurred in Beam Specimen GVC-1. This specimen was a fully prestressed design yet experienced flexural cracking in the precompressed tensile zone. Because this specimen underwent exposure to chlorides, it was possible that some of the prestressing wires failed during the fatigue testing, resulting in a corresponding increase in the tensile stress. Another alternative is that the specimen experienced an overload during the fatigue testing due to an equipment malfunction. The specimen autopsy results discuss these possibilities.

Figure 5-18: Longitudinal Cracking of Beam Specimens

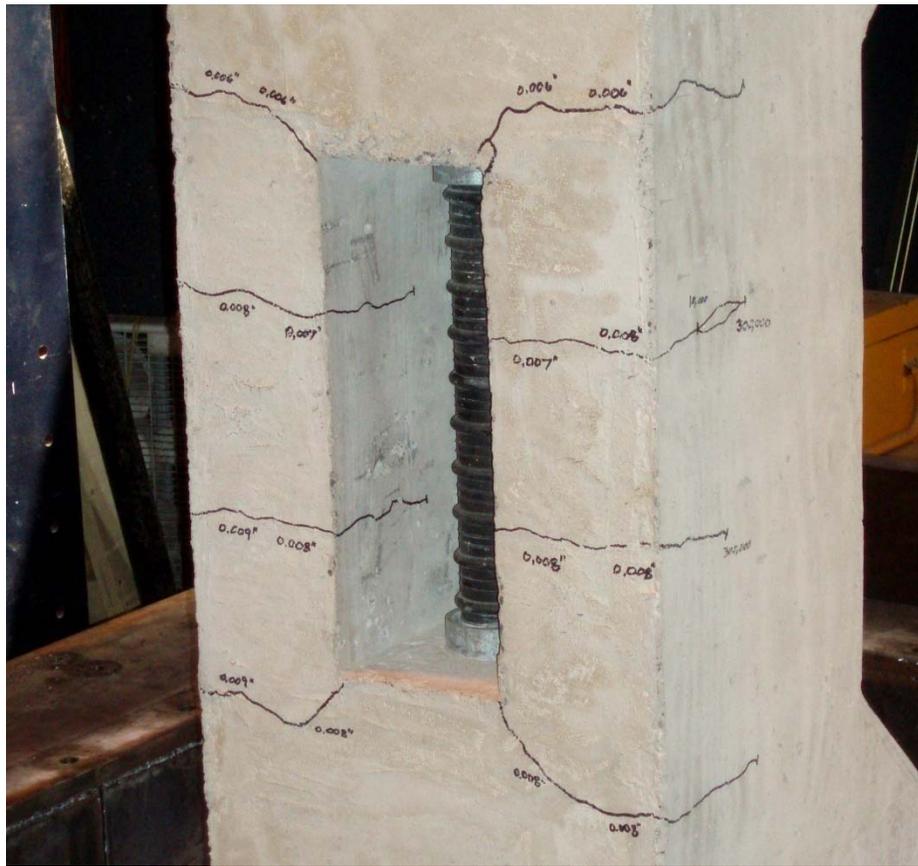
top surface of the beam. Crack width measurements for the GVC Series were less precise, as it was difficult to remove all of the build-up in and around the cracks from the exposure testing. In general, the flexural crack widths increased during the fatigue loading. Some researchers have attributed this increase to creep, while others have attributed it to continued microcracking occurring over time (ACI 423.5R 1999).

Figure 5-19: Typical Crack Pattern for Partially Prestressed Specimens

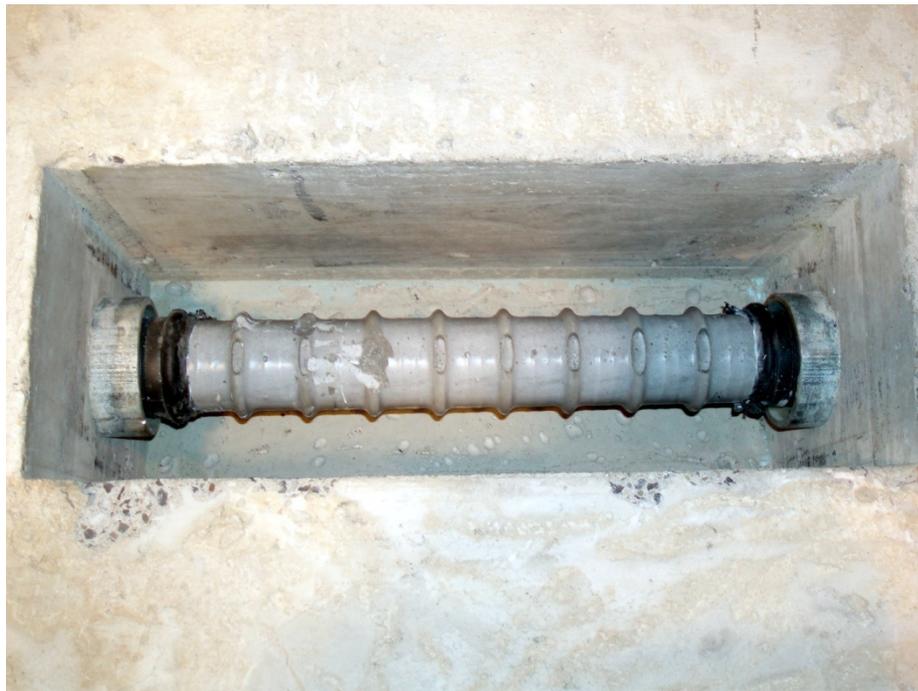
series of specimens. The behavior of the specimens without the void served as a reference point for comparison with those for which the void was purposefully planned. Furthermore, the coverage and tenacity of the grout was confirmed during removal, when the portion of the tendon within the end anchorages could only be removed after repeated blows from a 50-lb. jackhammer.

Figure 6-1: Exposed Grouted Tendon After Plastic Duct Removal for *In situ* Inspection

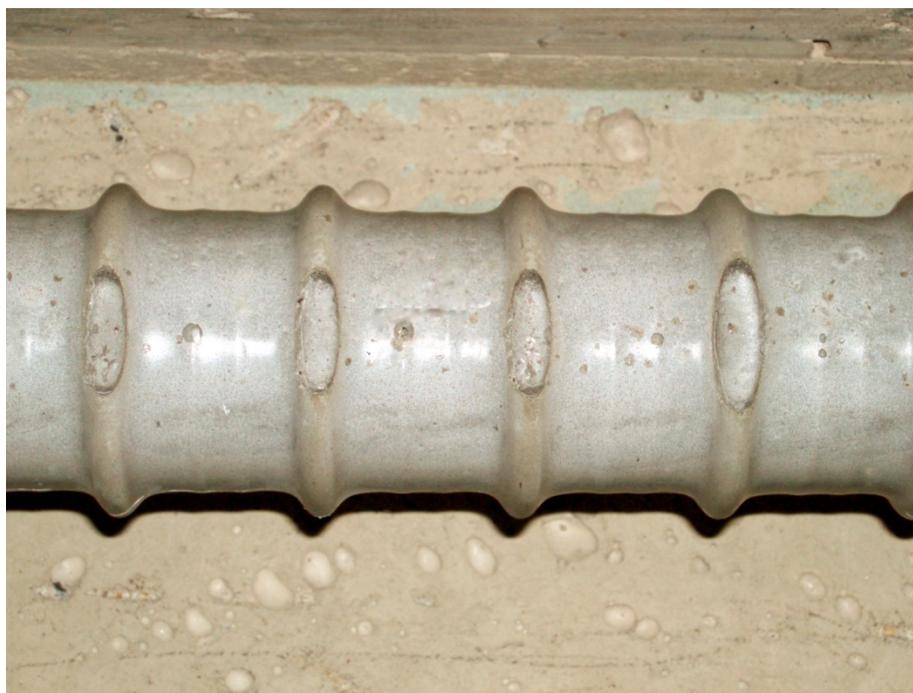
Figure 6-2: Close-Up of Air Pockets Along Peaks of Duct Ribs

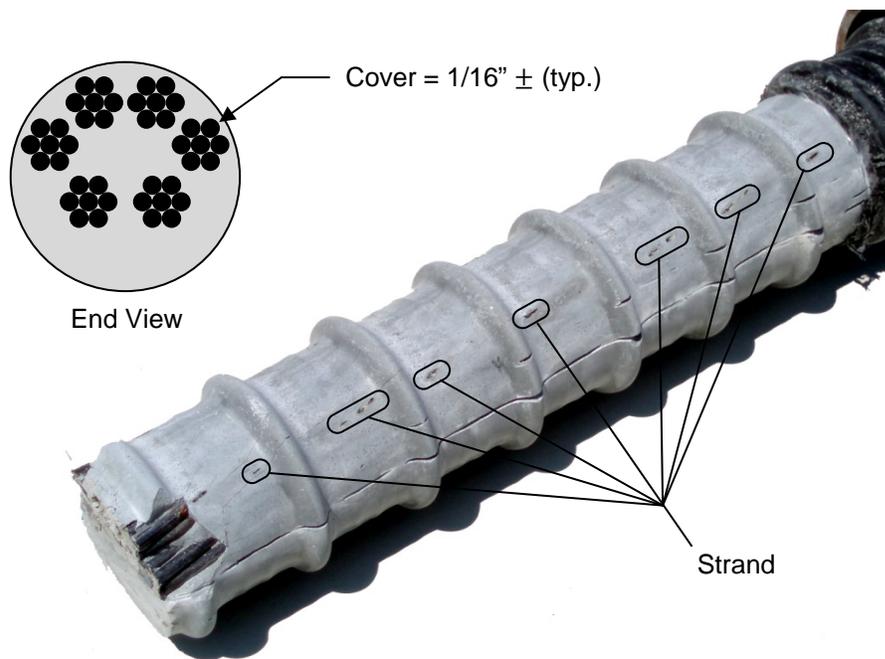
Figure 6-6: Beam Specimen AZ-3 Grouted Tendon with Schematic End View

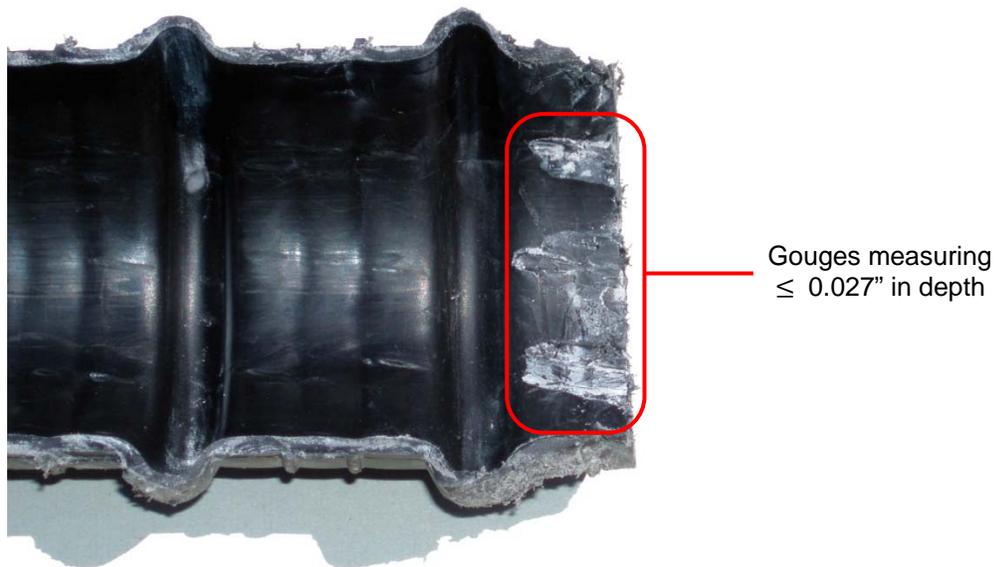
Figure 6-7: Gouges in Plastic Duct from Strand Stressing, Beam Specimen FR-3

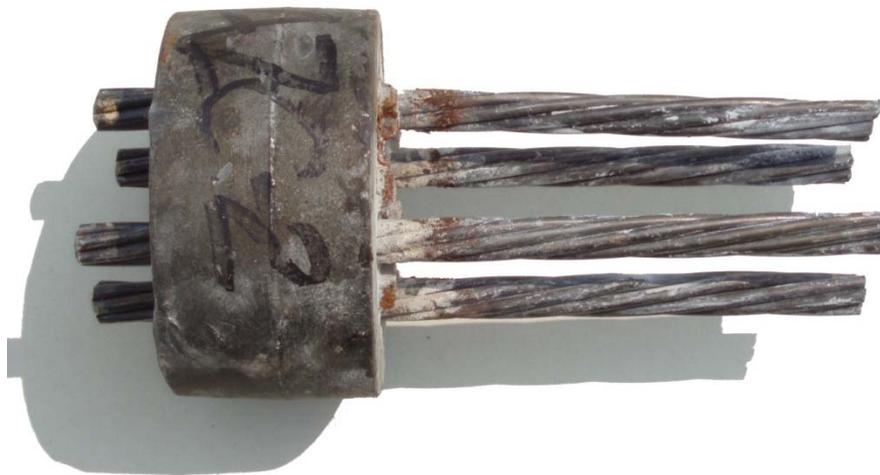
Figure 6-8: Strand Corrosion within Void Behind Anchor Head

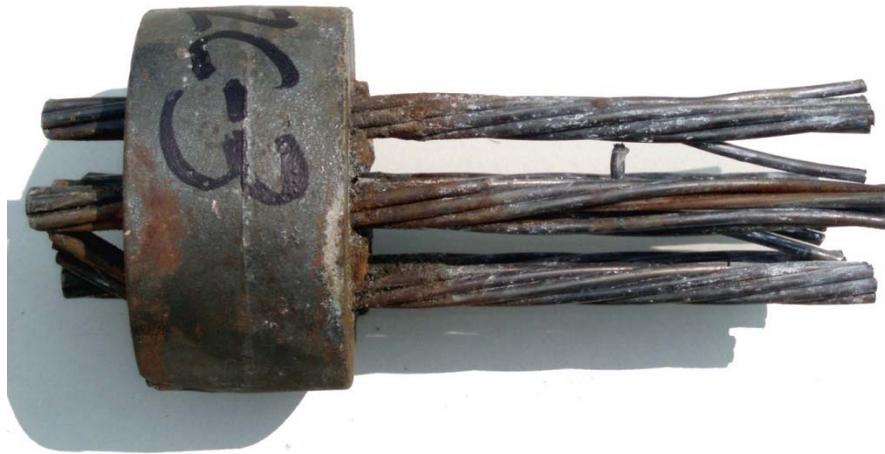
Figure 6-9: Strand Corrosion Within and Away from Grout Void

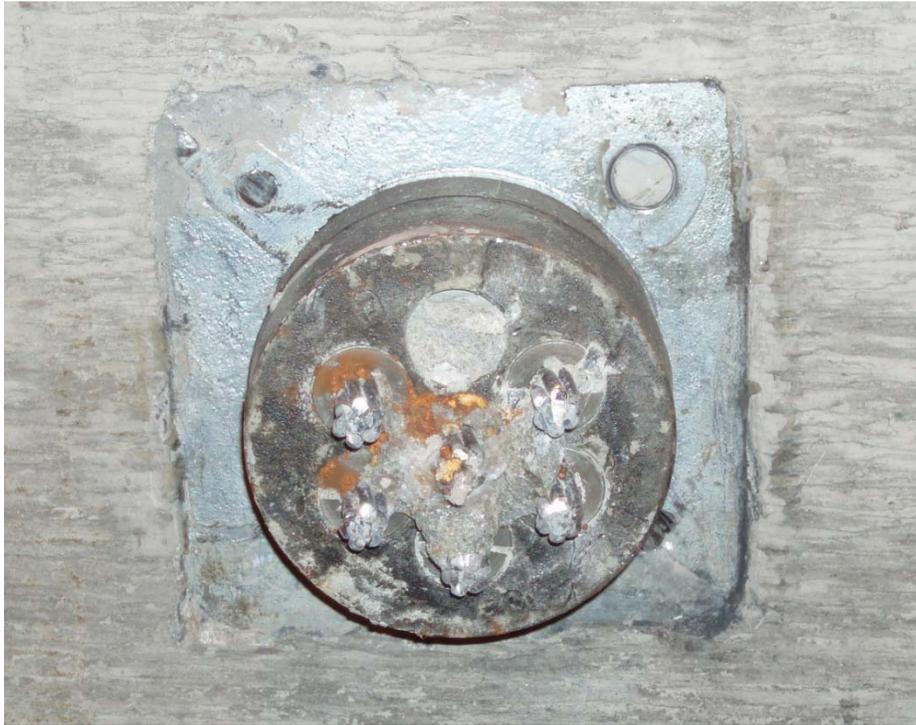
Figure 6-10: Strand Corrosion at Anchor Head Opposite to Grout Void

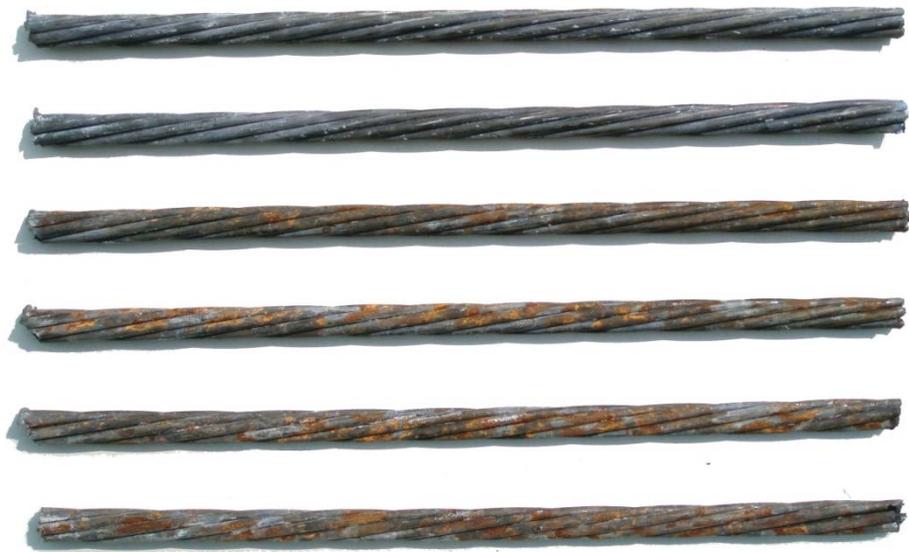
Figure 6-11: Strand Corrosion Experienced by GVC Beam Specimens

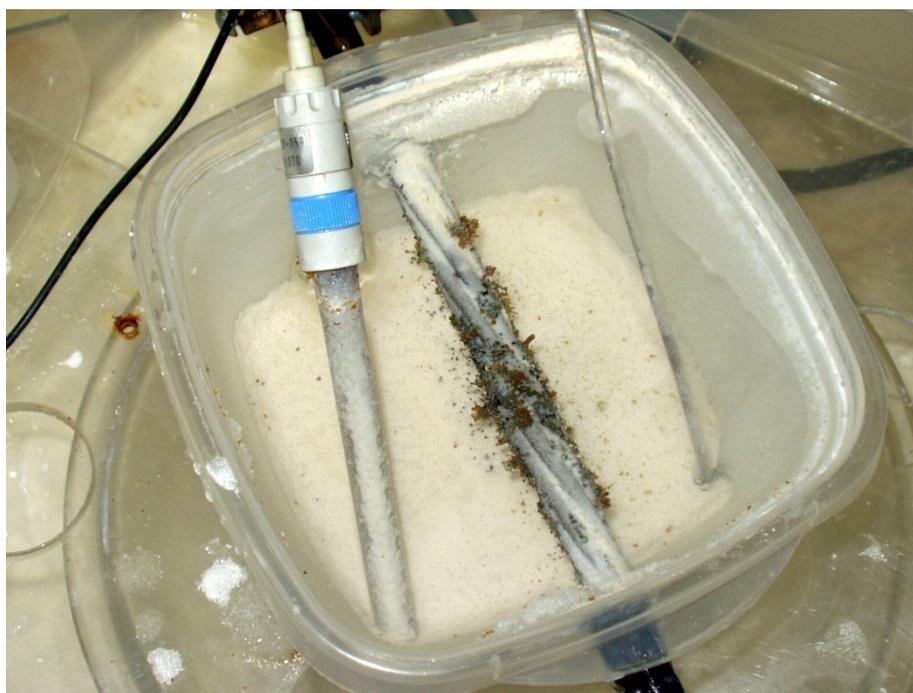
Figure A-1: Accelerated Corrosion Setup

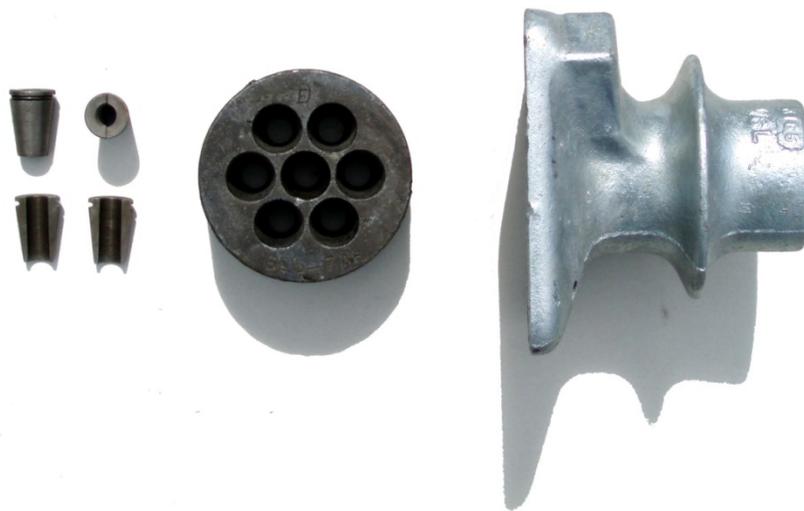
Figure C-3: VSL Type EC Stressing Anchorage

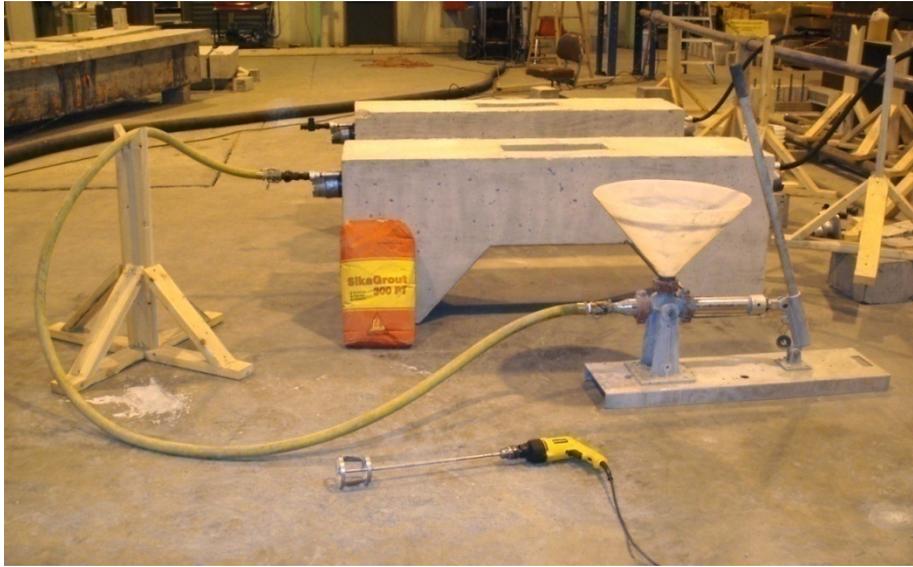
Figure C-6: Tendon Grouting Setup

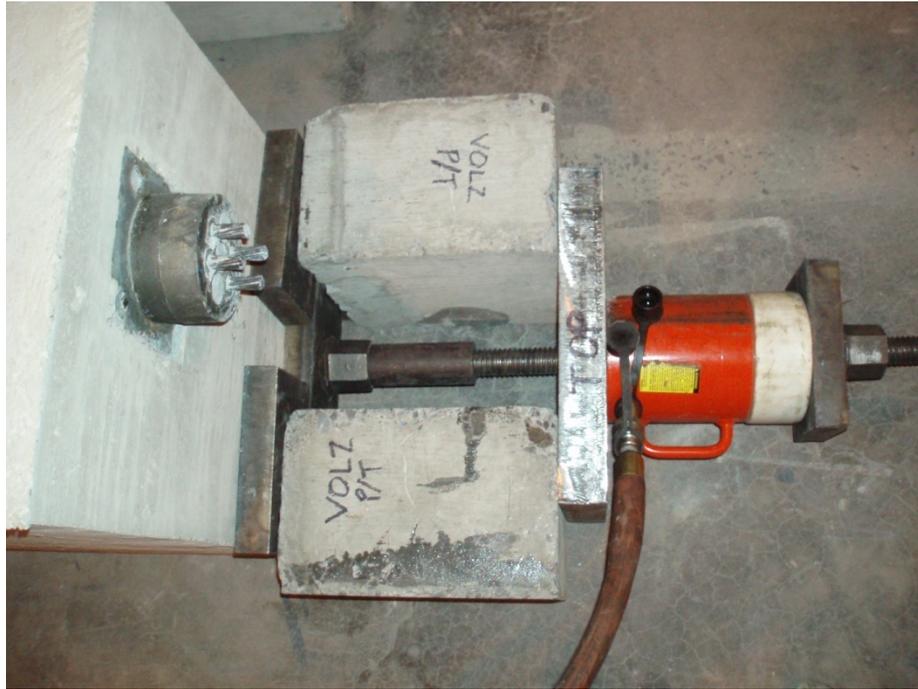
Figure C-8: Prestressing Bar Stressing Setup

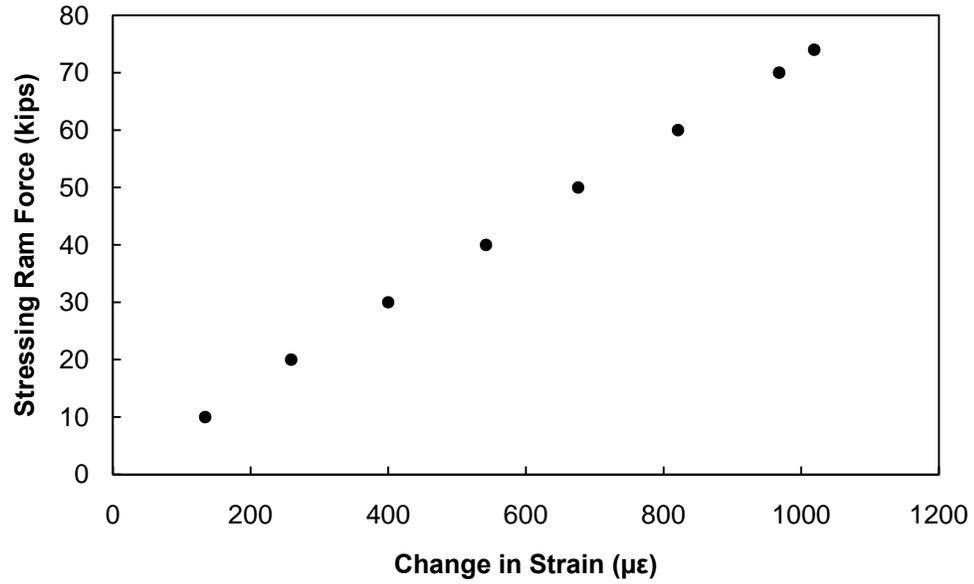
Figure D-5: Coupler Load-Strain Data for Anchor Zone Grout Void Corrosion Series

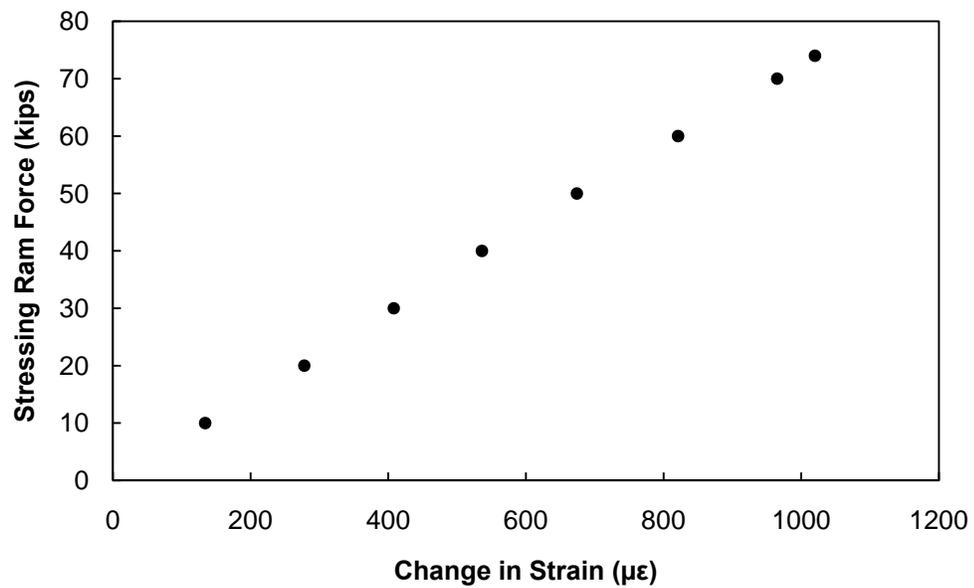
Figure D-6: Coupler Load-Strain Data for Crown Grout Void Corrosion Series

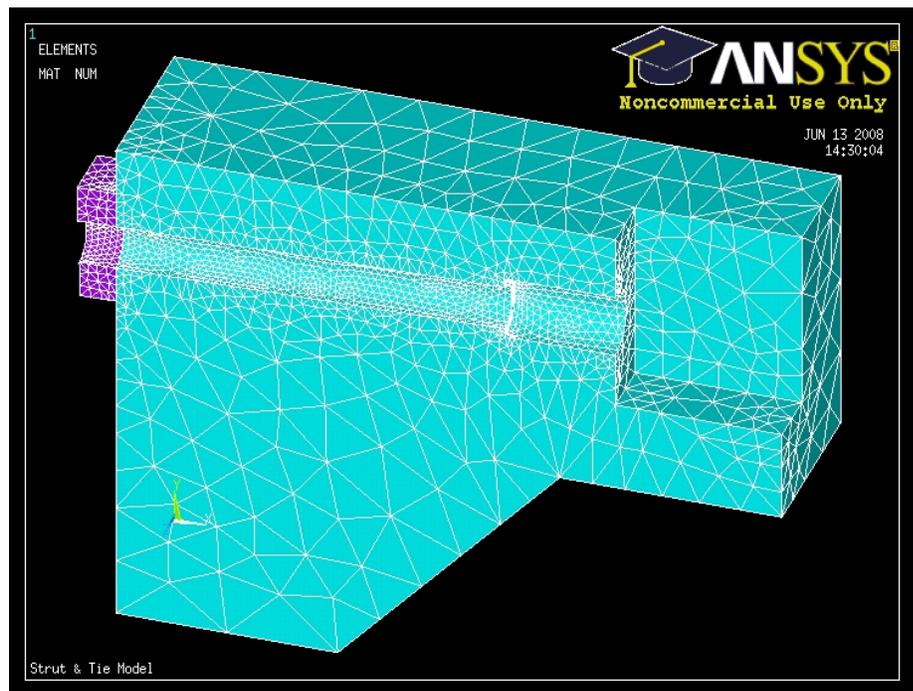
Figure F-1: Finite Element Model for Longitudinal Cracking

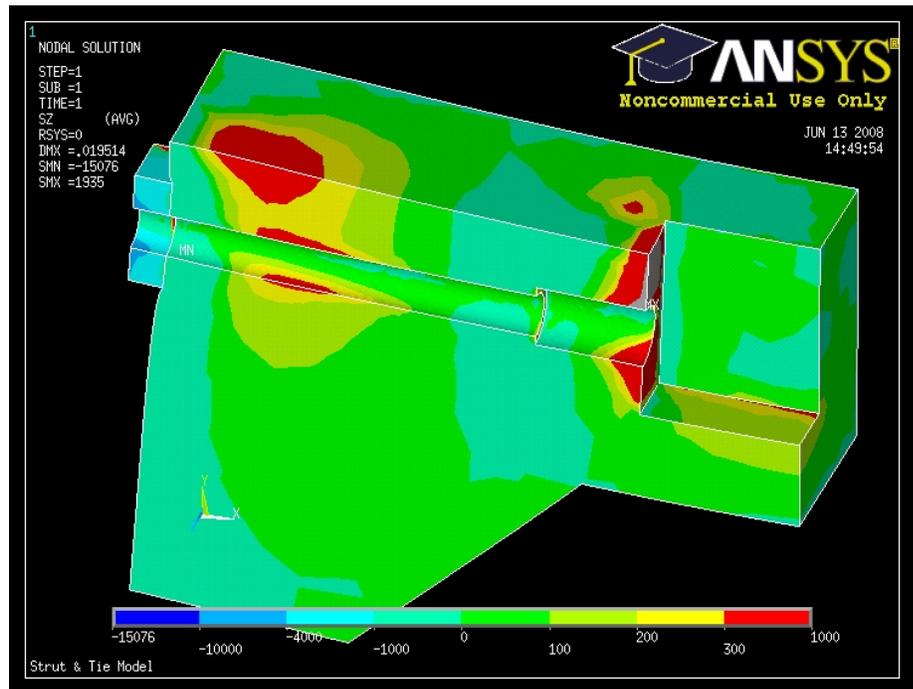
Figure F-2: Stresses Perpendicular to Longitudinal Plane During Jacking

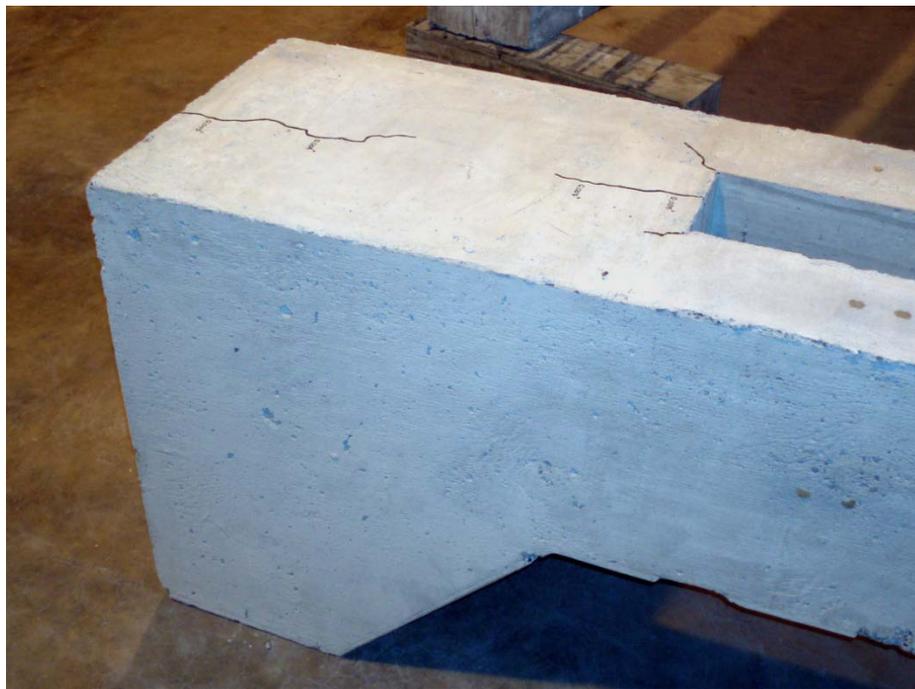
Figure F-3: Typical Longitudinal Cracking of Beam Specimens

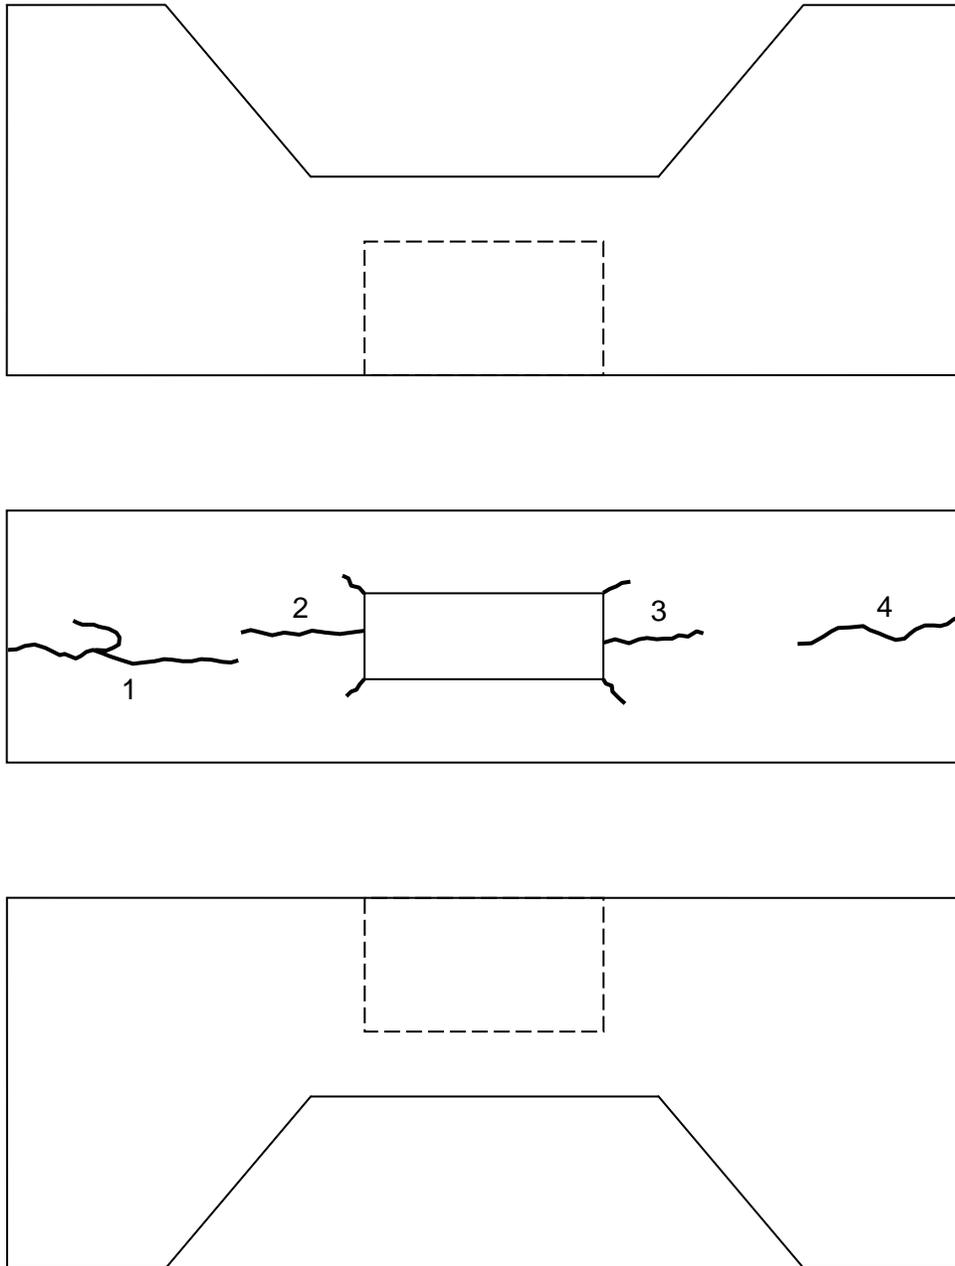
Figure G-1: Beam Specimen FR-1 Crack Map

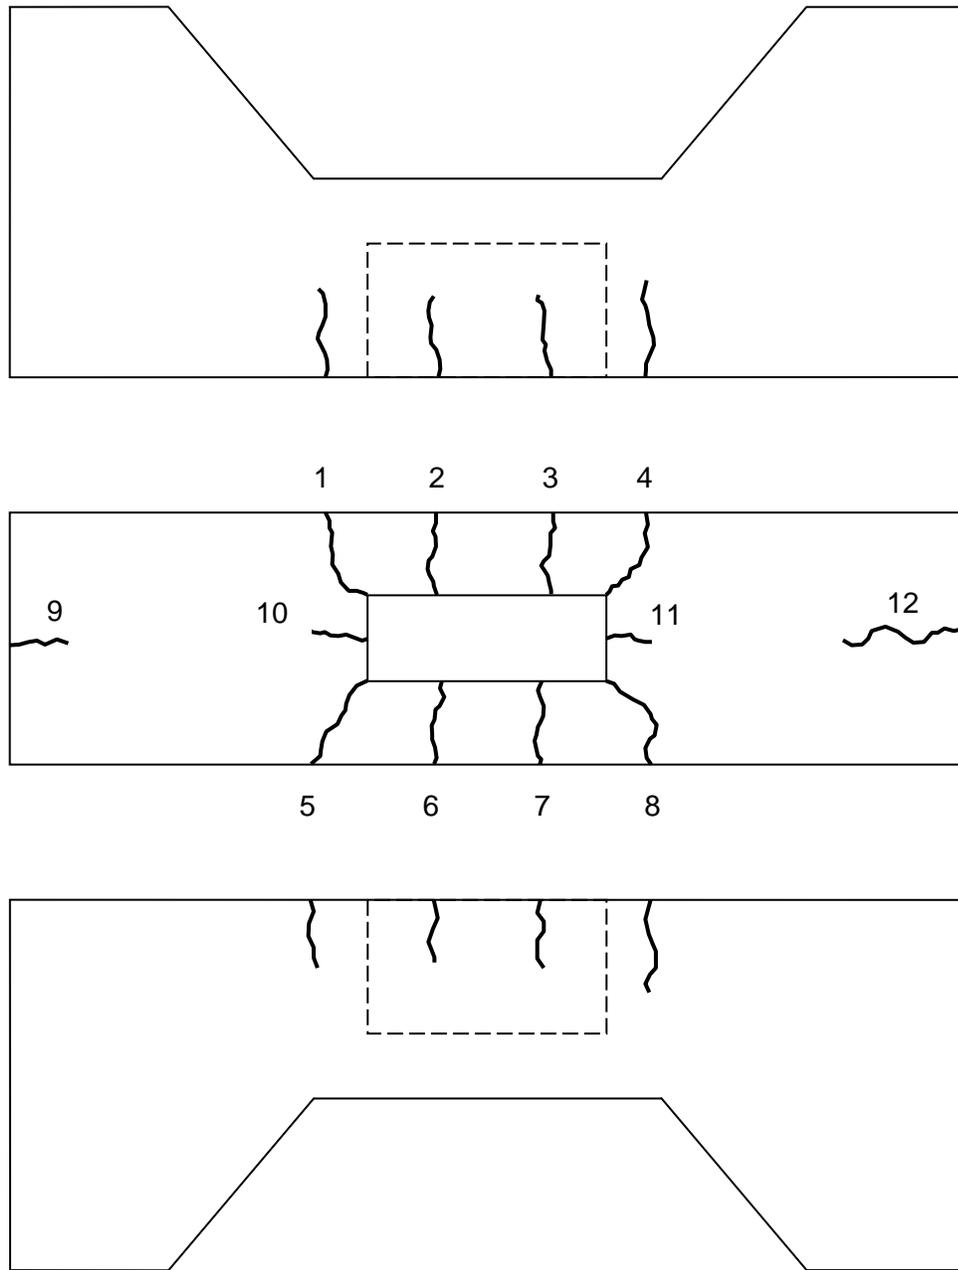
Figure G-2: Beam Specimen FR-2 Crack Map

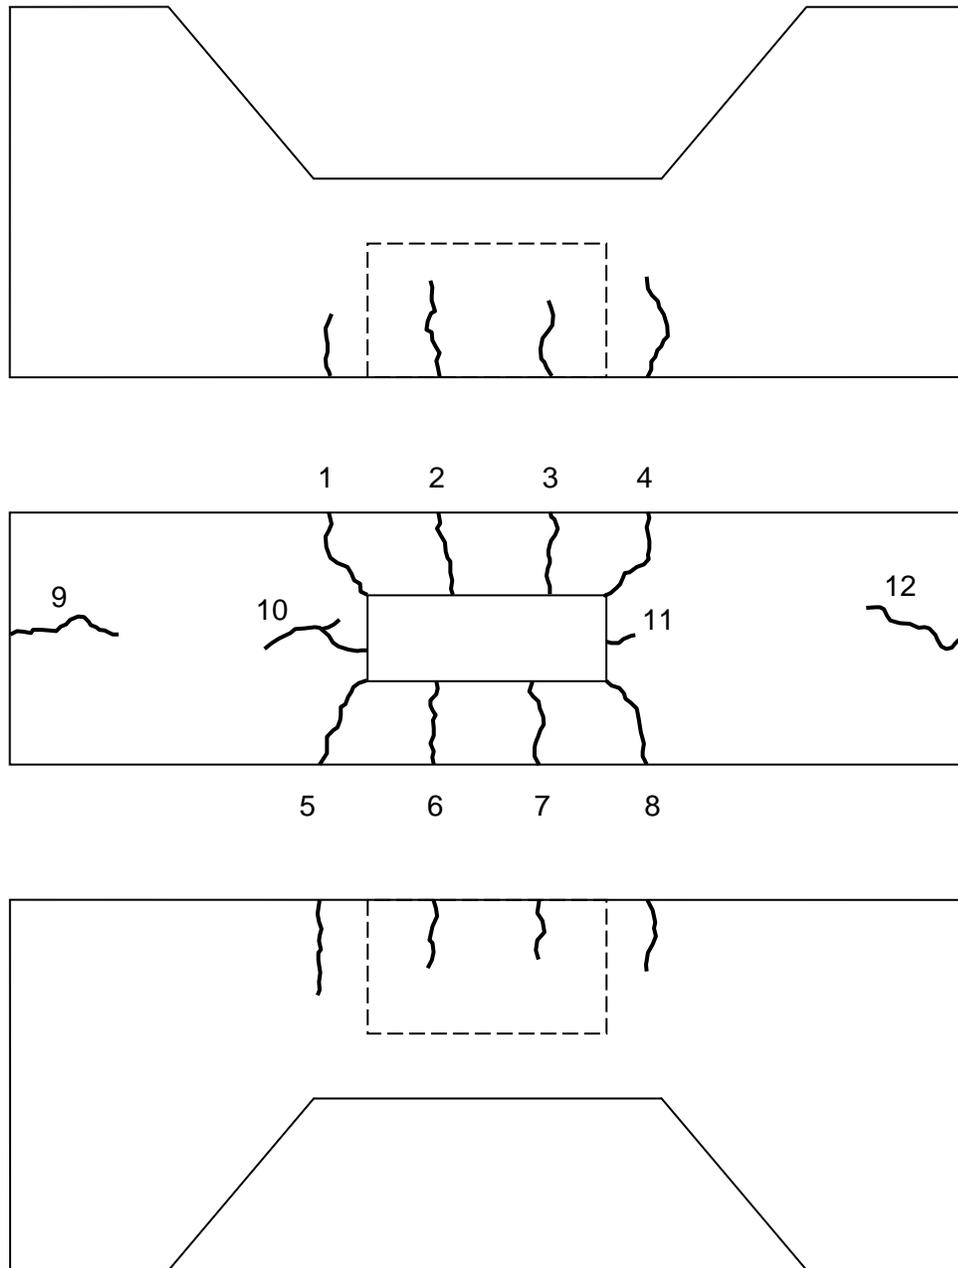
Figure G-3: Beam Specimen FR-3 Crack Map

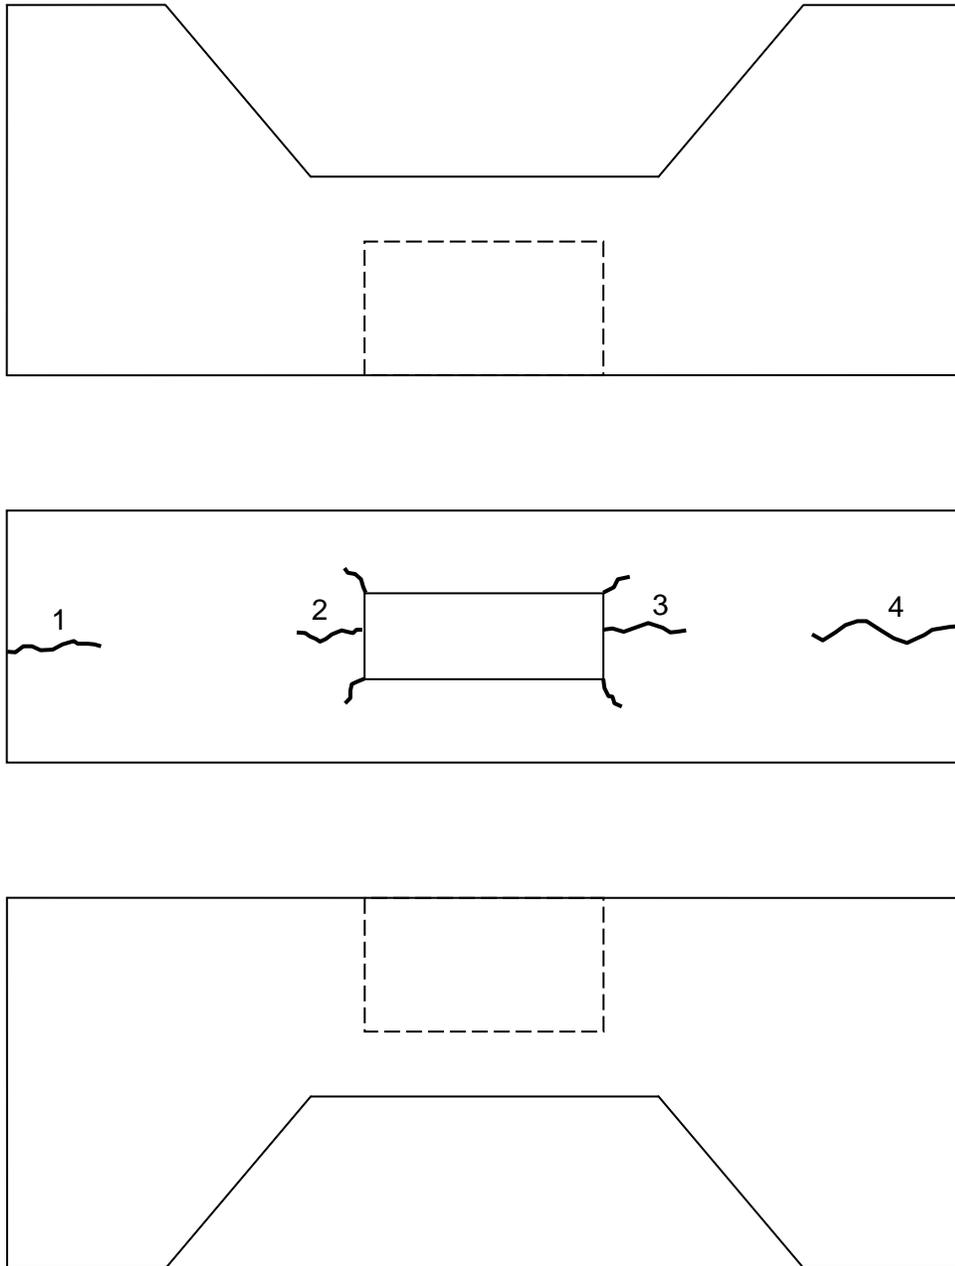
Figure G-4: Beam Specimen AZ-1 Crack Map

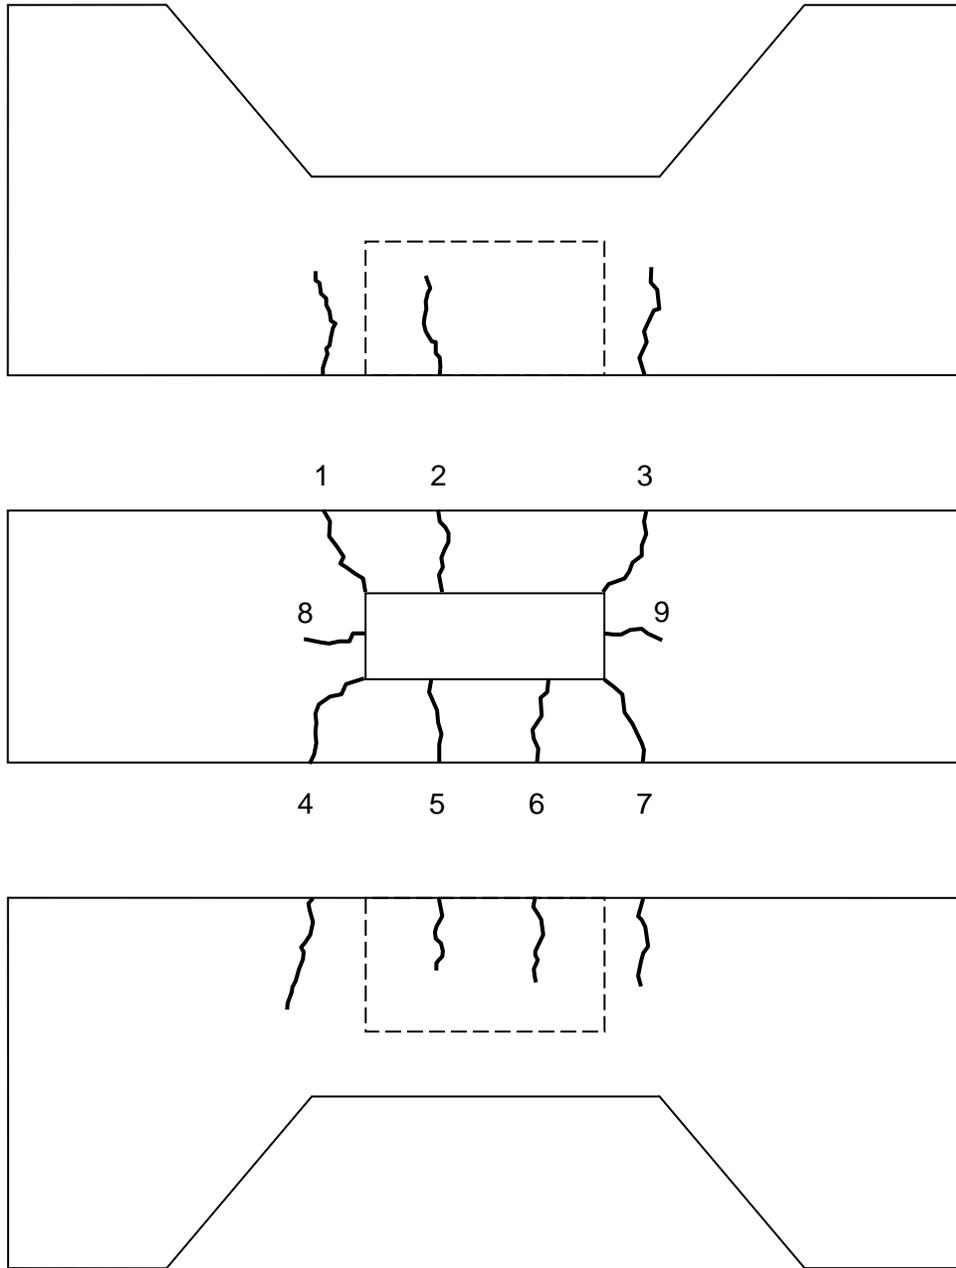
Figure G-5: Beam Specimen AZ-2 Crack Map

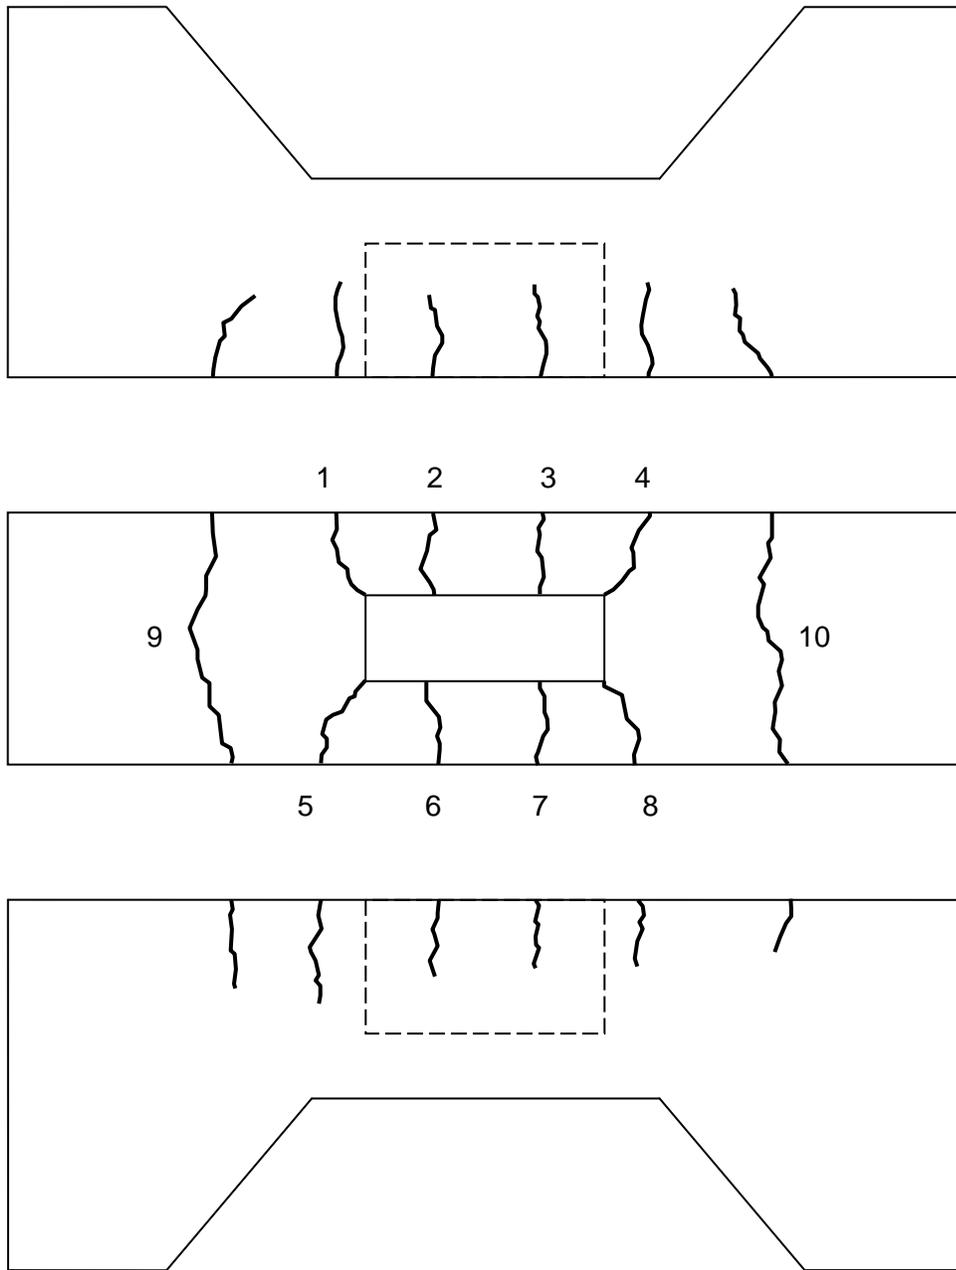
Figure G-6: Beam Specimen AZ-3 Crack Map

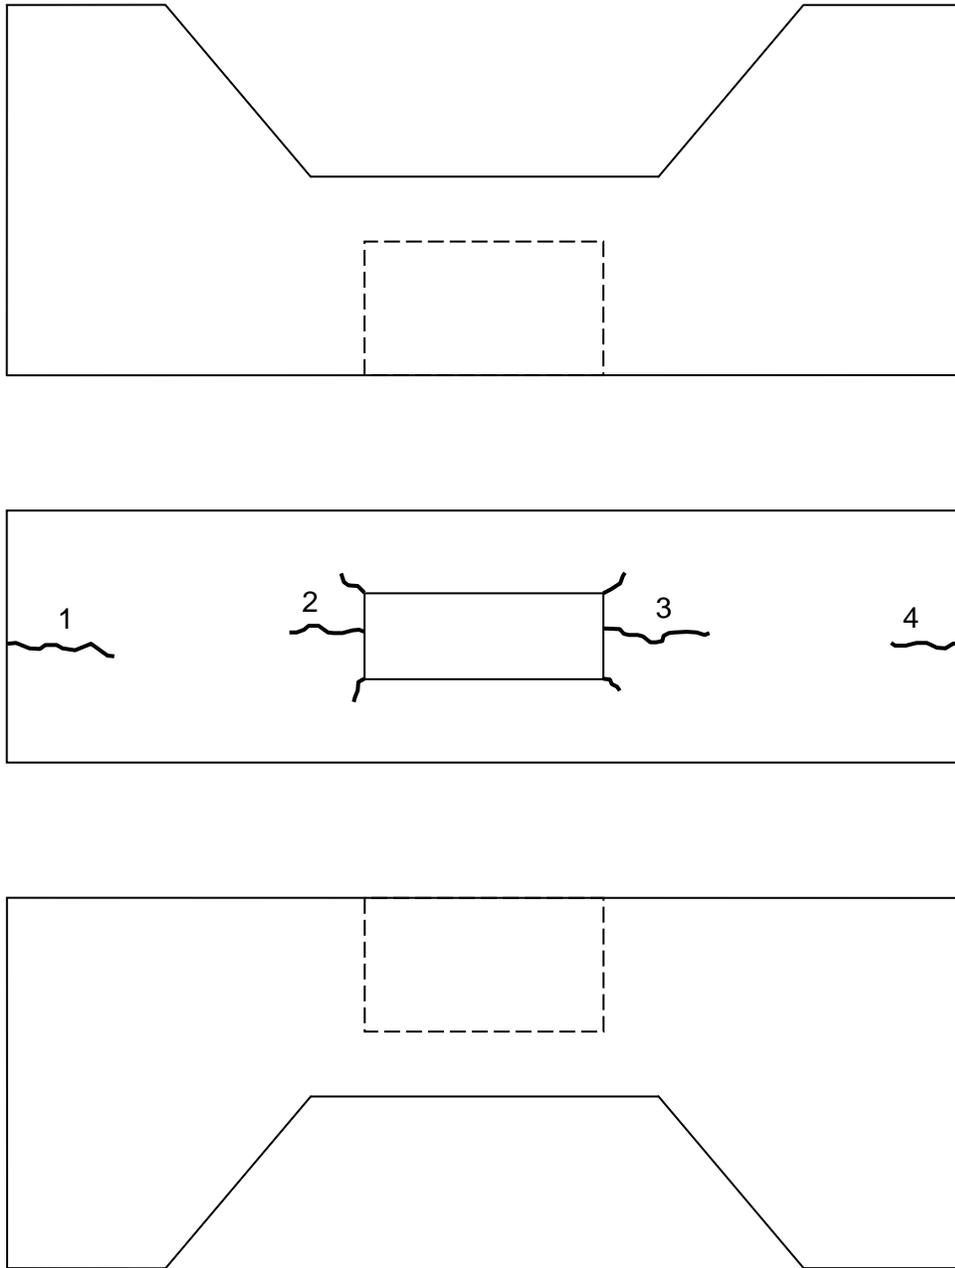
Figure G-7: Beam Specimen AZC-1 Crack Map
