The Pennsylvania State University
The Graduate School
Department of Civil and Environmental Engineering

**THE VIABILITY OF PARTIALLY POST-TENSIONED CONCRETE MEMBERS
IN AN AGGRESSIVE ENVIRONMENT, INCLUDING CYCLIC LOADING**

A Dissertation in
Civil Engineering
by
Jeffery Scott Volz

December 2008

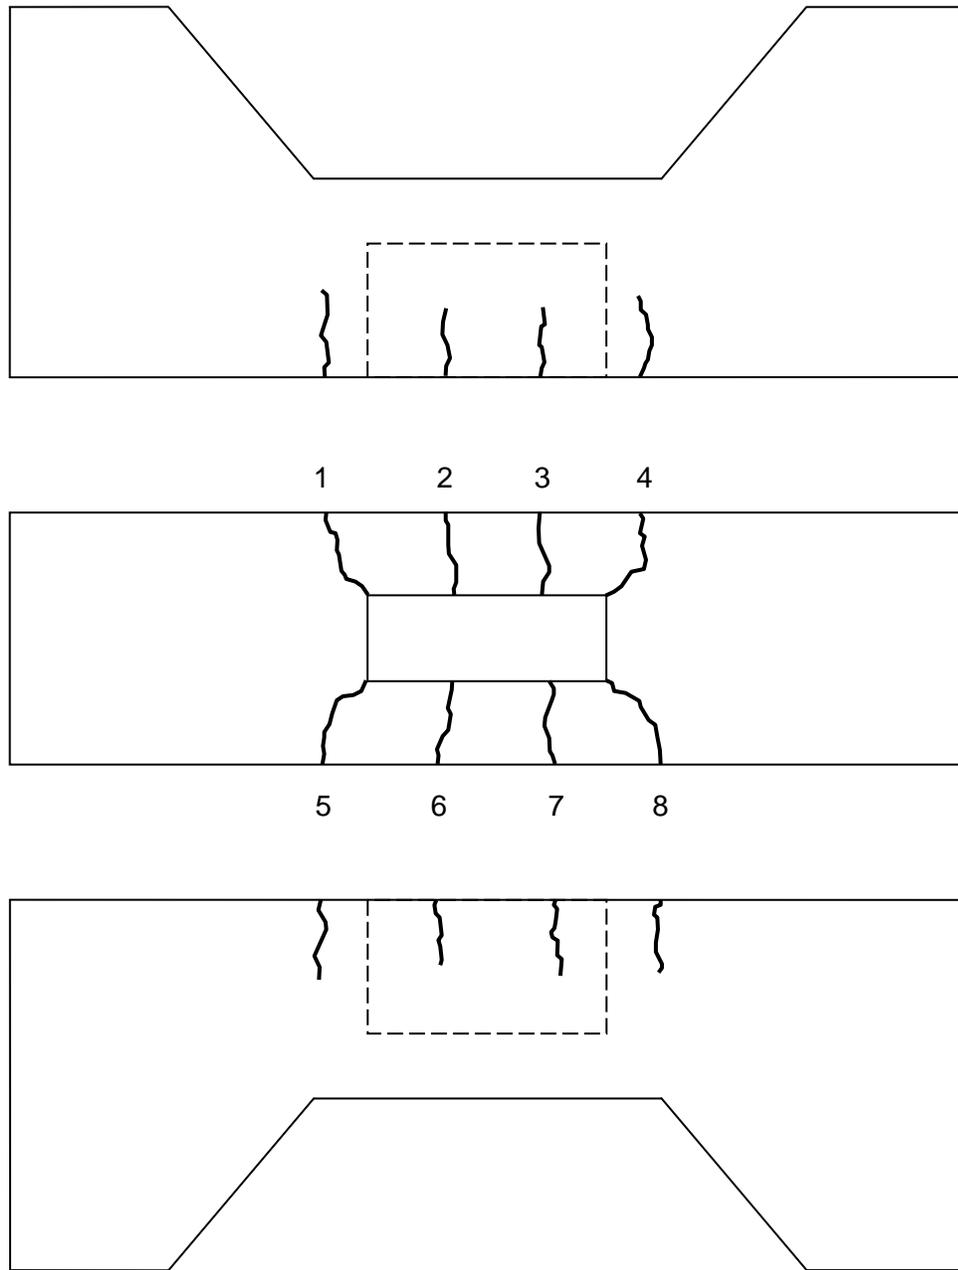
Figure G-8: Beam Specimen AZC-2 Crack Map

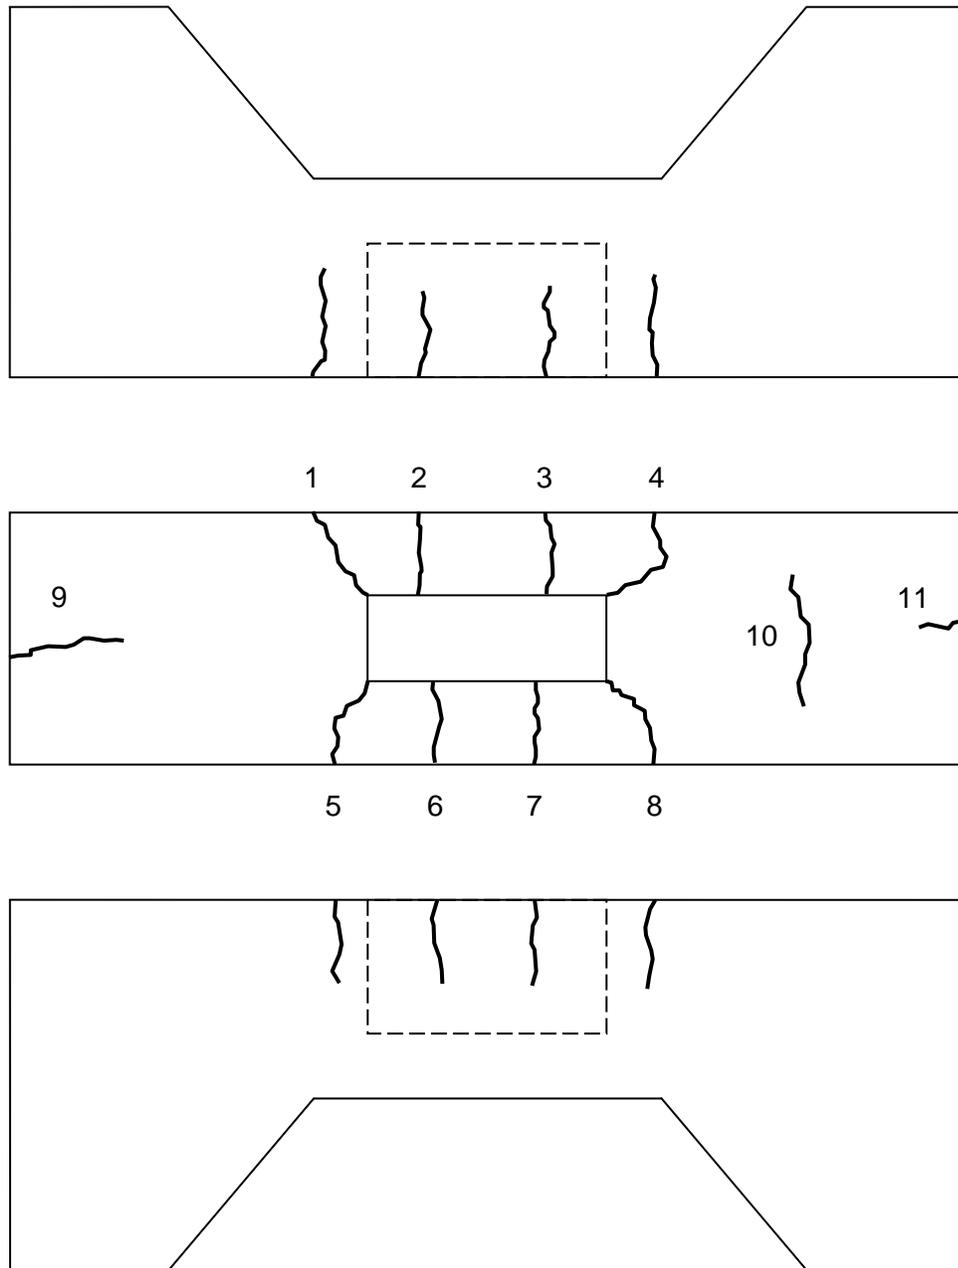
Figure G-9: Beam Specimen AZC-3 Crack Map

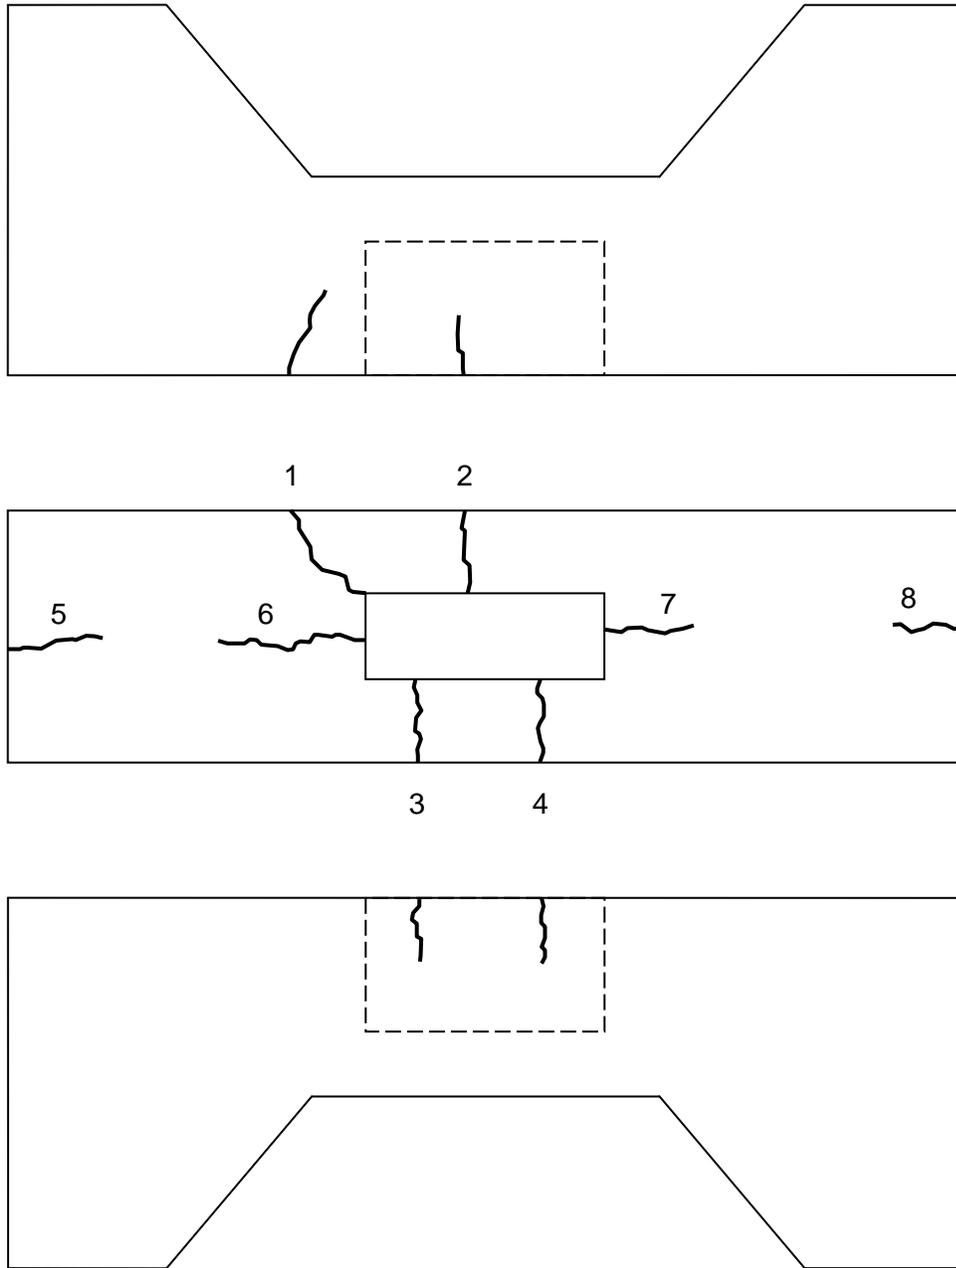
Figure G-10: Beam Specimen GVC-1 Crack Map

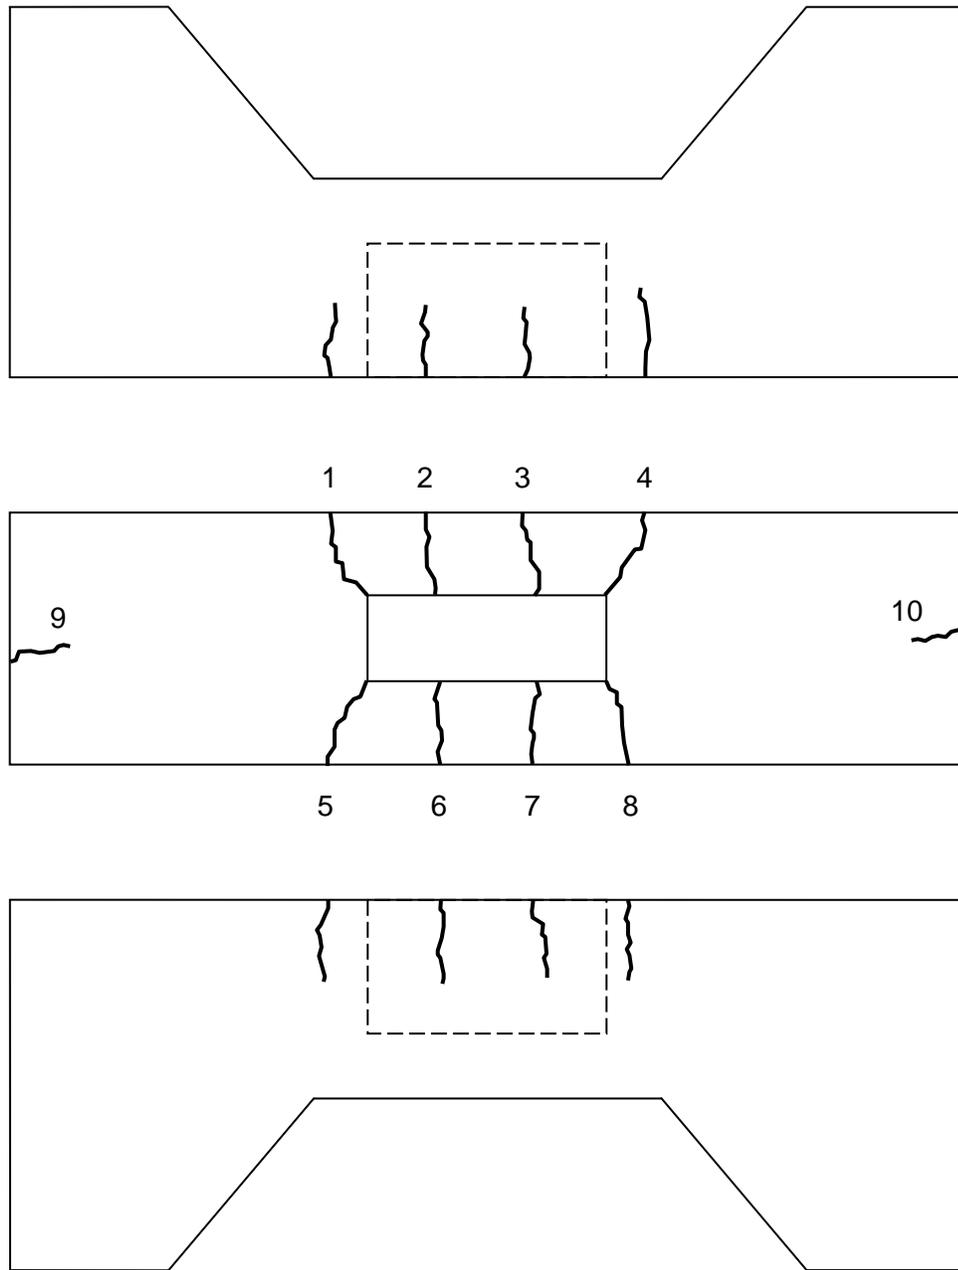
Figure G-11: Beam Specimen GVC-2 Crack Map

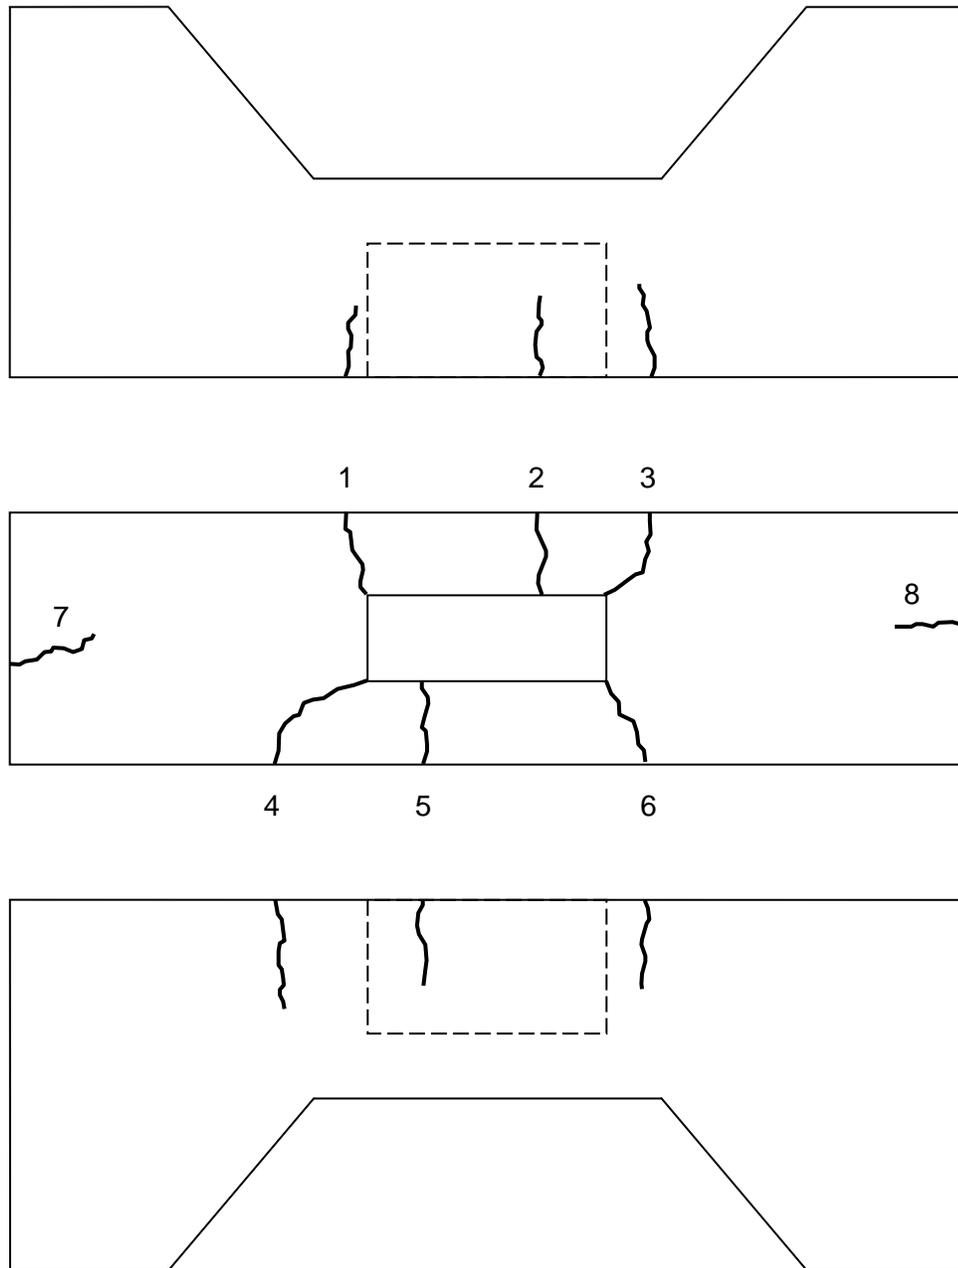
Figure G-12: Beam Specimen GVC-3 Crack Map
