The Pennsylvania State University
The Graduate School
Department of Engineering Science and Mechanics

**DAMAGE TOLERANCE OF LAYER-WISE HYBRID LAMINATES
CONSISTING OF GLASS REINFORCED FLEXIBLE AND
RIGID EPOXY RESINS**

A Thesis in
Engineering Mechanics

August 2008

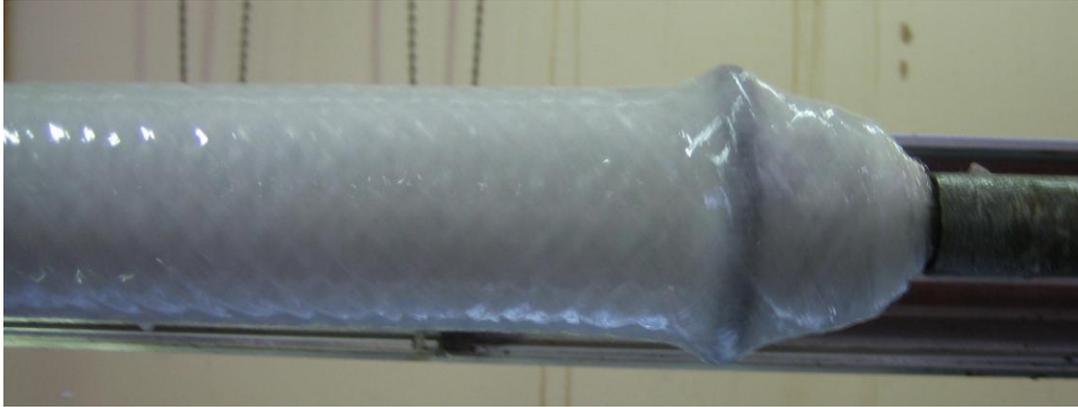
Figure 2.9: Part fully wound on mandrel.

The springs remained in place during the winding of the outer ± 45 -degree layers as shown in Figure 2.9. While the part was being wound, heat was applied to the part with a 5-kW radiant strip heater and the temperature was monitored using an infrared sensor. The temperature hovered around 45°C which allowed the resin to become slightly less viscous and flow evenly throughout the part. As the resin flowed outward, it brought with it any bubbles that may have been trapped between fibers. Therefore heating the part allowed for better consolidation, a slightly higher volume fraction as excess resin dripped off, and a lower void content.

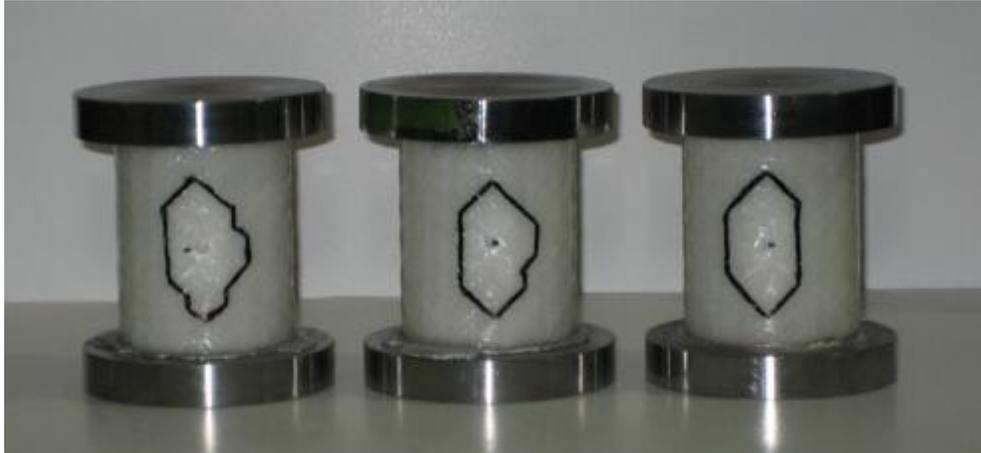
Figure 3.6: Composite tubes potted in Cerrobend and steel end caps.

clamping onto the ends of the composite tubes resulting in clamped-clamped boundary conditions. Composite tubes potted in the steel end caps using Cerrobend are pictured in Figure 3.6.

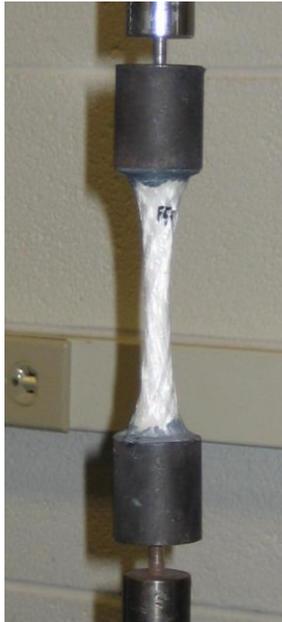
Figure 4.3: ± 45 -degree tube during tensile testing. Width of tube was initially uniform.

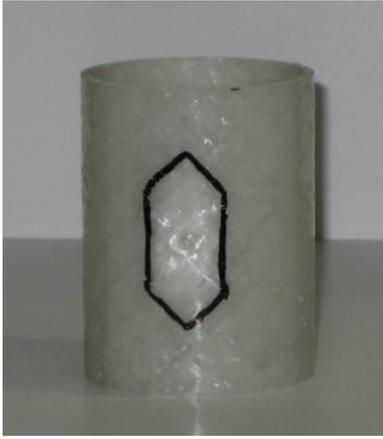
Figure 4.6 shows an all rigid, R5, tube and the micrograph of its cross section. The extent of damage, and therefore, dimensions of the area enclosed by the black solid lines was the smallest of any five-ply tubes. The average width of all three R5 specimens was 18.8 mm and the average length was 34.3 mm. The shape of the region, of this tube and all LWH tubes, is defined by the angle of the fibers in the laminate; the left and right boundaries are marked by ± 2 -degree fibers while the top and bottom boundaries are marked by ± 45 -degree fibers. This also shows that delaminations and matrix cracking can propagate along the directions of the fibers more easily than normal to the fibers. In the micrograph, permanent deformation of the tube wall can be seen as the laminate is curved downward in the middle at the site of the indentation. Also, white lines, indicating matrix cracking can be seen in the ± 45 -degree layers, radiating out and downward from the top surface, and in the ± 2 -degree layers traveling along the fiber direction.

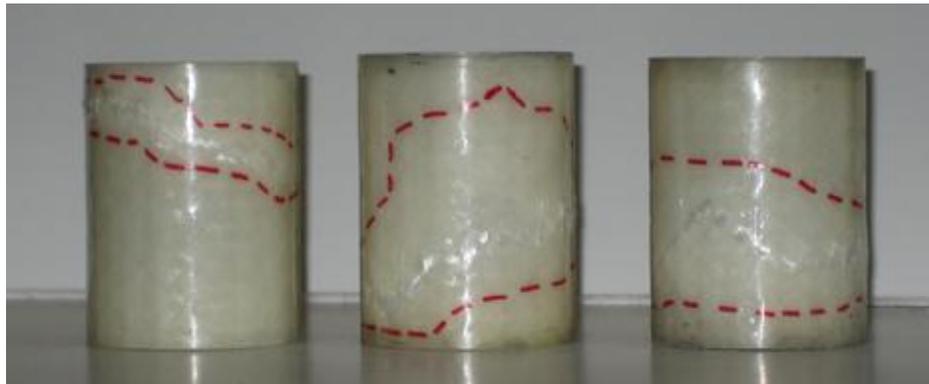
Unindented five-ply, $[(\pm 45)/(\pm 2)_2/(\pm 45)_2]$, R5 tubes after axial compression failure are shown in Figure 4.15. Red dashed lines indicate the approximate region in which damage occurred. A bright light was shone at the inside of the tube making the damaged regions appear darker. The damage included in these regions included matrix cracking, fiber breakage, and delaminations. Fiber breakage can be seen as a bulging, white line snaking around the middle of the tube. Some tubes had larger delaminated areas emanating from the site of fiber breakage. All failures occurred in the middle of the tube with minimal interaction with the end caps. Typical tubes had damage spread around three-quarters of the circumference.

Figure 4.15: Unindented R5 tubes after axial compression.

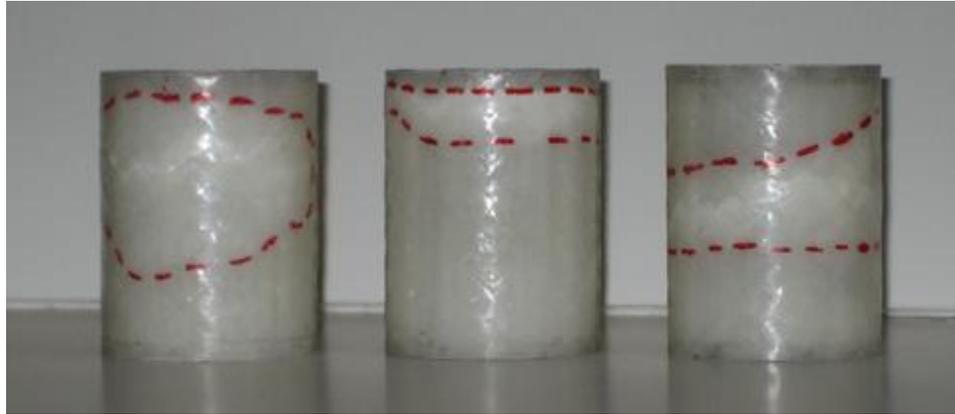
Unindented R4F1 tubes after compressive failure are shown in Figure 4.16. The damaged area on these tubes was considerably smaller than the R5 tubes, and this can be attributed to the lower load that caused failure and therefore lower energy in the system at failure.

Figure 4.16: Unindented R4F1 tubes after axial compression.

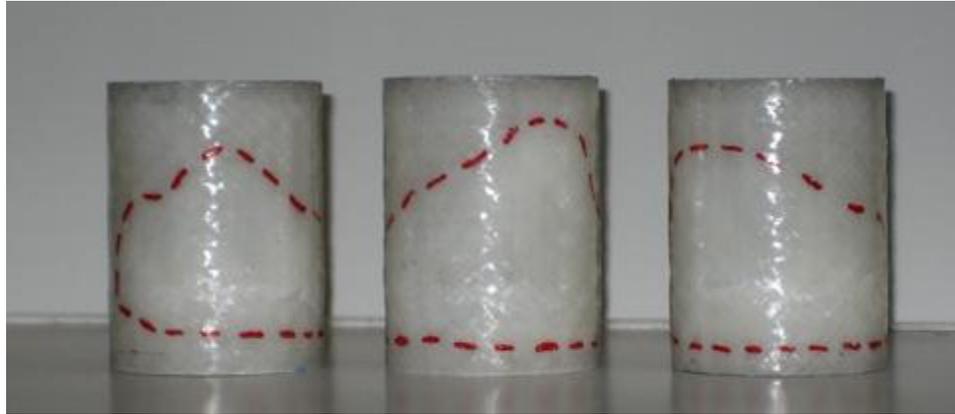
Unindented R3F1R1 tubes are shown in Figure 4.17. The size of the damaged areas is larger in the R3F1R1 tubes than the R4F1 tubes, and this can be attributed to a higher load at failure. All of the R3F1R1 tubes had large delaminated regions surrounding the site of fiber breakage.

Figure 4.17: Unindented R3F1R1 tubes after axial compression.

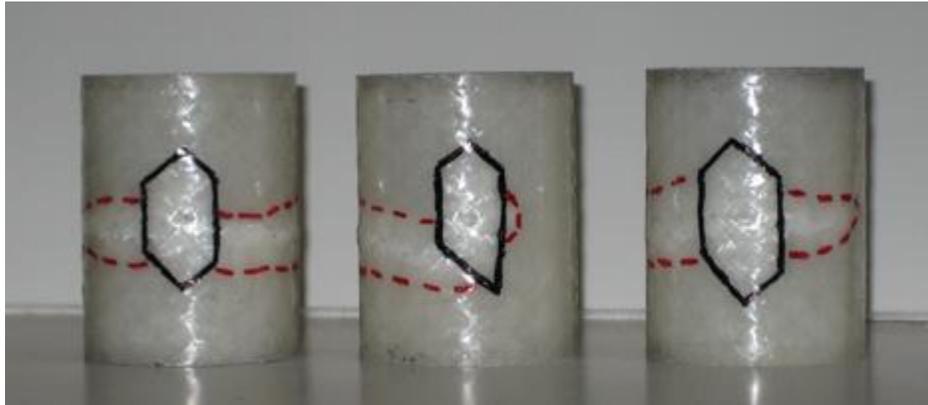
Figure 4.22: Indented R5 tubes after axial compression.

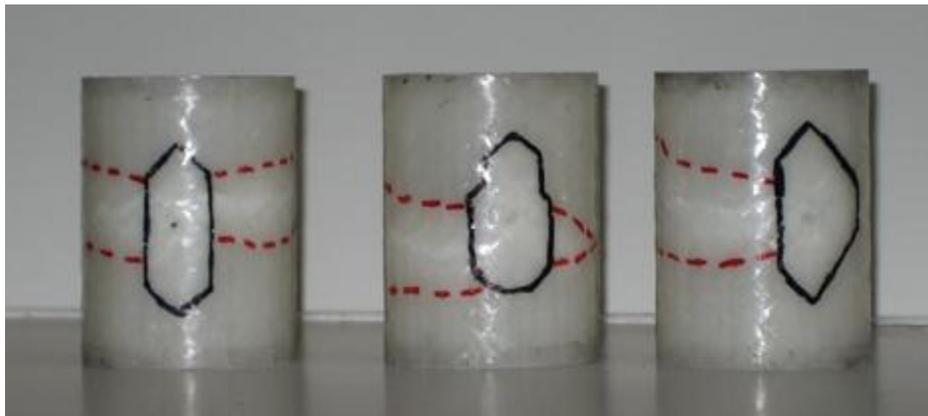
Figure 4.23: Indented R4F1 tubes after axial compression.

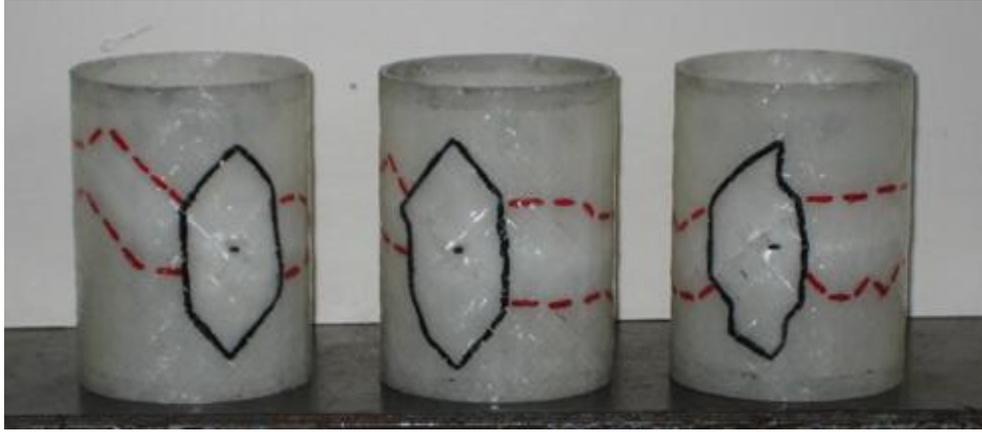
Figure 4.25: Indented R2F1R2 tubes after axial compression.

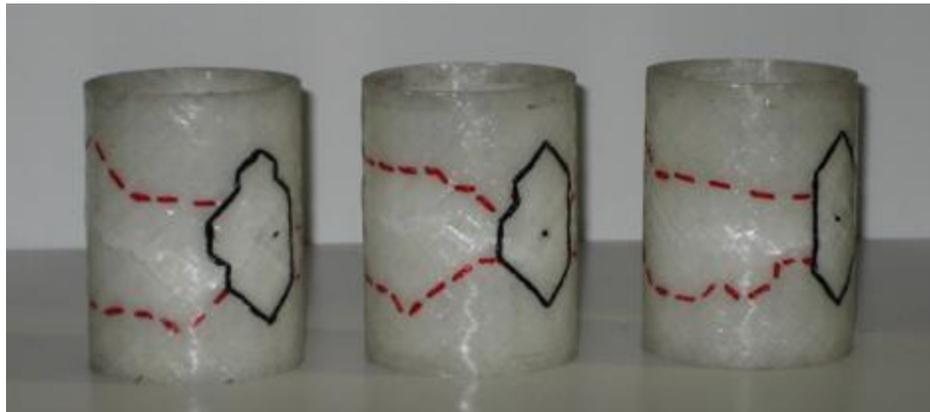
Figure 4.26: Indented R1F1R3 tubes after axial compression.

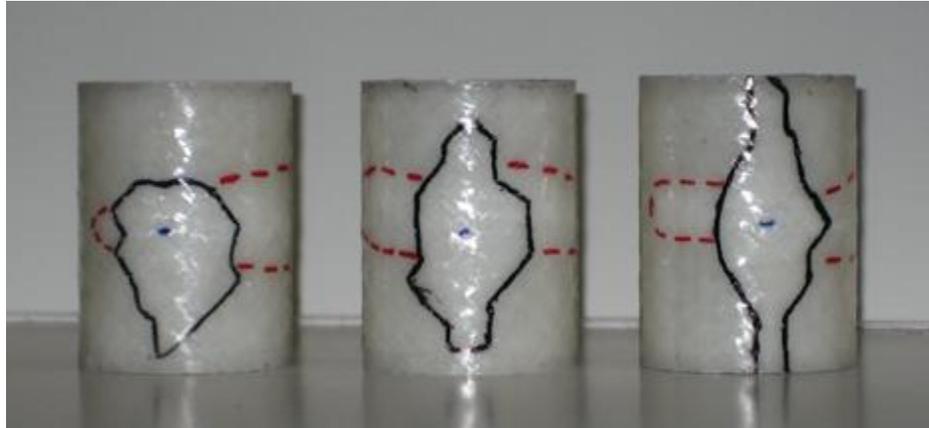
Figure 4.27: Indented F1R4 tubes after axial compression.

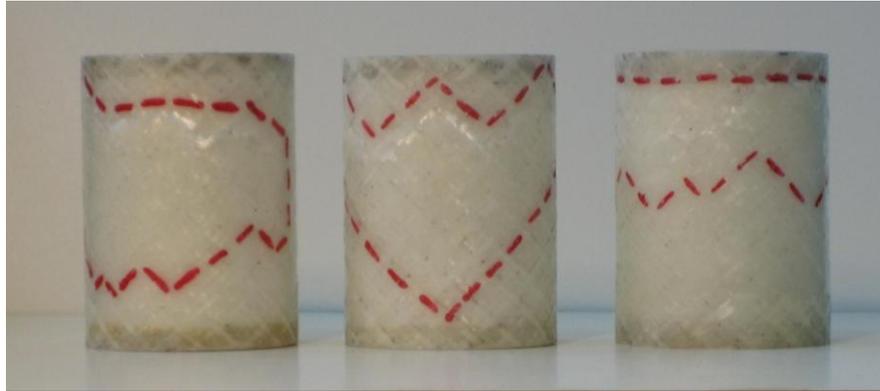
Figure 4.36: R9 tubes after axial compression.

Figure 4.36 shows the R9 tubes after quasi-static axial compression. Unlike the R5 tubes, the R9 tubes experienced fiber breakage that spread along the ± 45 -degree fiber lines. Whitening, indicating fiber breakage and fibers bulging out from the surface, can be seen on all of the tubes. The size of the delaminated areas covered most of the height

of the tubes at some point around the circumference. The delaminated areas also followed the lines of the ± 45 -degree fibers.

Figures 4.36-4.38 show unindented nine-ply $[\pm 45/(\pm 2)_4/(\pm 45)_4]$ tubes after axial compression. The hybridization arrangement of these tubes was designed on the observation that placing the FMC layer at the outer $\pm 2/\pm 45$ -degree interface in the ± 45 -degree ply demonstrated the greatest percent retention in compression after impact strength in the five-ply tubes. This series of tests also investigated the effect of using different modulus epoxies in the FMC layer. The R9 tube is all rigid, the R5P1R3 tube uses a partially flexible epoxy in the FMC layer, and the R5F1R3 uses the more flexible epoxy in the FMC layer.

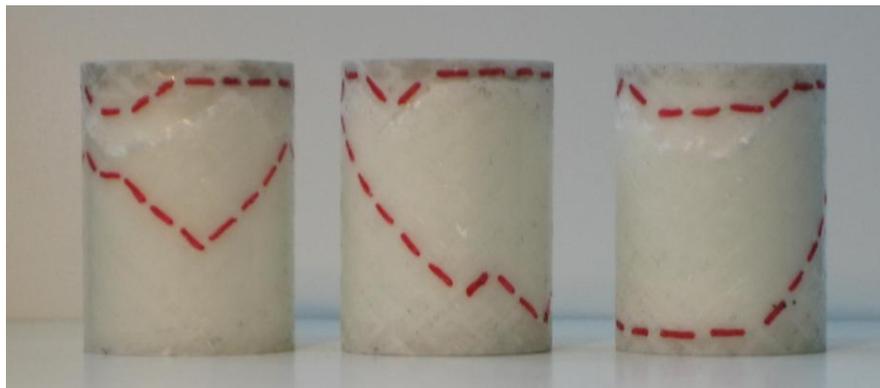
Figure 4.37: R5P1R3 tubes after axial compression.

Figure 4.37 shows the R5P1R3 tubes after compression. The delaminations again covered most of the height of the tubes and followed the lines of the ± 45 -degree fibers. Also, whitening from fiber breakage can be seen along the ± 45 -degree lines, but is less defined than on the R9 tubes.

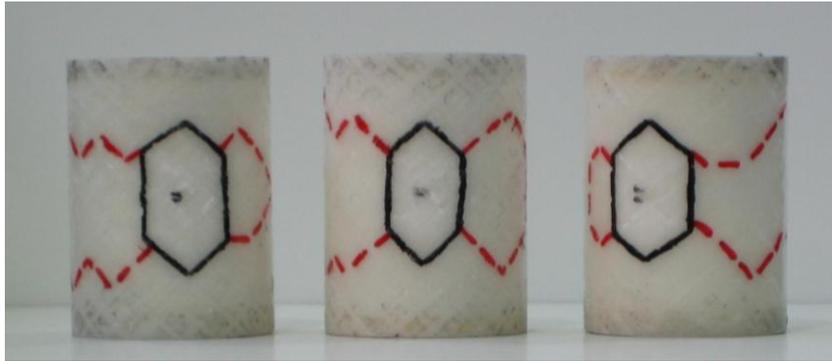
Figure 4.42: Indented R5F1R3 tubes after axial compression.

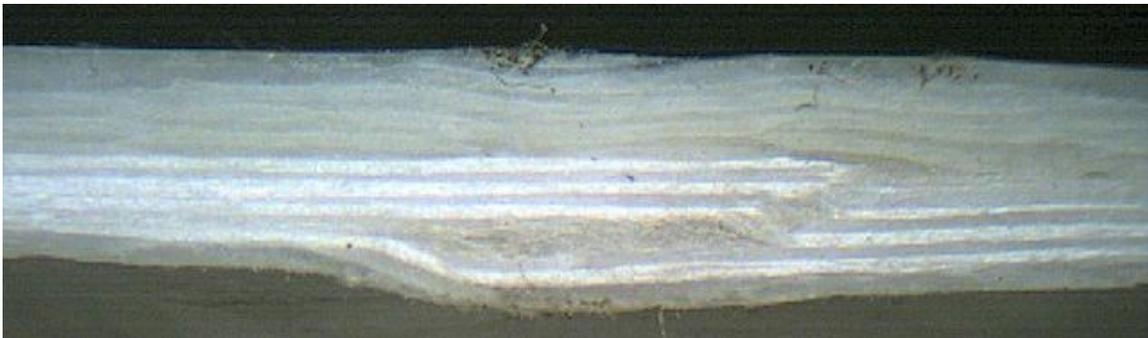
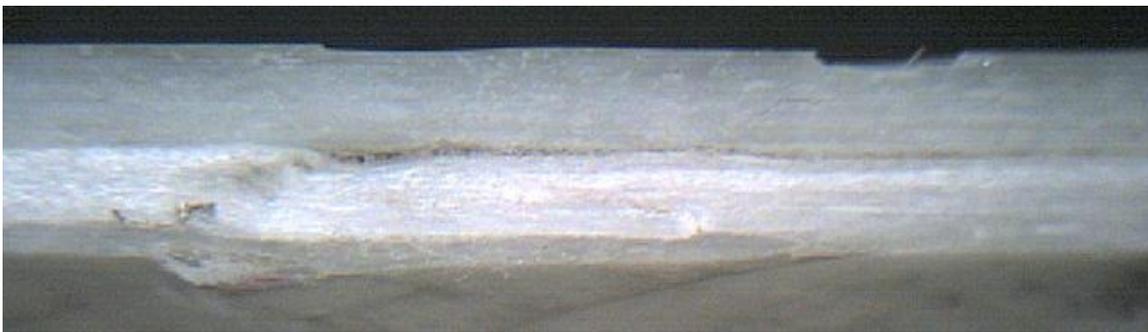
Figure 4.46: R5P1R3 tube cross sections after axial compression: unindented, indented at indentation, indented away from indentation.

Figure 4.46 shows the tube with the partially flexible FMC layer, type R5P1R3. The ± 2 -degree fibers appear to have been shredded instead of breaking or kinking in the unindented tube cross section. Most if not all of the delamination occurred within the ± 2 -degree fibers and not at the interfaces between the ± 2 -degree fibers and the ± 45 -degree fibers. A similar pattern appears in the indented tube at the site of indentation. The

“shredded” region is located mostly between two ± 2 -degree layers while all of the ± 2 -degree fibers appear to kink instead of break. Also at the site of indentation, permanent deformation on the top surface can be seen as well as matrix cracking throughout the ± 45 -degree fibers. Away from the site of indentation, fibers behave in the same manner.

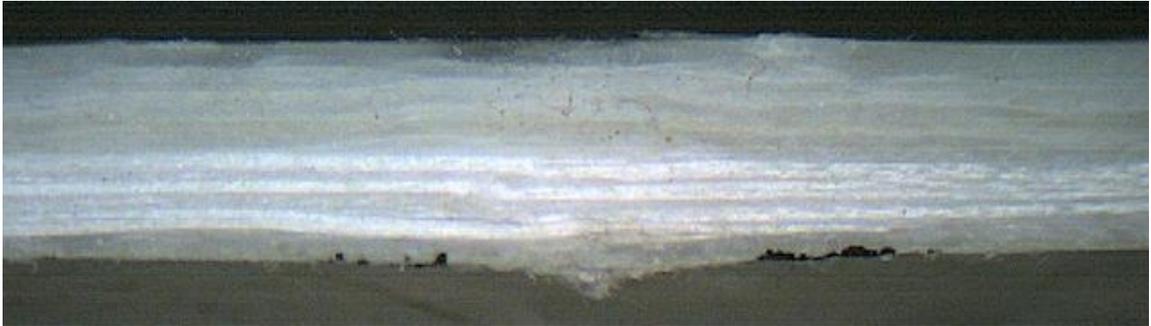
Figure 4.47: R5F1R3 tube cross sections after axial compression: unindented, indented at indentation, indented away from indentation.

Micrographs of the R5F1R3 tubes are shown in Figure 4.47. The unindented tube has kinked fibers similar to the R5P1R3 tube, but the failure region is more confined and without the “shredded” appearance. It appears that there is some delamination at both $\pm 2/\pm 45$ -degree interfaces. The indented tube at the site of indentation has no visible permanent deformation at the top surface and has very faint matrix cracking. Only a few of the ± 2 -degree fiber layers appear to be broken, and the fibers are only slightly displaced. Away from the site of indentation, more of the ± 2 -degree fibers are broken; it appears they are still kinking instead of breaking cleanly across the ± 2 -degree layer, but the region over which they bend is much smaller than in either of the nine-ply tubes. Delaminations are not visible in either of the micrographs.

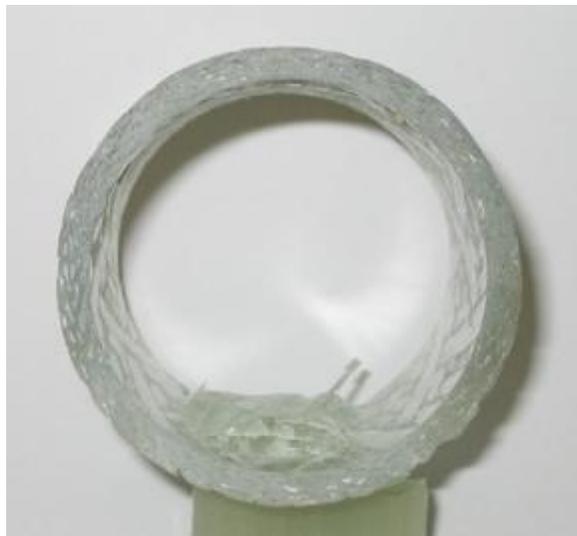
Figure A2.2: Severed fibers cut by interior end supports.

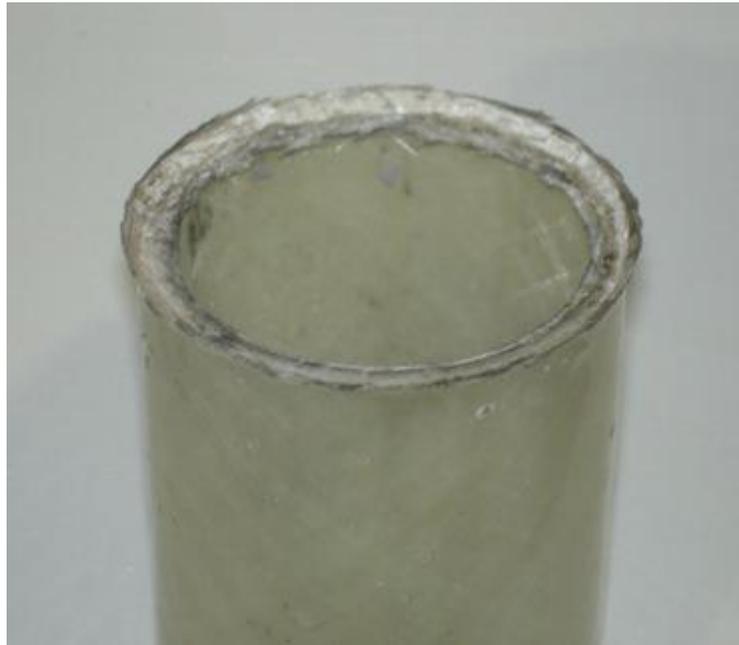
Figure A2.5: End brooming in an unsupported composite tube.

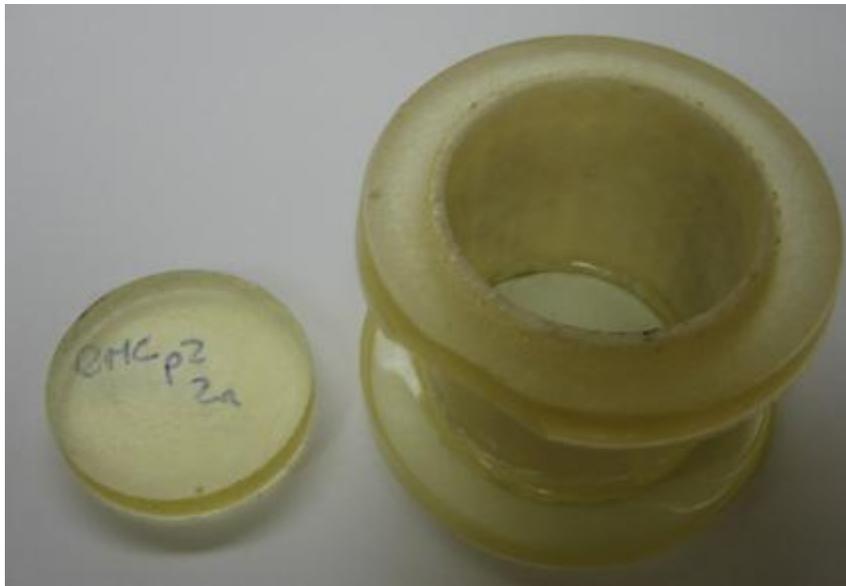
Figure A2.6: Composite tube potted in epoxy with separated inner epoxy disk.
