**CRITICAL MEMBER REMOVAL AND LOAD REDISTRIBUTION OF A  
DETERIORATED TRUSS BRIDGE**

A Thesis in

Civil Engineering

Lynsey D. Reese

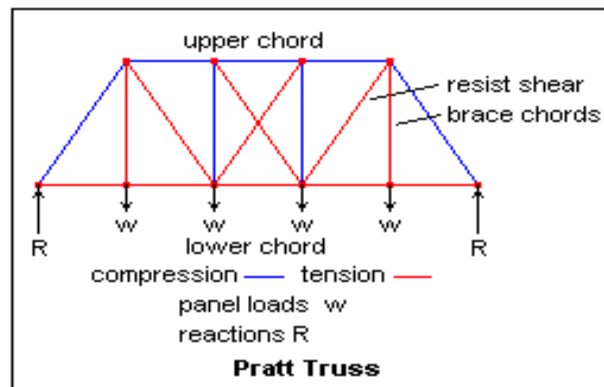
Figure 1-2. Pratt Truss Idealized Force Diagram

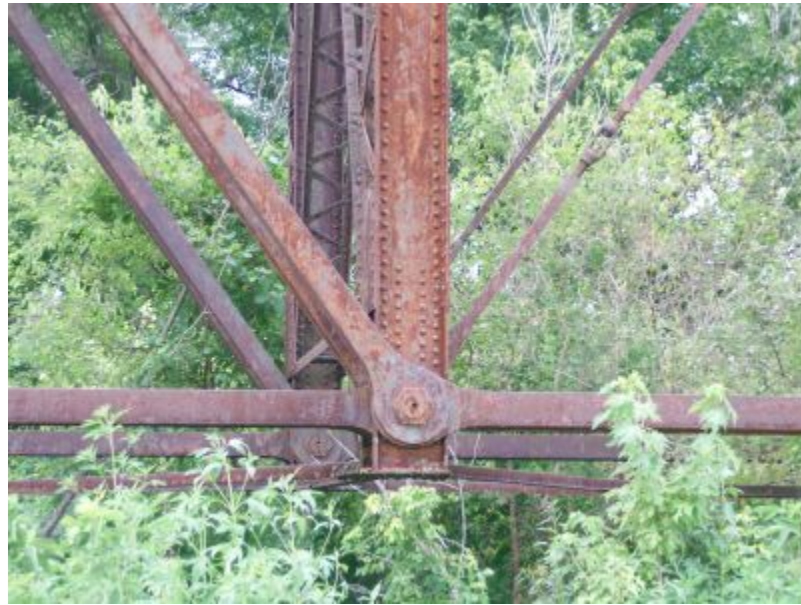
Figure 2-2. Typical Detail of Eyebar Chain and Hanger Connection

The failure was attributed to a fracture of one of the nonredundant eyebars supporting the main span (Fisher 1984). The fracture of the eyebar was determined to be a combination of stress-corrosion cracking and corrosion-fatigue (Dicker 1971). Failure of the eyebar (Shown in Figure 2-2) created a zipper-type collapse by redistributing the load to other members causing overloads on those members. The bridge collapsed in a progressive fashion from the initial failure of the eyebar and the entire main span fell into the Ohio River.

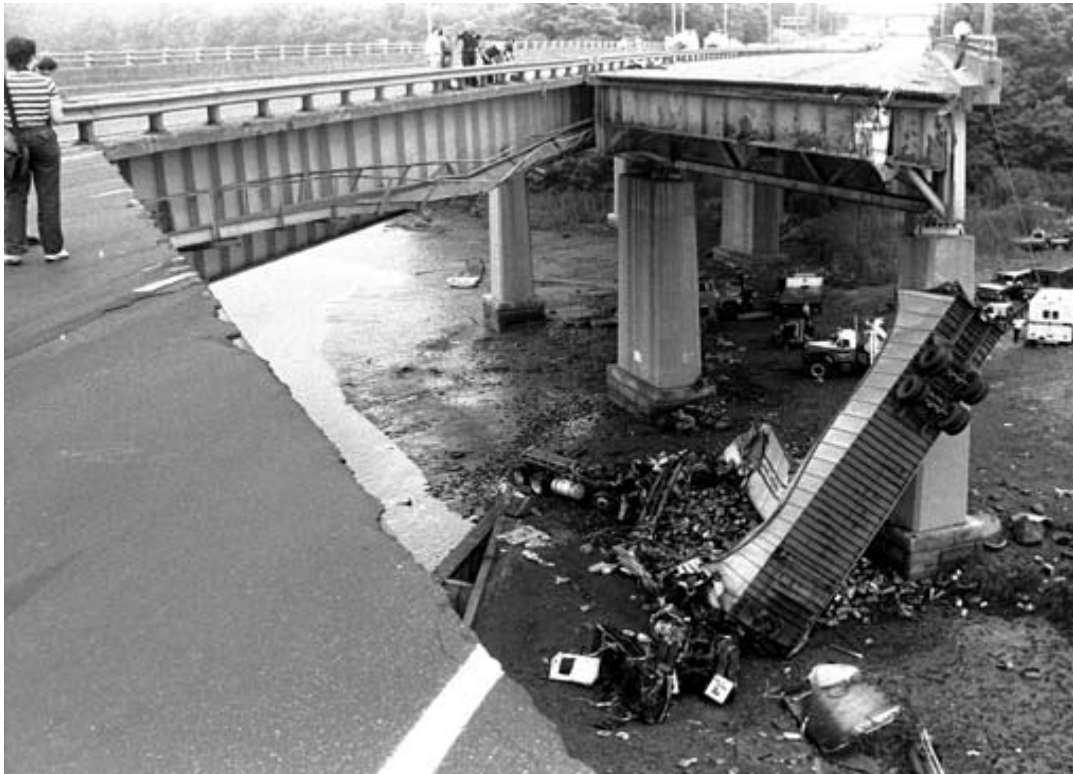
Figure 2-3. Mianus River Bridge Collapse

Another example of a zipper-type collapse was the Mianus River Bridge collapse, Figure 2-3, in 1983 on I-95 in Connecticut (built in 1957). It was the result of a faulty pin-and-hanger assembly (NTSB 1984) shown in Figure 2-4(a) and Figure 2-4(b). The figure shows a typical schematic of a pin-and-hanger assembly that was in place at the time of the collapse. The hanger in the assembly experienced tensile forces and when it failed it led to a zipper-type collapse similar to that of a tension member in a truss bridge. It was a zipper-type collapse because the tension member (the hanger) failed causing an entire section of the bridge to collapse.

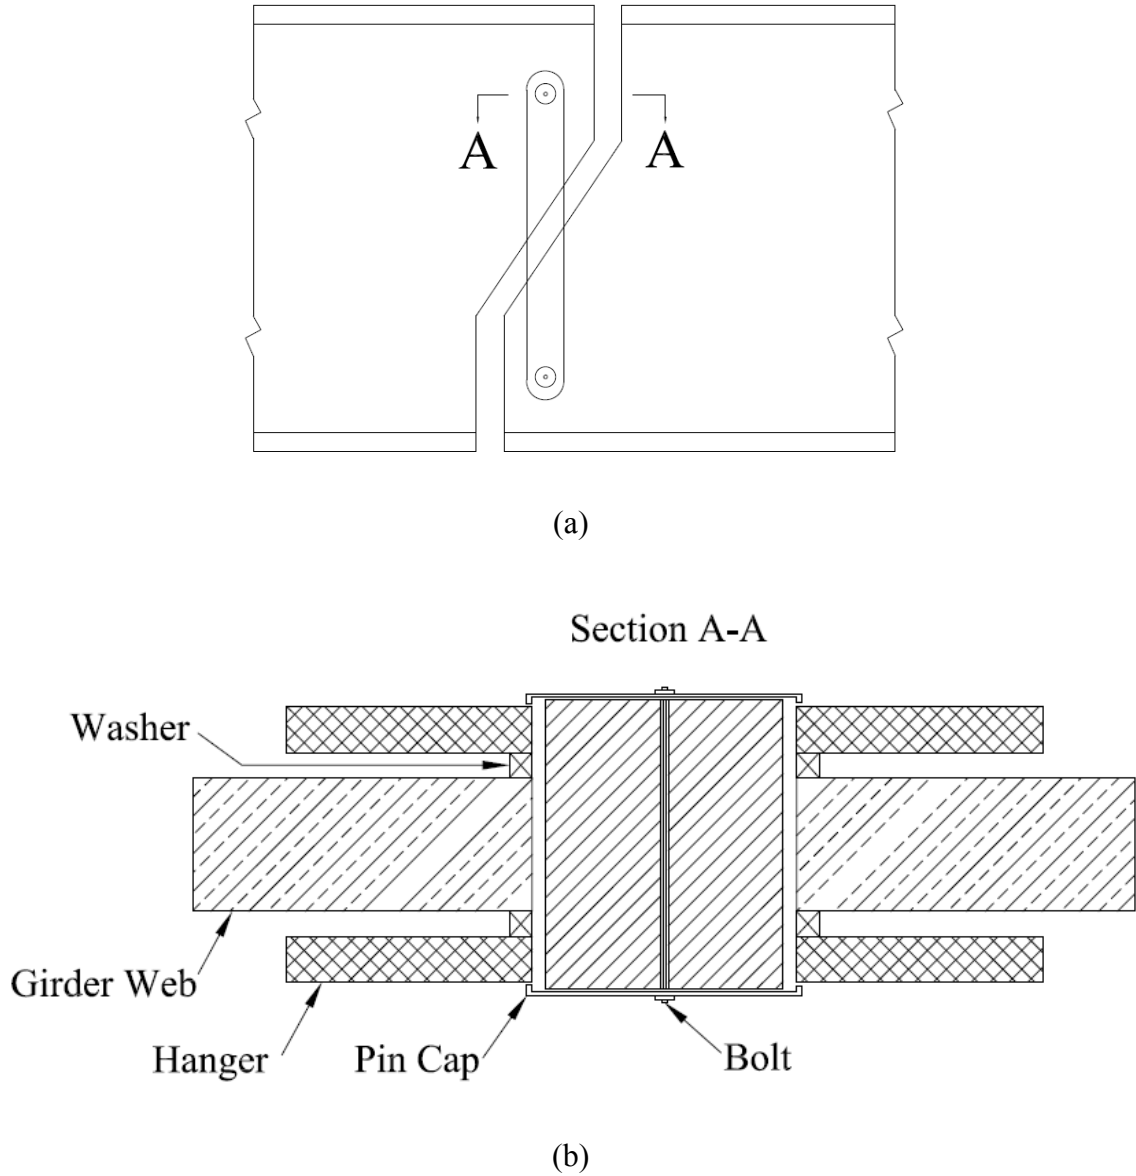
Figure 2-4. Schematic of Pin-and-Hanger Assembly of the Mianus River Bridge

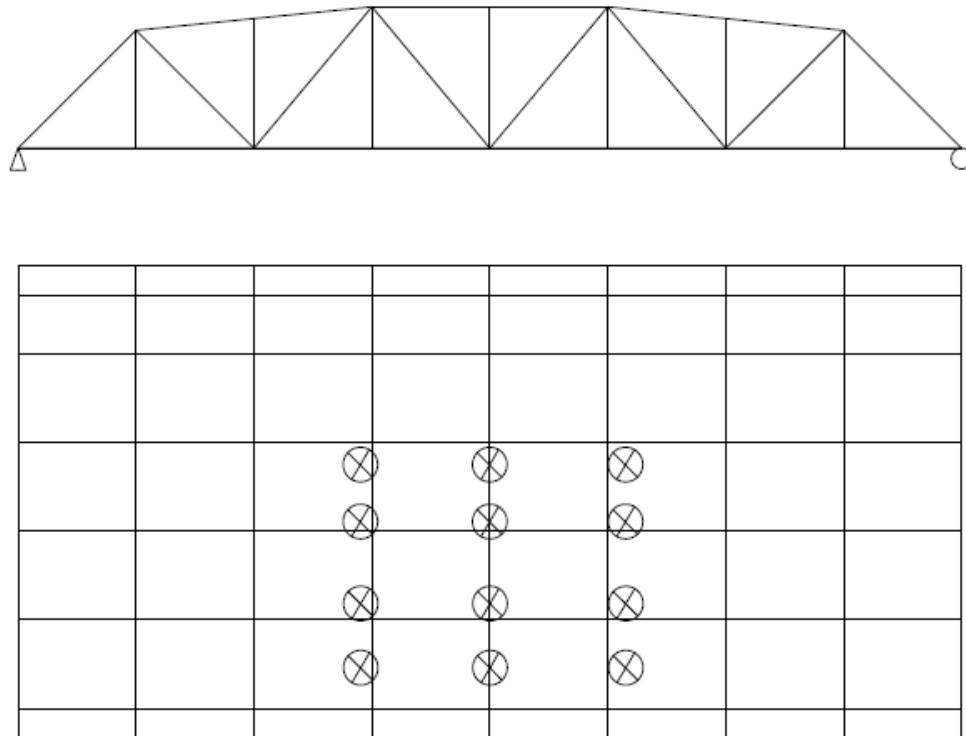
Figure 2-5. Loading Pattern for Truss Bridge

bridges. For their approach, load factors  $LF_1$  and  $LF_d$ , are used to help establish the redundancy of bridge structures and were calculated using a three-dimensional finite element analysis.  $LF_1$  is the multiple of side-by-side HS-20 trucks that the structure can carry in addition to unfactored dead loads (using elastic analysis) before the first member reaches the resistance predicted by design specifications (Dexter et al. 2005). Figure 2-5 shows a representative example of a loading pattern to determine  $LF_1$ . In addition to the loading pattern shown other patterns would be analyzed to determine any other critical members in the structure.

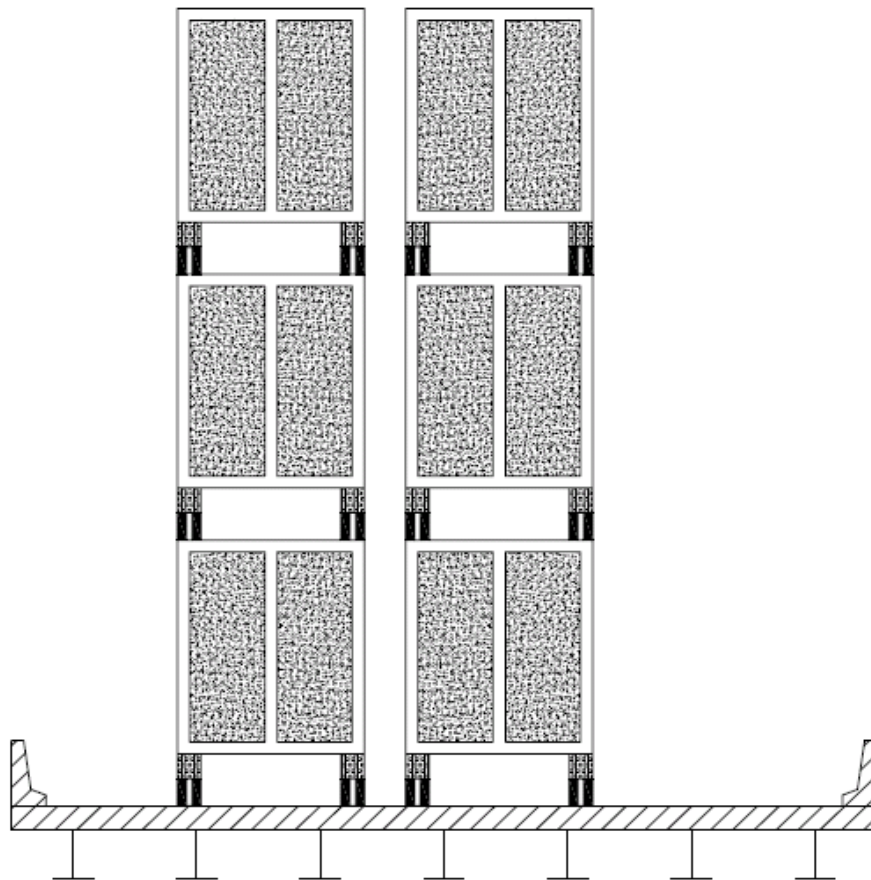
Figure 2-6. Schematic of Multiple HS-20 Trucks

$LF_d$  is the residual capacity of the damaged structure and is calculated by performing a nonlinear analysis of the damaged structure (with critical member removed) under the effect of unfactored dead load and incrementally applied multiples of side-by-side HS-20 truck loads until the system collapses.  $LF_d$  gives a measure of the capacity of the structure for the damaged condition limit state. Using  $LF_1$  and  $LF_d$  provide a measure of the level of redundancy in the bridge. Figure 2-6 shows a schematic of multiples of side-by-side HS-20 trucks (Ghosn and Moses 1998).

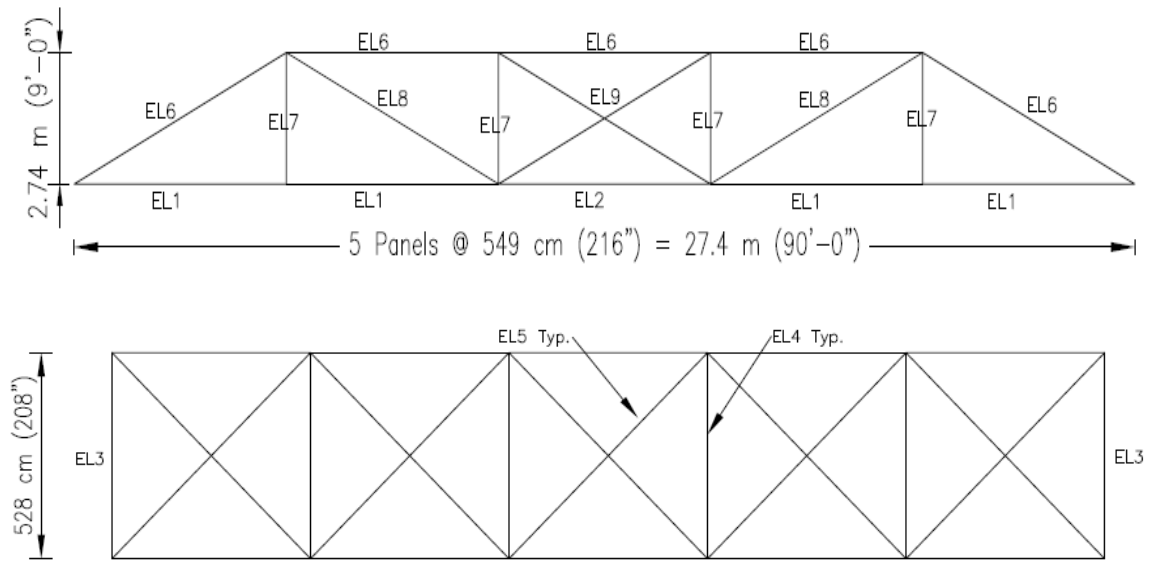
Figure 3-2. Typical Truss Elevation and Framing Plan, Rock Creek Bridge

The overall geometry of the bridge is shown in the typical truss elevation and structure framing plan drawings in Figure 3-2. Member cross sections and sizes are shown in Figure 3-3, and are summarized, along with relevant properties in Table 3-1.

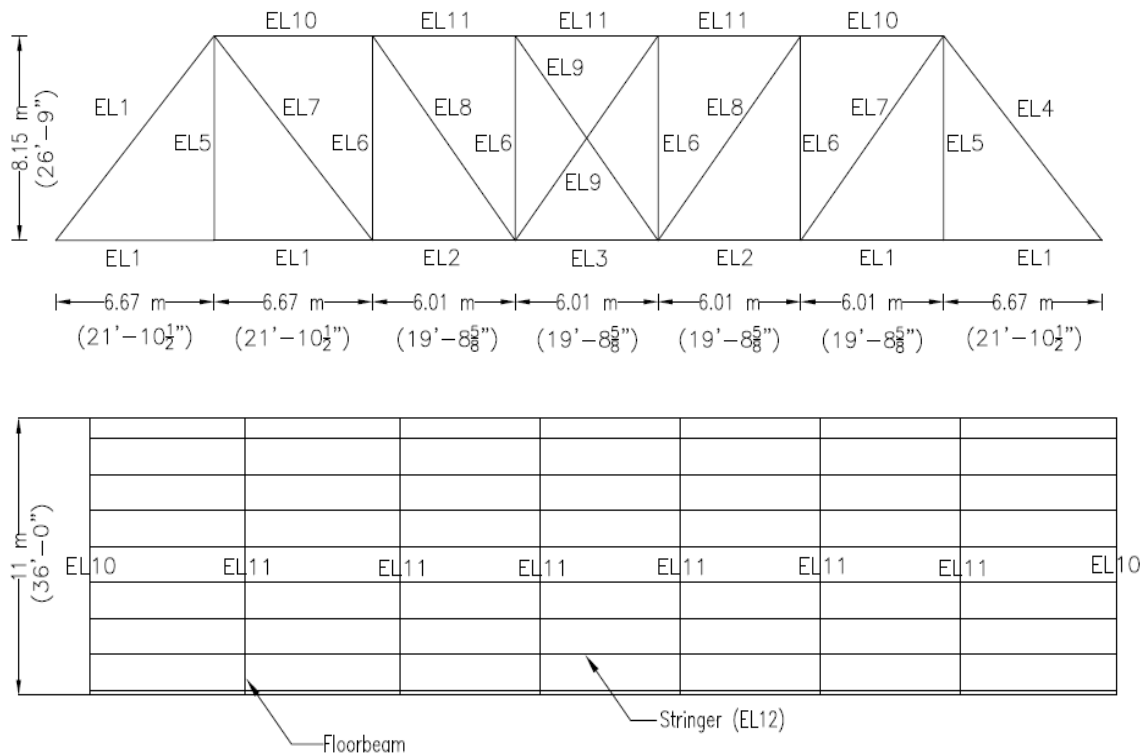
Figure 3-5. Typical Truss Elevation and Framing Plan, Beech Creek Veterans Memorial Bridge

The overall geometry of the bridge is shown in Figure 3-5. The sizes and types of the truss members are summarized in Table 3-2. Figure 3-6 details the member cross sections and is referenced in Figure 3-5.

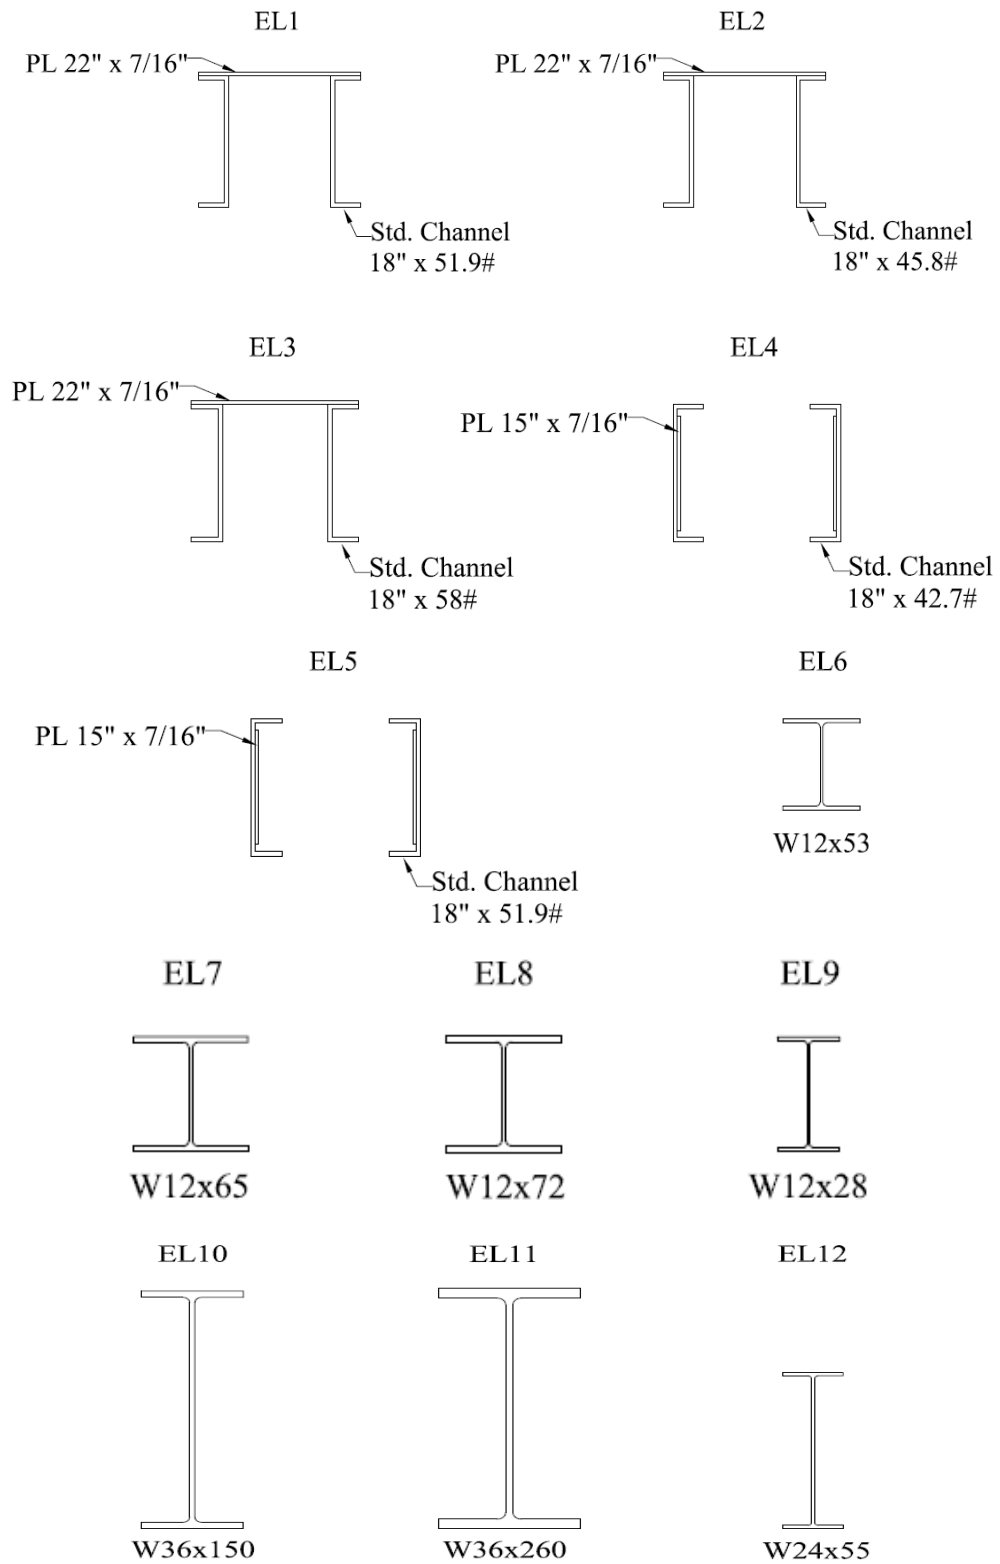
Figure 3-6. Member Cross Sections, Beech Creek Veterans Memorial Bridge

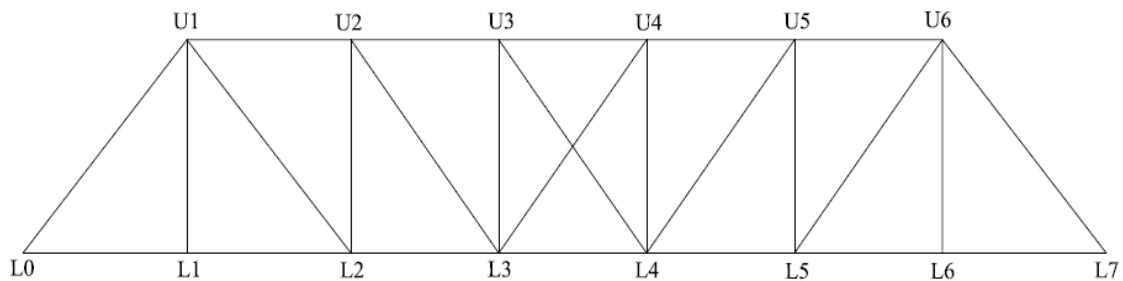
Figure 3-7. Beech Creek Veterans Memorial Bridge Condition Evaluation Identification

Prior to the 1993 rehabilitation of the Beech Creek Veterans Memorial Bridge an in-depth condition evaluation was completed by the Pennsylvania Department of Transportation District 2-0 (1993). The information gathered from the condition evaluation will be used in the following chapters to create a deteriorated model of the Beech Creek Veterans Memorial Bridge. The condition evaluation used a member designation as shown in Figure 3-7 for the entire inspection. The following is pertinent information collected from the superstructure condition evaluation.

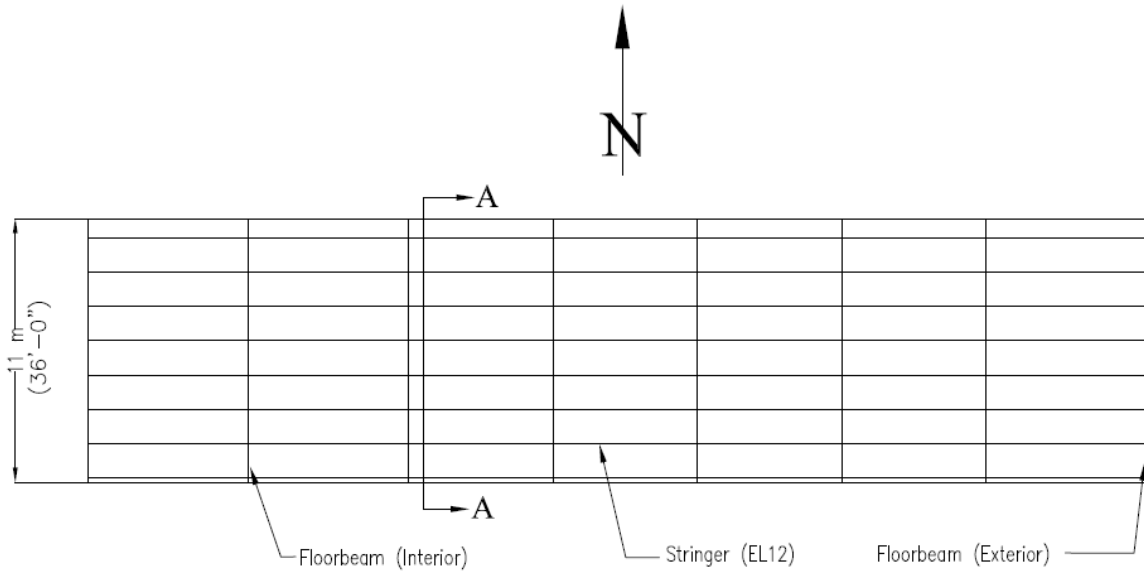
Figure 3-8. Framing Plan, Beech Creek Veterans Memorial Bridge

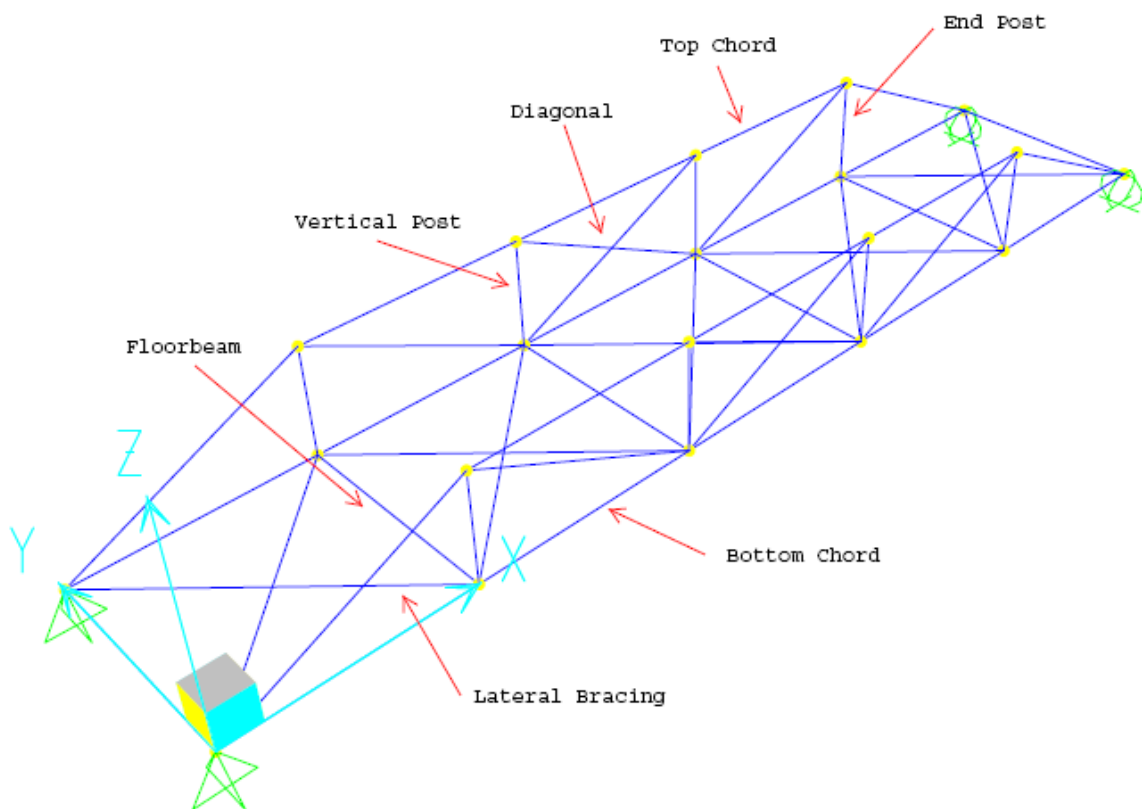
Figure 4-1. Truss Components

3-1 and are based on field measurements of the bridge members. Figure 4-1 shows a model of a truss bridge. The floor system, including the stringers and the floorbeams, were modeled with beam elements. The truss members, including end posts, vertical posts, top chords, bottom chords and the lateral bracings in the floor system were also modeled using beam elements. Diagonal members in the truss were modeled using truss elements. The modeling technique used in the Rock Creek Bridge model was based on work completed by Azizinamini et al. (1997).

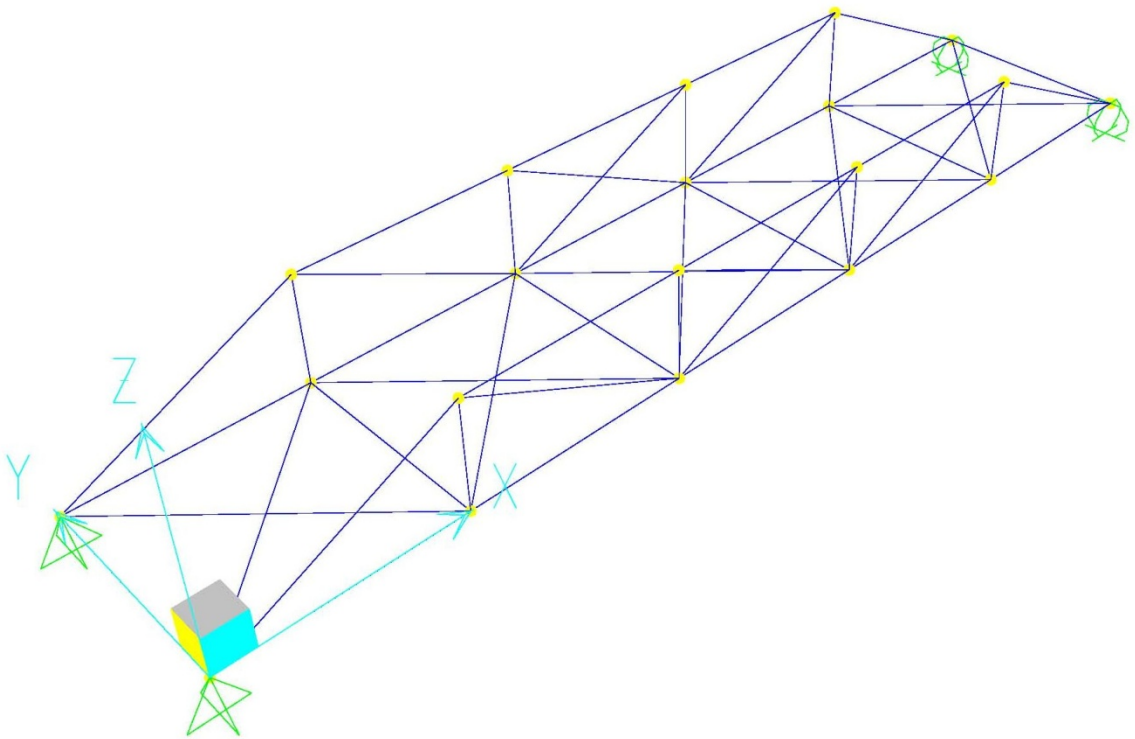
Figure 4-2. Analytical Model, Rock Creek Bridge

and eyebar connection present in the Rock Creek Bridge. Boundary conditions were also of importance and initially consisted of simply supported conditions with pins at one end of the bridge and rollers at the opposite end. Based on the work by Azizinamini the hinges and rollers provided in the truss and supports were assumed to function properly even though they were rusted and corroded. Material properties for the model were based on coupon tests completed on selected compression members as shown in Table 4-1 (Azizinamini et al. 1997). An elastic, small deformation analysis was completed. Figure 4-2 shows the Rock Creek Bridge pristine model.

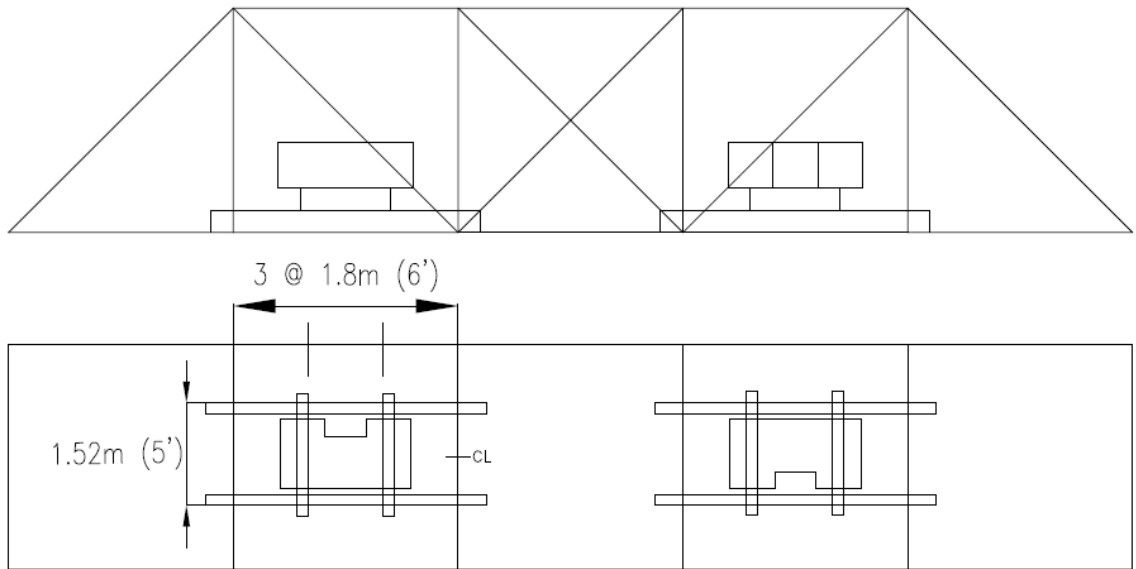
Figure 4-4. Dead Load Configuration, Elevation and Plan View, Rock Creek Bridge

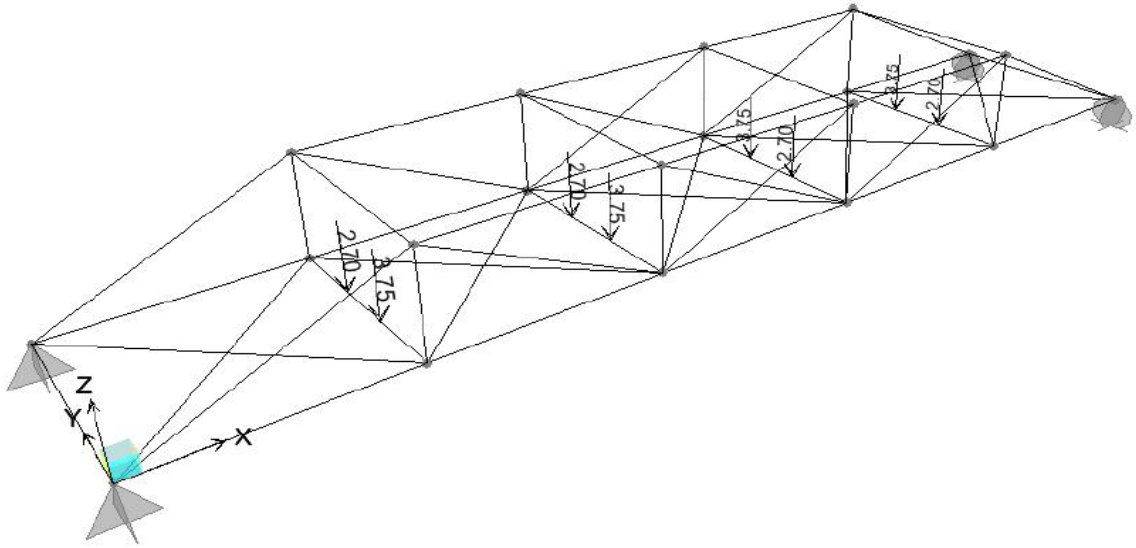
Figure 4-5. Dead Load Concentrated Loads, Rock Creek Bridge

The concentrated loads for the model were determined using the geometry of the concrete block and the unit weight of concrete  $23.6 \text{ N/m}^3$  (150 pcf). Figure 4-5 shows the point loads used for the model.

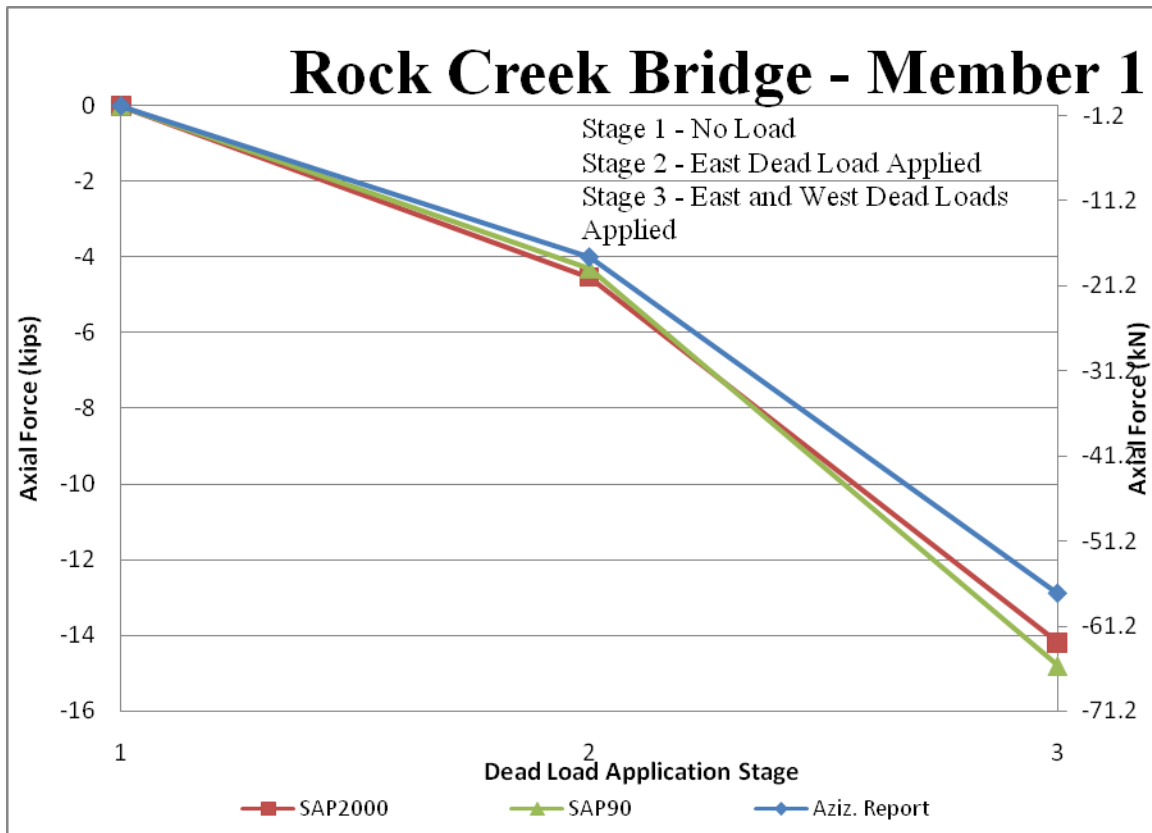
Figure 4-7. Axial Force in Member 1, Rock Creek Bridge

Figure 4-7 shows representative axial forces in Member 1 of the model of Rock Creek Bridge. The results are reported at two stages corresponding to the placement of each concrete block on the bridge structure. The horizontal axis in this figure identifies each loading stage with Stage 1 corresponding to zero dead load and Stages 2 and 3 corresponding to placement of the first and second concrete blocks onto the bridge ignoring the self weight of the bridge. The vertical axis in the figure represents the axial force. Azizinamini and SAP90 results were compiled from previous research (Azizinamini 1997) while the SAP2000 results were from the current analytical model described in previous sections. Results for the other instrumented members are shown in Appendix A - Figures A4.1 to A4.10.

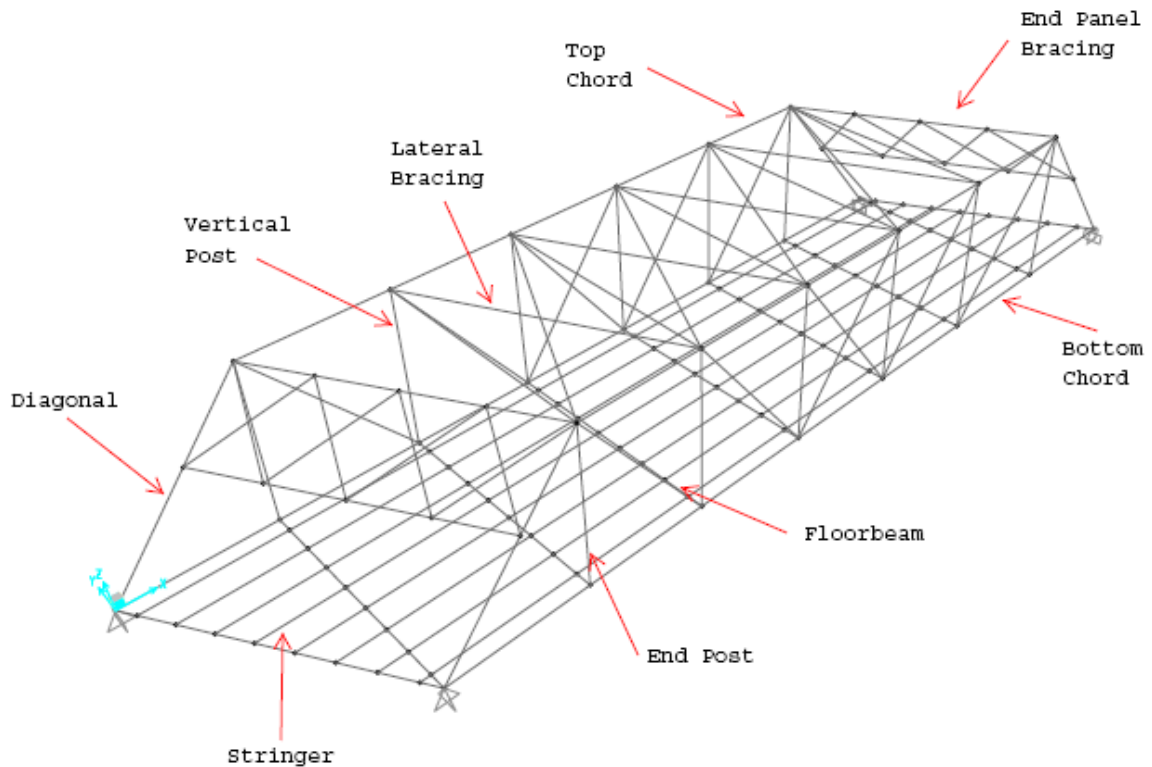
Figure 4-8. Components of Beech Creek Veterans Memorial Bridge

The Beech Creek Veterans Memorial Bridge was modeled using truss and beam elements. The Section Designer in SAP2000 was used to define each member's cross sectional properties and geometry. Cross sectional properties are given in Table 3-2 and Figure 3-6 shows bridge geometry. The floor system, including floorbeams and stringers, were modeled using beam elements. The vertical posts, bottom and top chord, and end posts of the truss were modeled as beam elements. The diagonals of the truss, the lateral bracing and the end panel bracing were modeled as truss elements. Figure 4-8 shows the components in the Beech Creek Veterans Memorial Bridge.

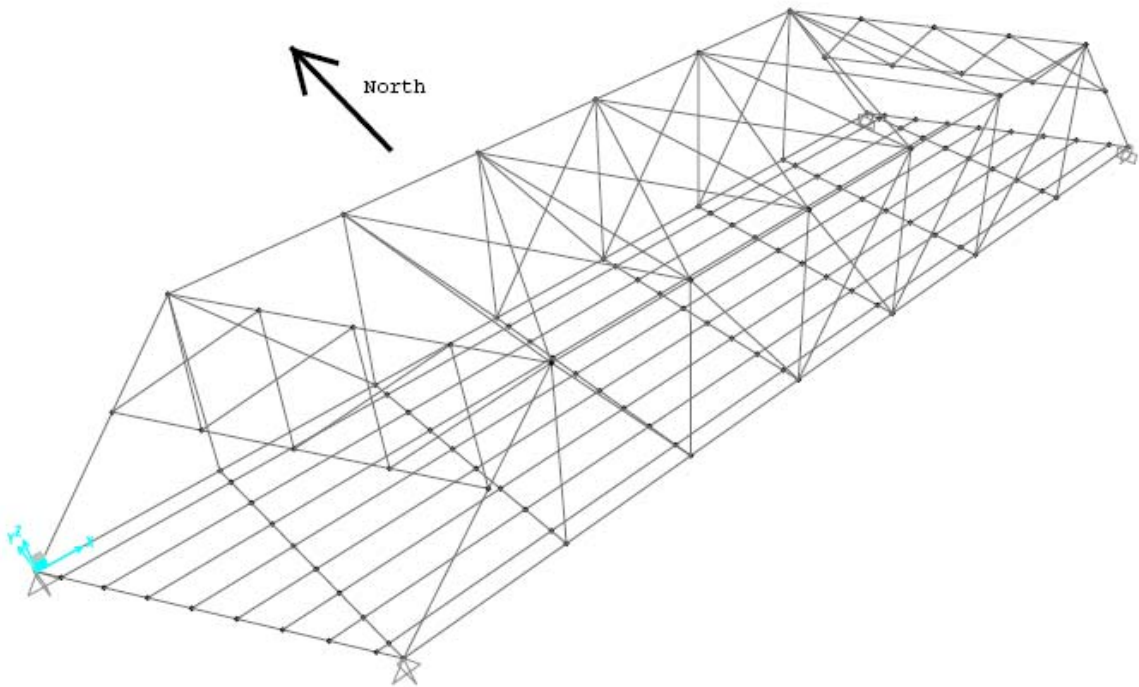
Figure 4-9. Beech Creek Veterans Memorial Bridge Pristine SAP2000 Model

analysis was completed. Figure 4-9 shows the finite element model of the Beech Creek Veterans Memorial Bridge.

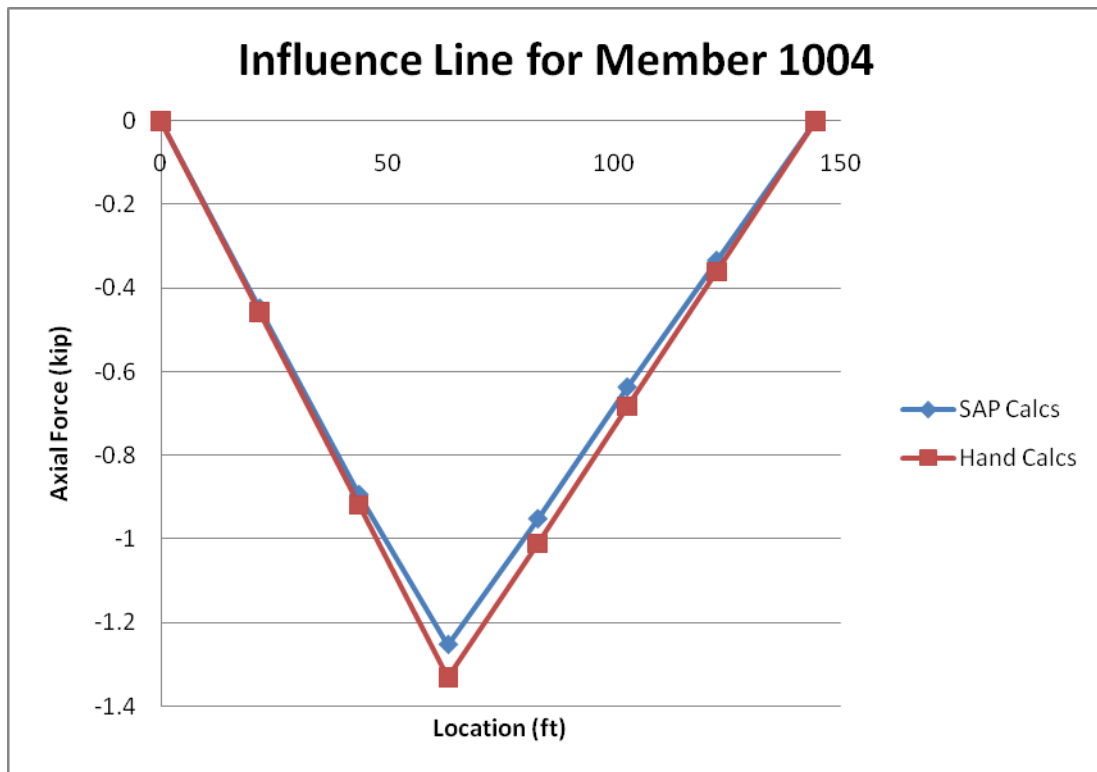
Figure 4-11. Influence Line for Member 1004, Beech Creek Veterans Memorial Bridge

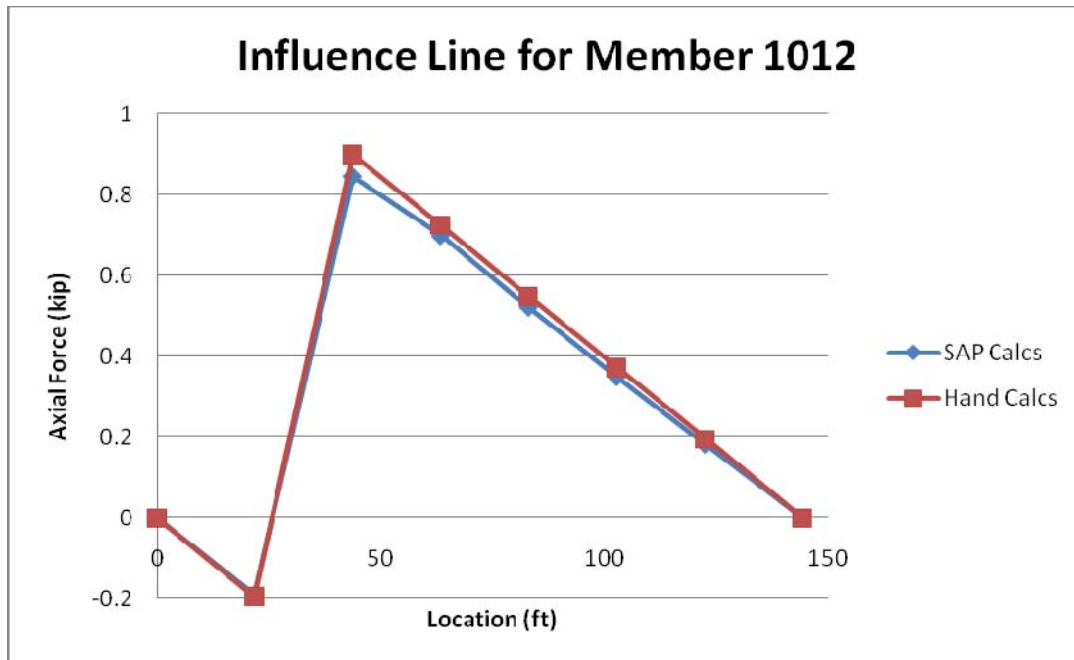
Figure 4-12. Influence Line for Member 1012, Beech Creek Veterans Memorial Bridge

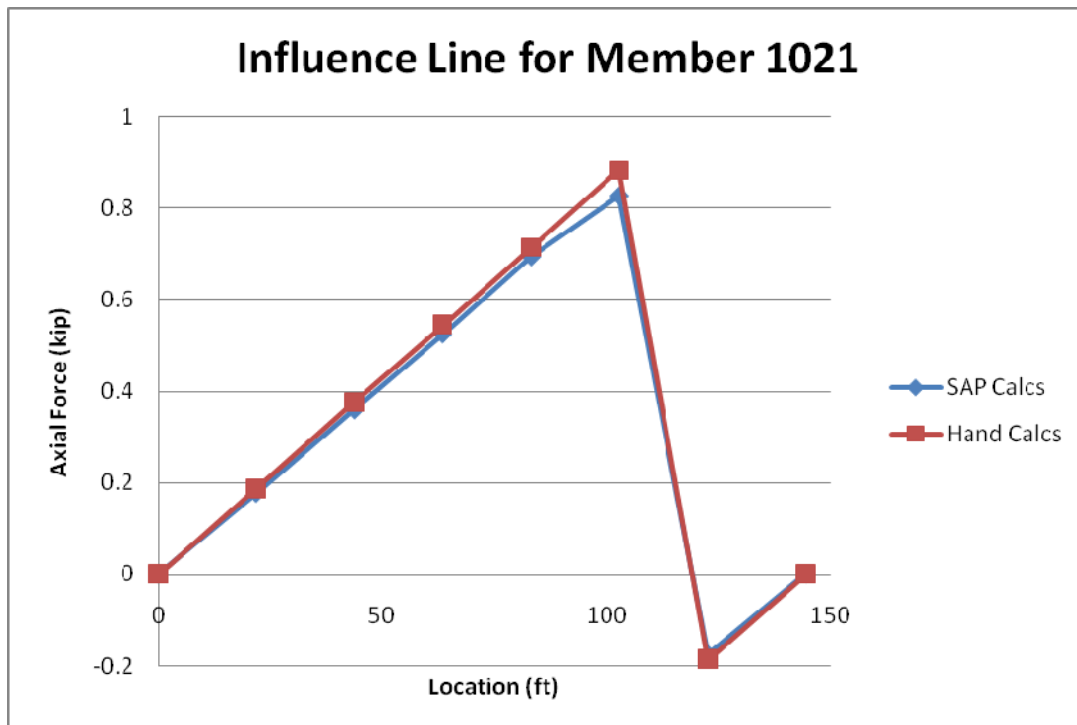
Figure 4-13. Influence Line for Member 1021, Beech Creek Veterans Memorial Bridge

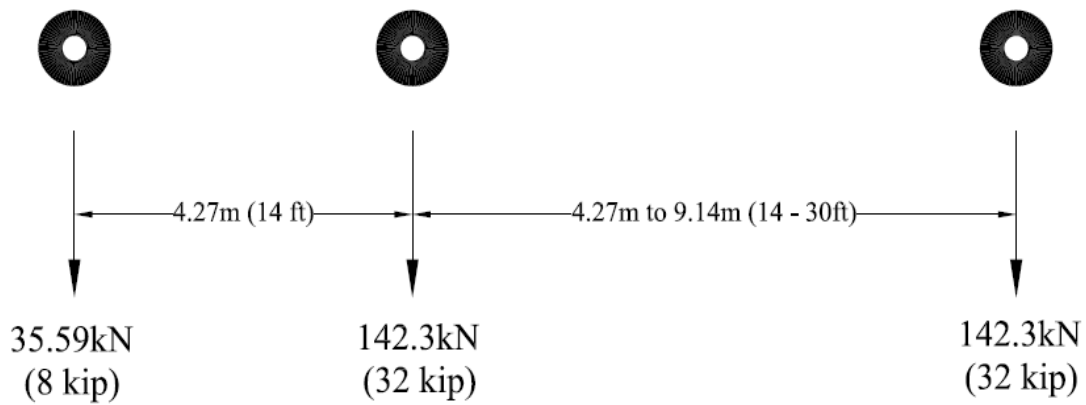
Figure 5-2. Standard AASHTO HS-20 Truck

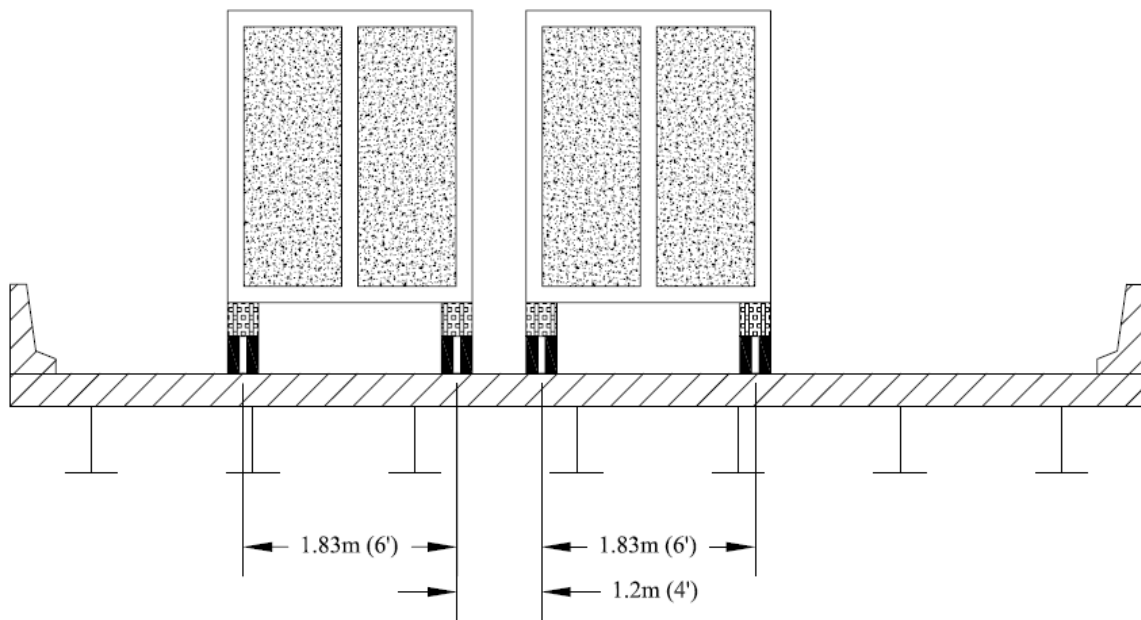
Figure 5-3. Minimum Side-by-Side HS20 Truck Spacing

the centerline of each pair of side-by-side trucks; Lane 1 corresponding to causing maximum effect in the north truss and Lane 2 causing maximum effect to the south truss. This was accomplished by using the minimum curb distance of 0.61 m (2 ft), the width of the axles shown in Figure 5-2, and the minimum required transverse spacing between HS-20 trucks shown in Figure 5-3.

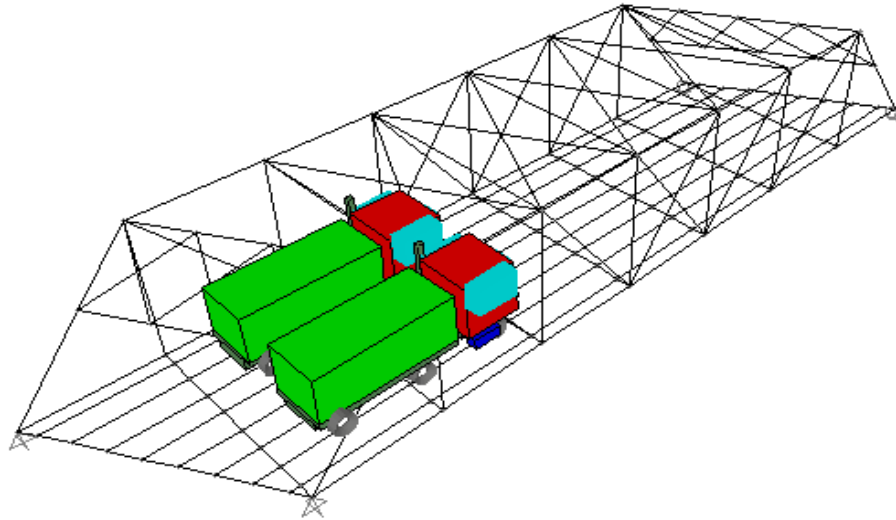
Figure 5-4. Schematic of Side-by-Side HS-20 Trucks

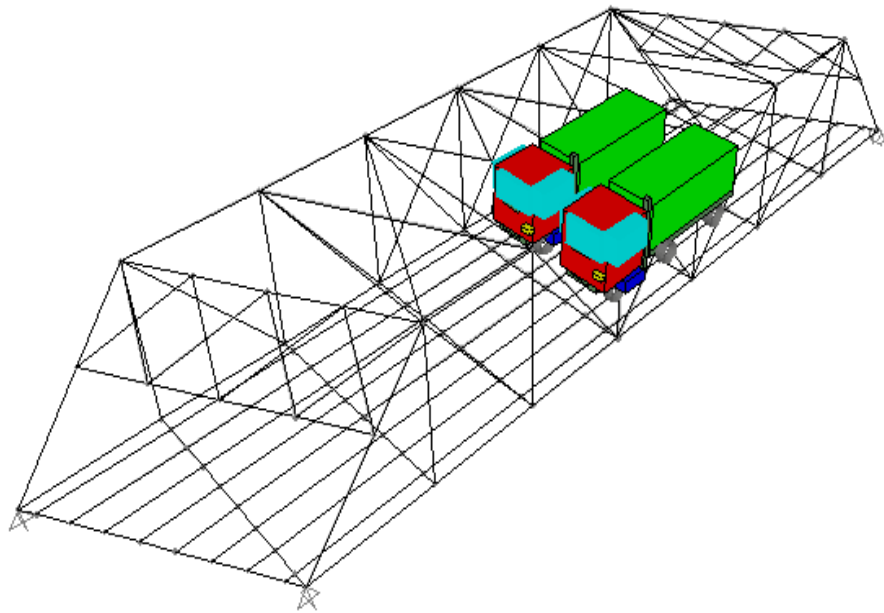
Figure 5-5. HS-20 Trucks Traversing East to West

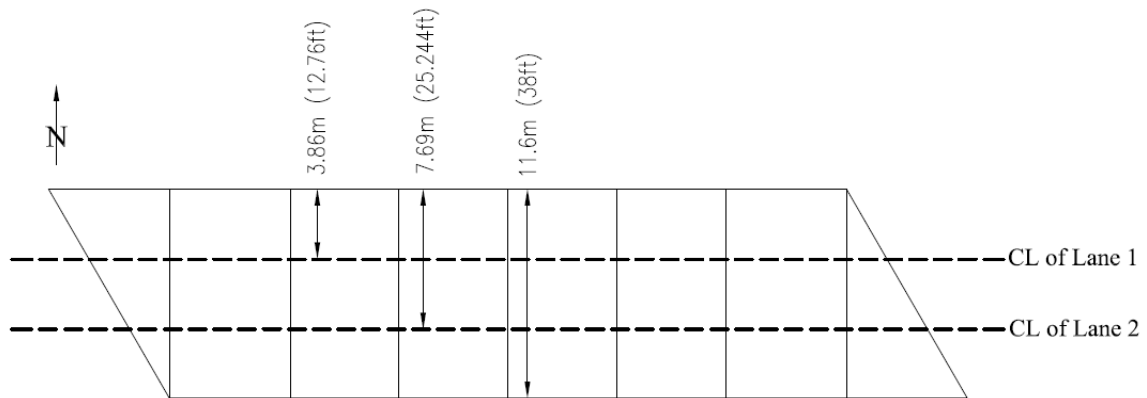
Figure 5-6. Lane Designations

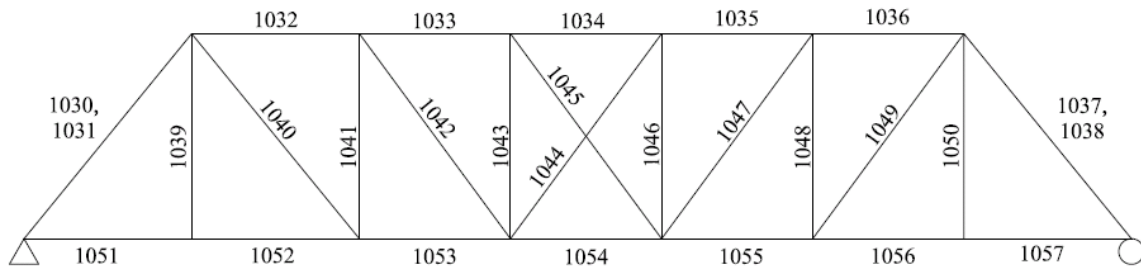
Figure 5-8. South Truss Member Identification

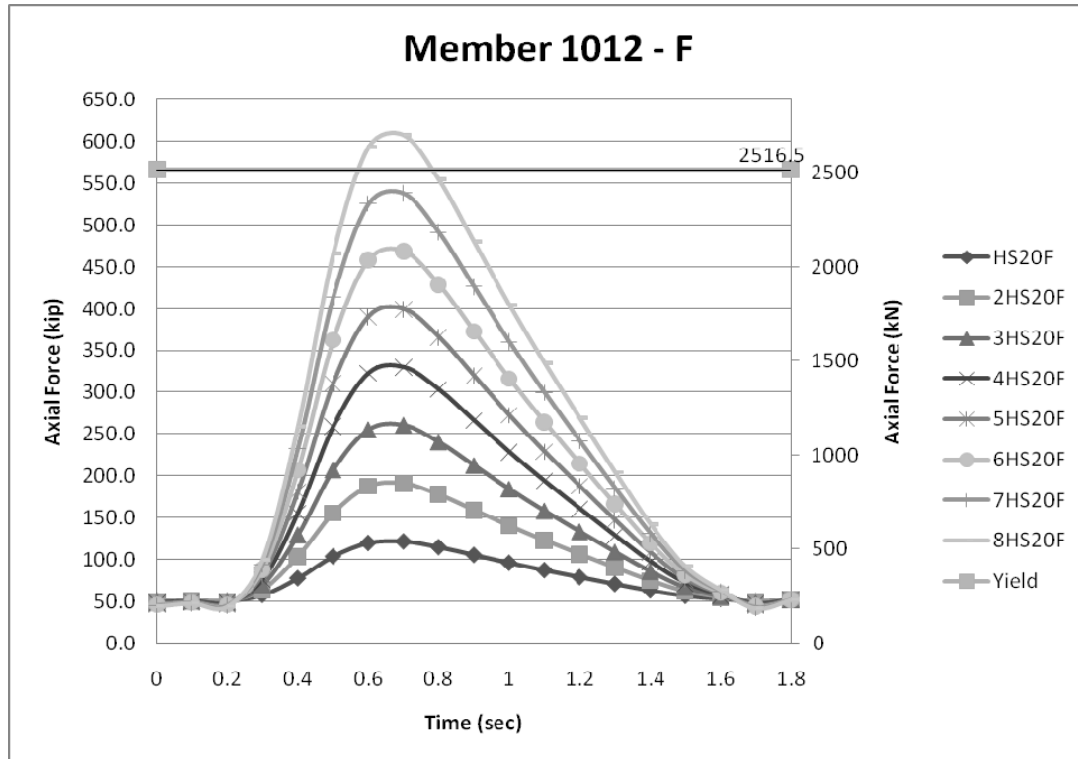
Figure 5-9. Axial Force in Member 1012 Due to Incrementing West to East HS-20

The horizontal axis represents the time steps and the vertical axis is the axial force in the member due to the different HS-20 trucks. Also shown on each plot is the yield capacity for each member of 2516.5 kN (565.5 kips).
