**CRITICAL MEMBER REMOVAL AND LOAD REDISTRIBUTION OF A  
DETERIORATED TRUSS BRIDGE**

A Thesis in

Civil Engineering

Lynsey D. Reese

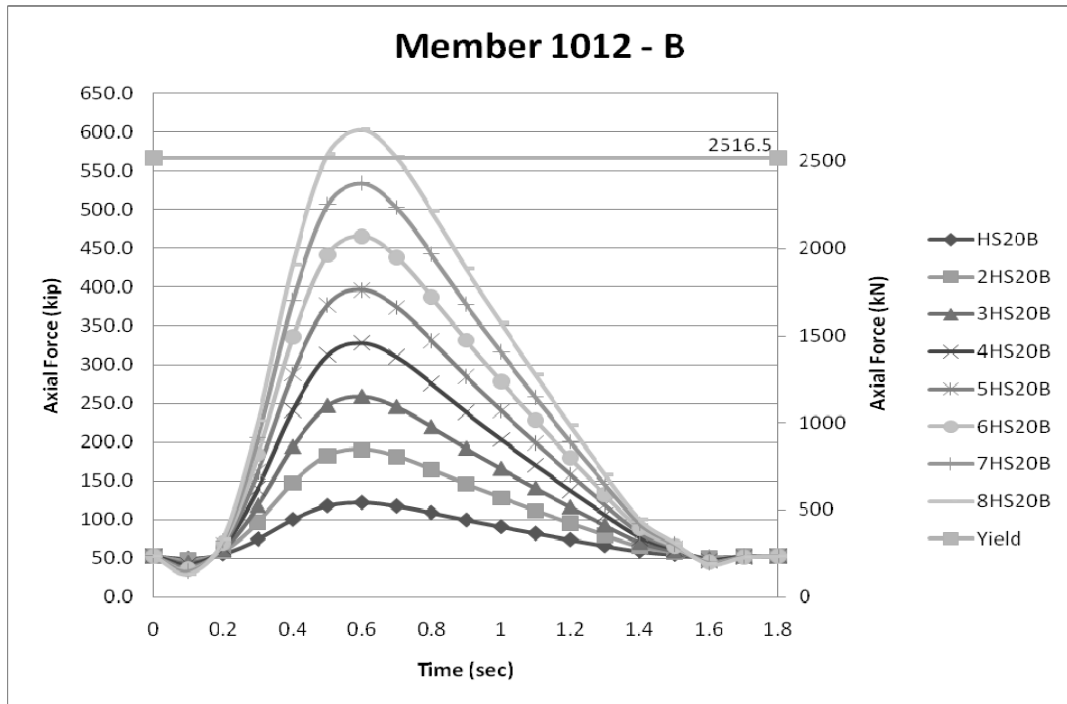
Figure 5-10. Axial Force in Member 1012 Due to Incrementing East to West HS-20

The horizontal axis represents the time steps and the vertical axis is the axial force in the member due to the different HS-20 trucks. Also shown on each plot is the yield capacity for each member of 2516.5 kN (565.5 kips).

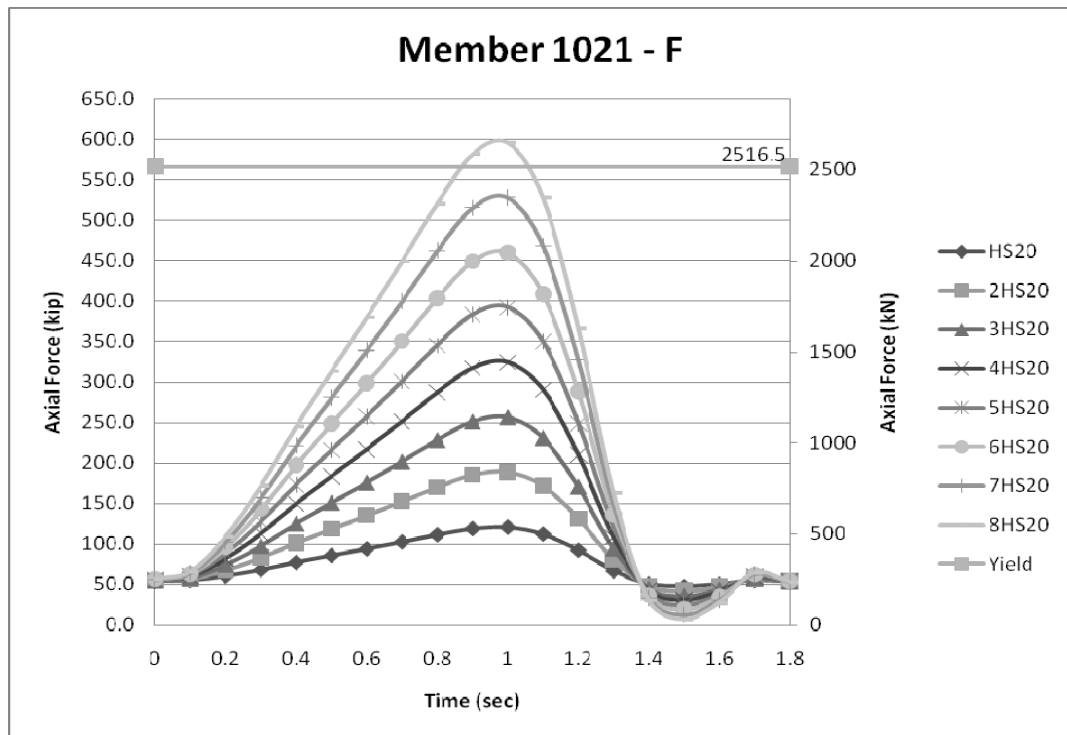
Figure 5-11. Axial Force in Member 1021 Due to Incrementing West to East HS-20

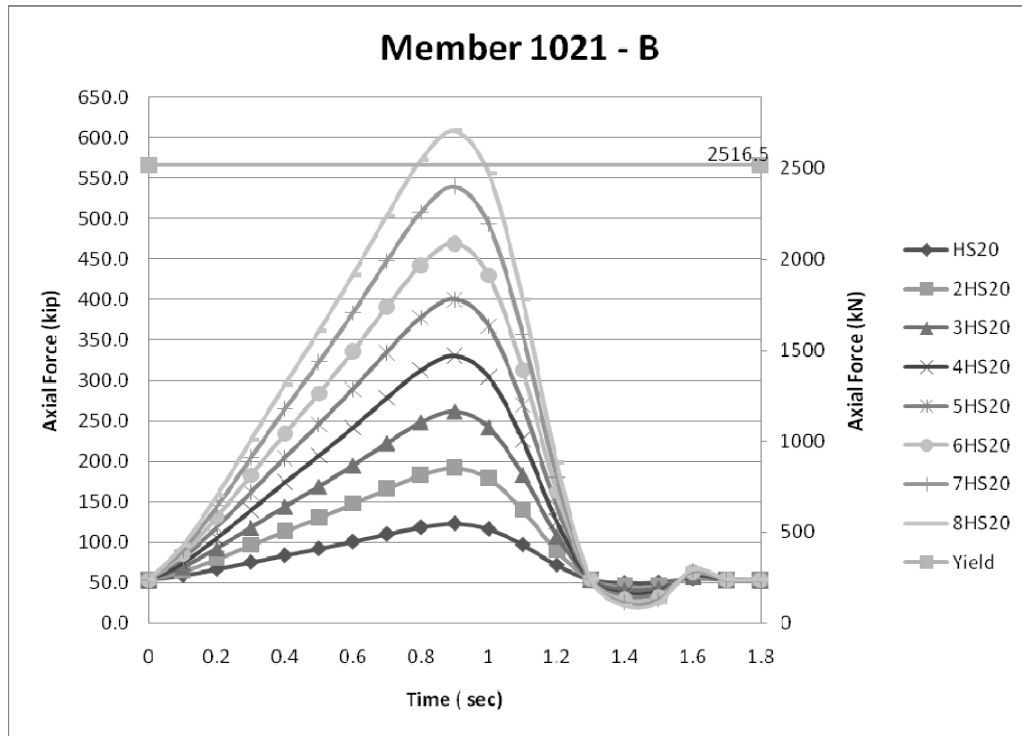
Figure 5-12. Axial Force in Member 1021 Due to Incrementing East to West HS-20

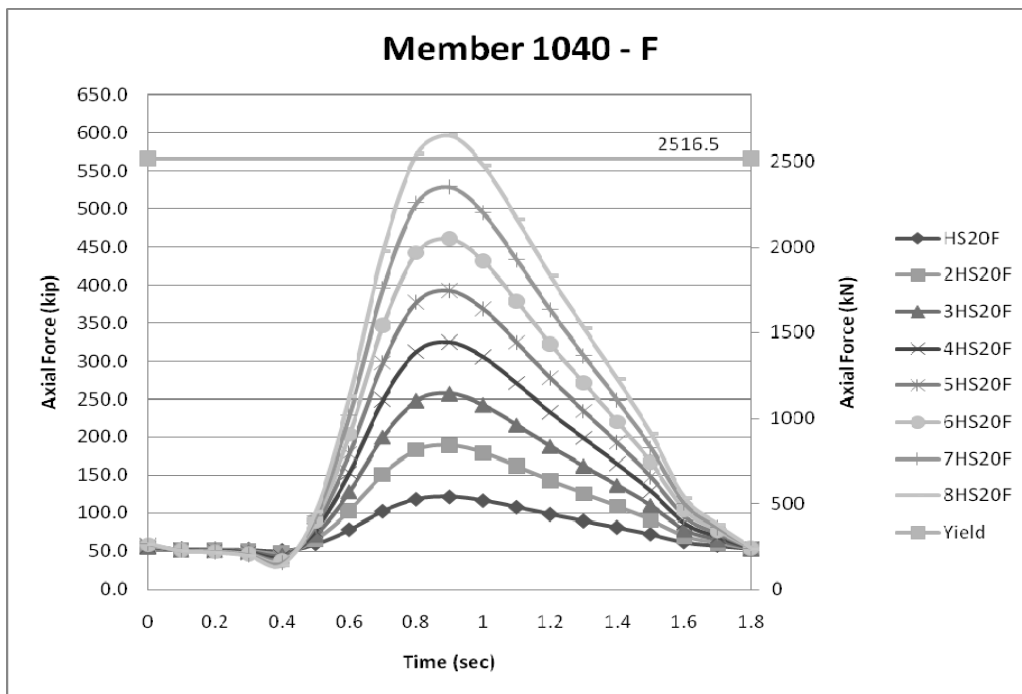
Figure 5-13. Axial Force in Member 1040 Due to Incrementing West to East HS-20

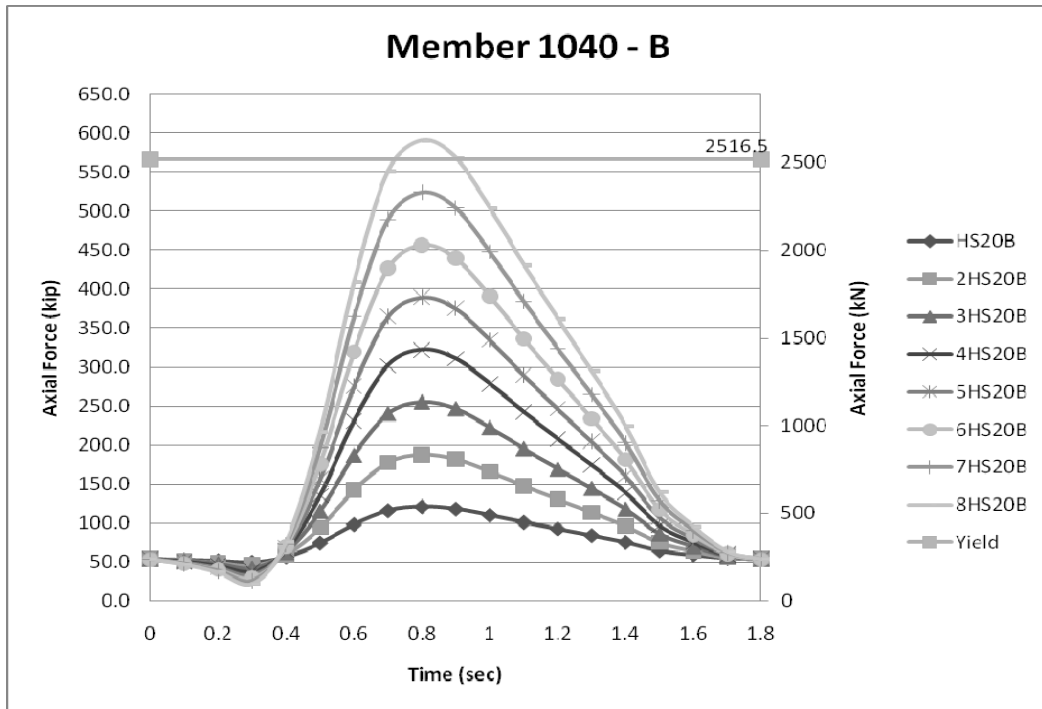
Figure 5-14. Axial Force in Member 1040 Due to Incrementing East to West HS-20

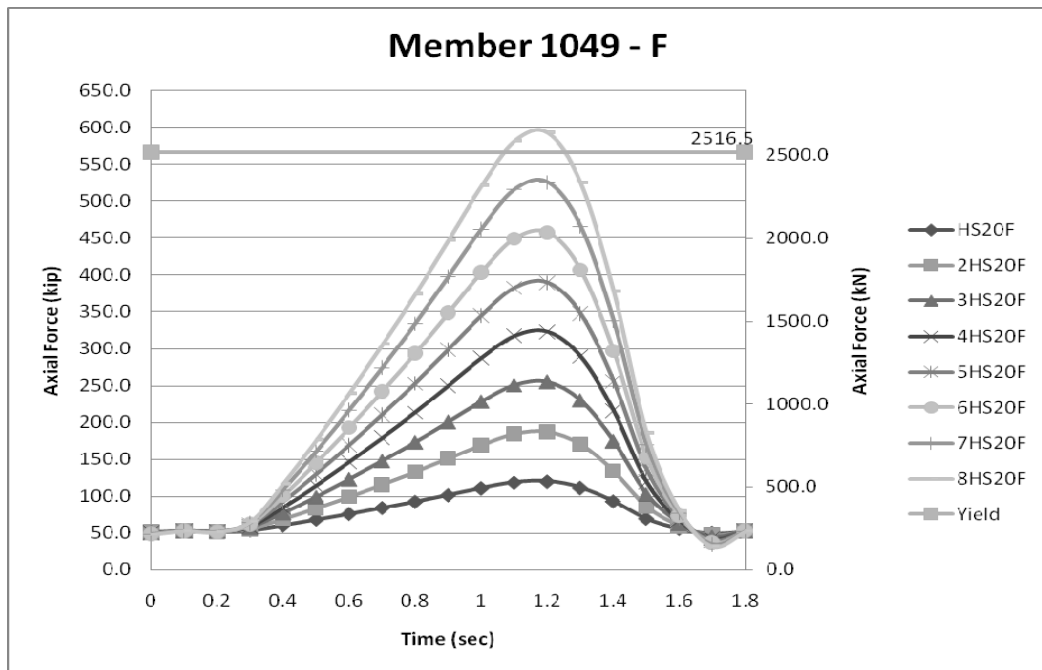
Figure 5-15. Axial Force in Member 1049 Due to Incrementing West to East HS-20

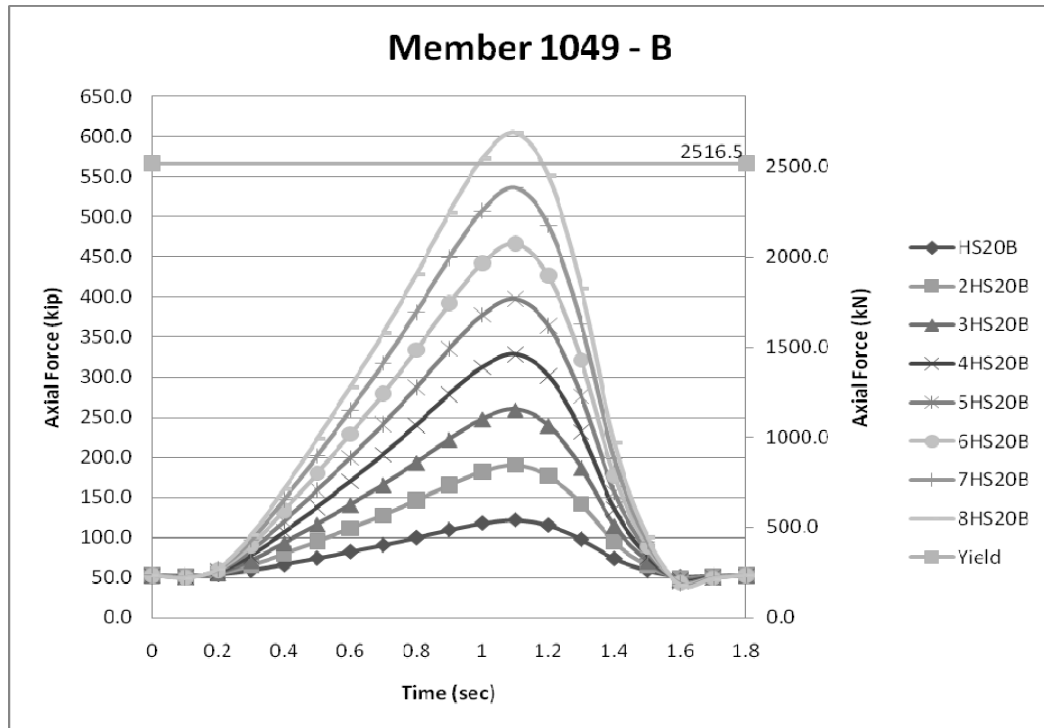
Figure 5-16. Axial Force in Member 1049 Due to Incrementing East to West HS-20

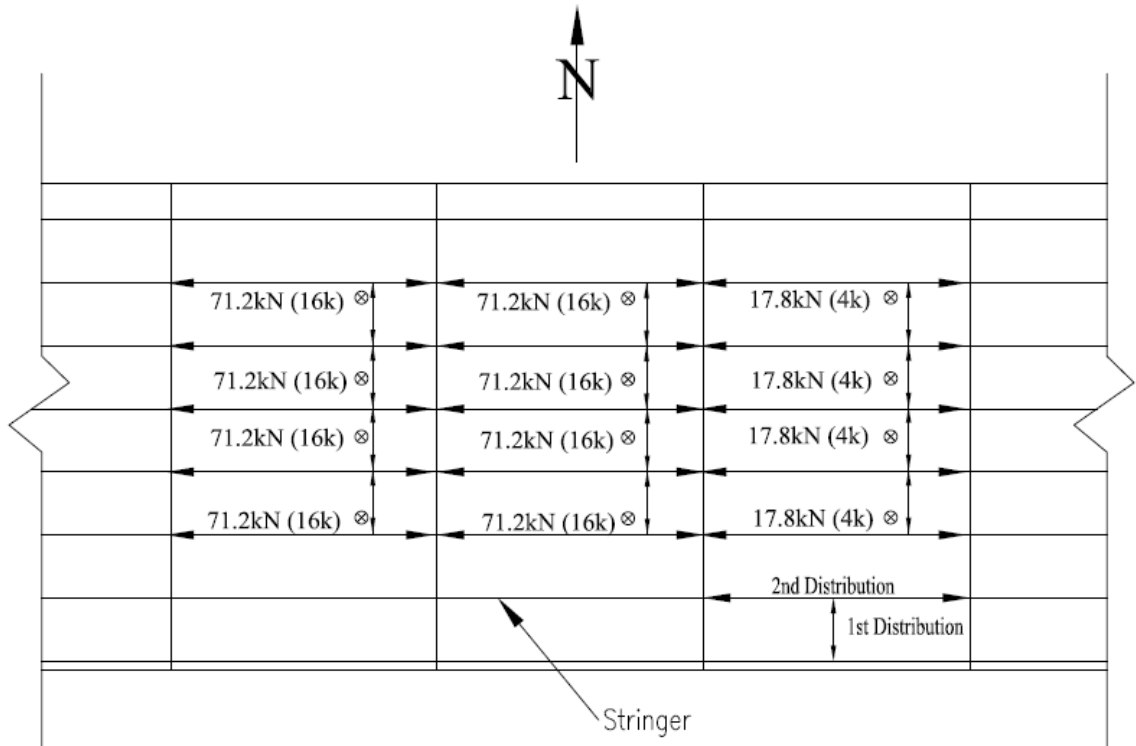
Figure 5-17. Typical Wheel Load Distribution to Joints for HS-20 Truck

Figure 5-17 shows a typical floorsystem in the Beech Creek Veterans Memorial Bridge and the wheel load distribution completed for transferring the loads to the surrounding joints. The wheel loads were first transversely distributed to the stringers assuming the deck was simply supported. After the load was transferred to the stringers, the point loads were longitudinally distributed to the floorbeams assuming the stringers were simply supported and the floorbeams carried these loads to the truss lower chord. This process was completed for each critical load location. Once the loads were distributed to the joints, a critical member removal analysis was completed to determine the member failure sequence and load redistribution.

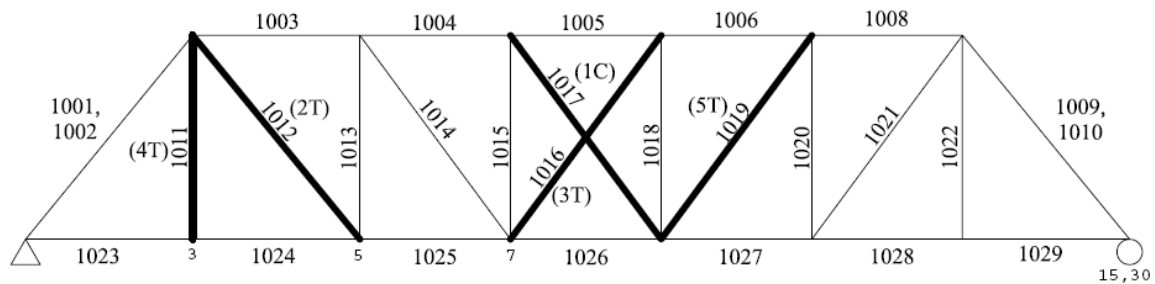
Figure 5-18. Failed Members in North Truss, Critical Member 1012

failed, it was impossible to retrieve a deflected shape because the bridge was assumed to have collapsed. Since it appears that there are large bending effects in the top and bottom chord they needed to be checked for combined axial and bending effects to ensure that the members were under the yield stress.

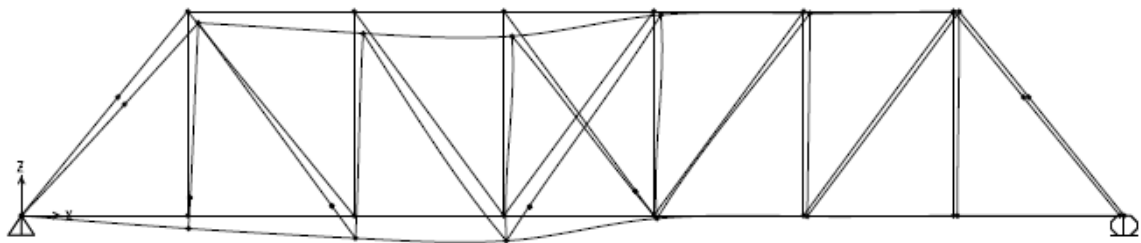
Figure 5-19. Deflected Shape, Critical Member 1012

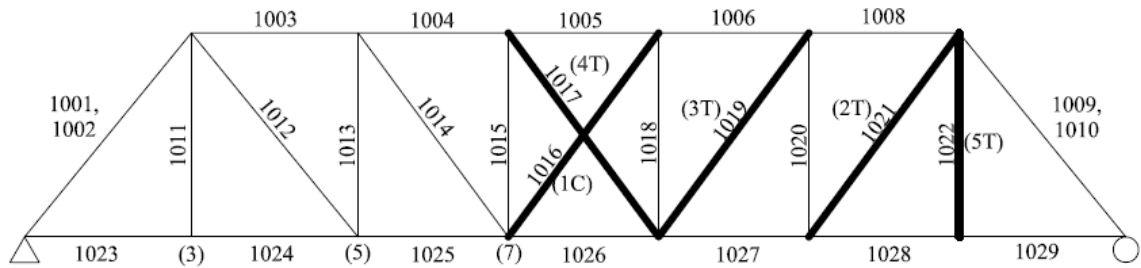
Figure 5-20. Failed Members, Critical Member 1021, North Truss

Member 1021 was analyzed in the same manner as Member 1012. Force controlled hinges were placed in the two counters and then the critical member, member 1021. After the load had been redistributed to the remaining structure one member was above the critical tensile force, Member 1019. A force controlled hinge was placed in the member, using hinge properties shown in Tables 5-1 and 5-6, and the analysis was completed again. Member 1017 failed during the analysis and the load in the member was redistributed to surrounding members. After a hinge was put in the member and the analysis was completed again, Member 1022 was the next critical member. During this analysis, the program terminated. Figure 5-20 displays the critical members and shows the four diagonals that failed under the eight HS-20 trucks. Figure 5-21 shows the deflected shape of the North Truss after all of the members except the final member, Member 1022, has failed. After the final member failed, it was impossible to retrieve a deflected shape because the bridge was assumed to have collapsed. Since it appears that there are large bending effects in the top and bottom chord they needed to be checked for combined axial and bending effects to ensure that the members were under the yield stress.

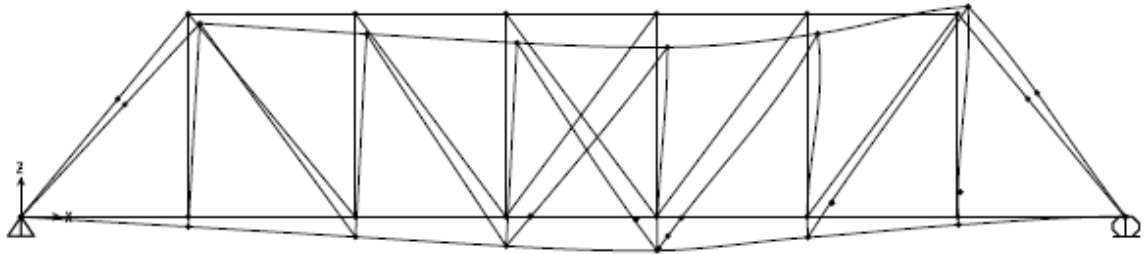
Figure 5-21. Deflected Shape, Critical Member 1021

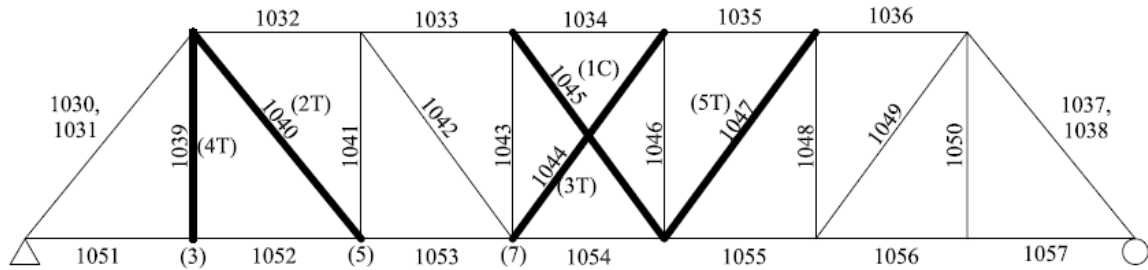
Figure 5-22. Failed Member, Critical Member 1040, South Truss

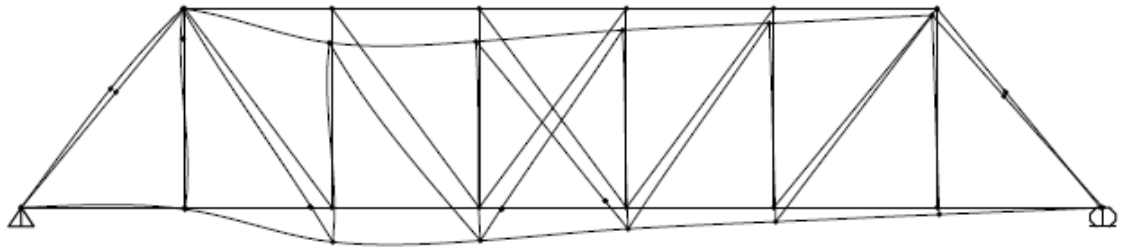
Figure 5-23. Deflected Shape, Critical Member 1040

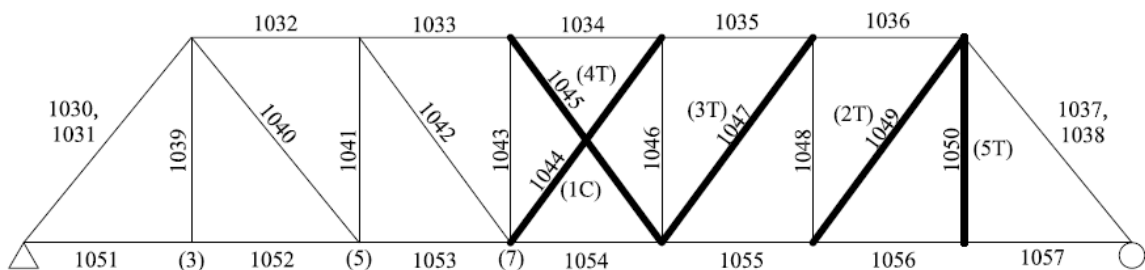
Figure 5-24. Failed Members, Critical Member 1049, South Truss

The last critical member analyzed was Member 1049. Force controlled hinges were placed in the two counters and then the critical member, Member 1049. After Member 1049 failed the load was redistributed to the rest of the structure. Member 1047 had a tensile force greater than the allowable and a hinge was placed in the member. The analysis was completed again and the load redistribution was analyzed. Member 1045 was the next member to fail. After the load redistribution, Member 1050 was a critical member with axial forces greater than the limit. At that point, the analysis terminated. Figure 5-24 shows the failed members and the sequence in which they failed in the analysis. Figure 5-25 shows the deflected shape of the South Truss after all of the members except the final member, Member 1050, has failed. After the final member failed, it was impossible to retrieve a deflected shape because the bridge was assumed to have collapsed. Since it appears that there are large bending effects in the top and bottom chord they needed to be checked for combined axial and bending effects to ensure that the members were under the yield stress.

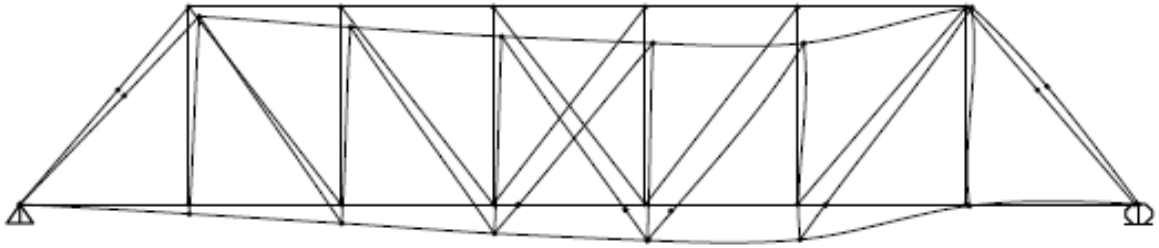
Figure 5-25. Deflected Shape, Critical Member 1049

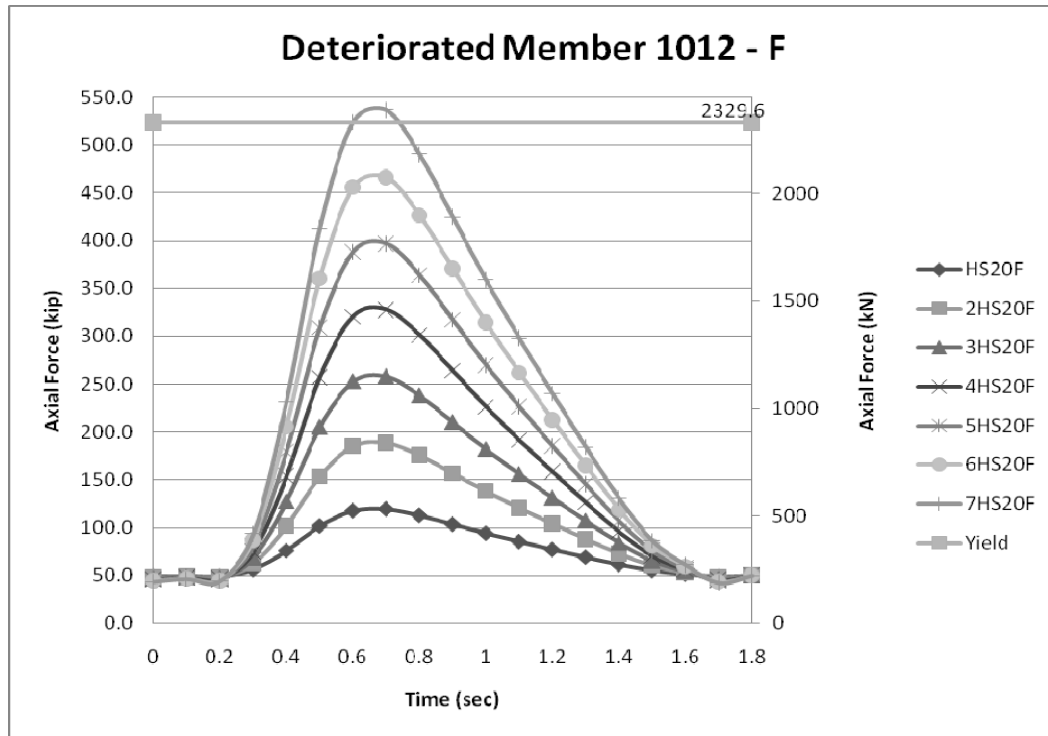
Figure 5-26. Axial Force in Member 1012 Due to Incrementing West to East HS-20 Truck

Each of the two critical members determined previously had a critical location for trucks traversing in both directions. Both directions were investigated because of the skew of the bridge. The directions of the truck were the same as the pristine model. Figures 5-26 through 5-29 show the axial forces in each critical member for a single HS-20 truck through seven stacked HS-20 truck loadings. The horizontal axis represents the time steps and the vertical axis is the axial force in the member due to the different HS-20 trucks. Also shown on each plot is the yield capacity for each member.

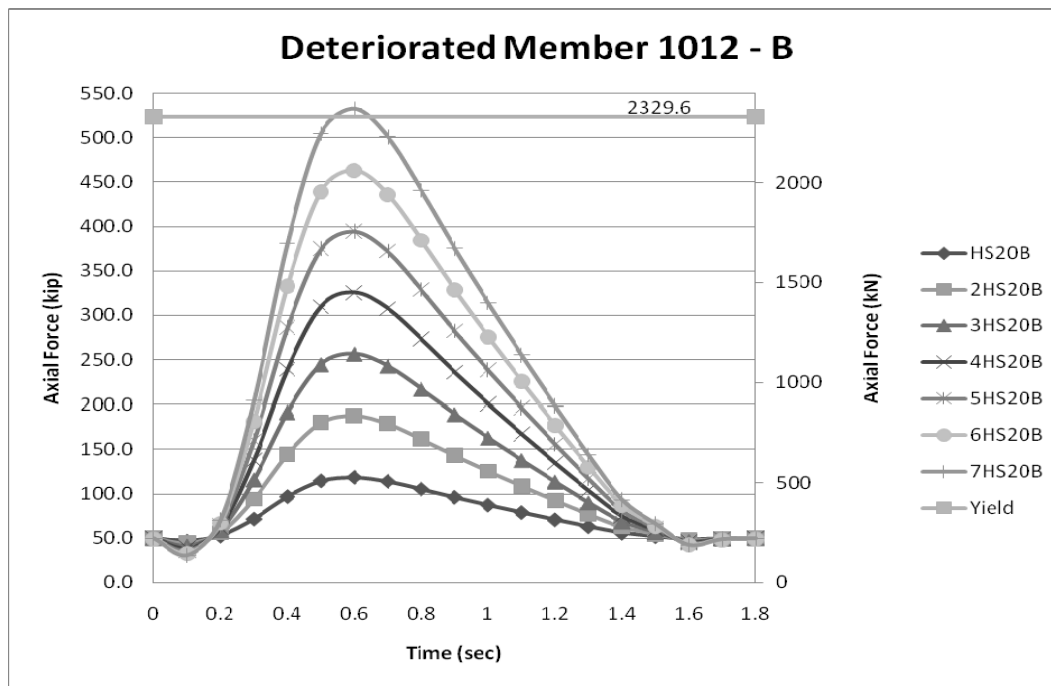
Figure 5-27. Axial Force in Member 1012 Due to Incrementing East to West HS-20 Truck

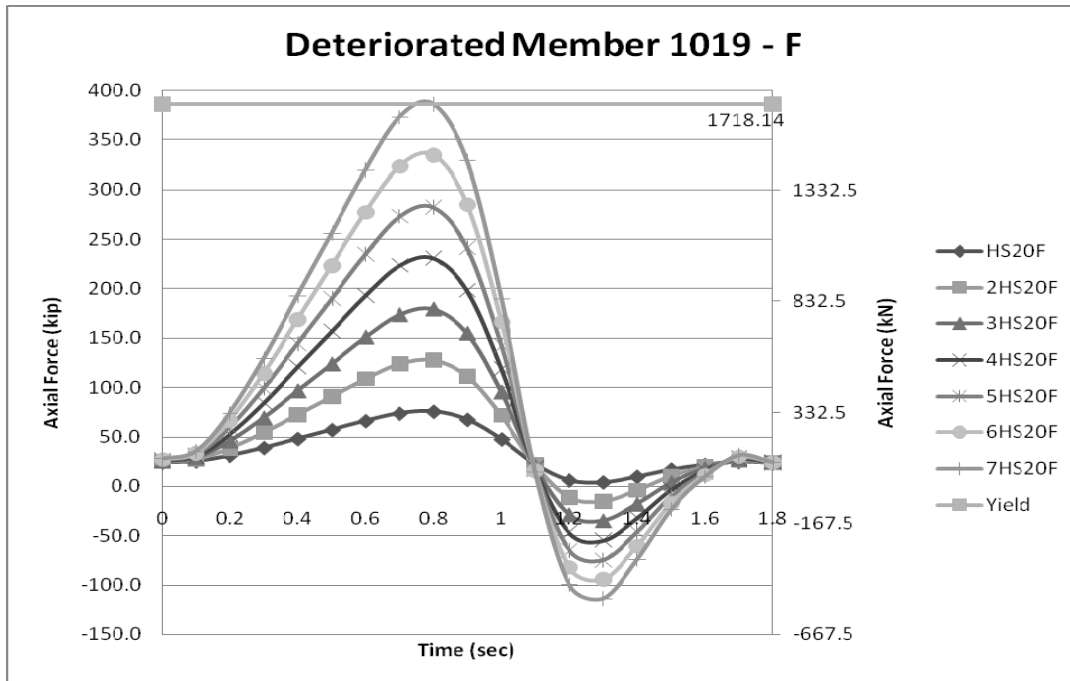
Figure 5-28. Axial Force in Member 1019 Due to Incrementing West to East HS-20 Trucks

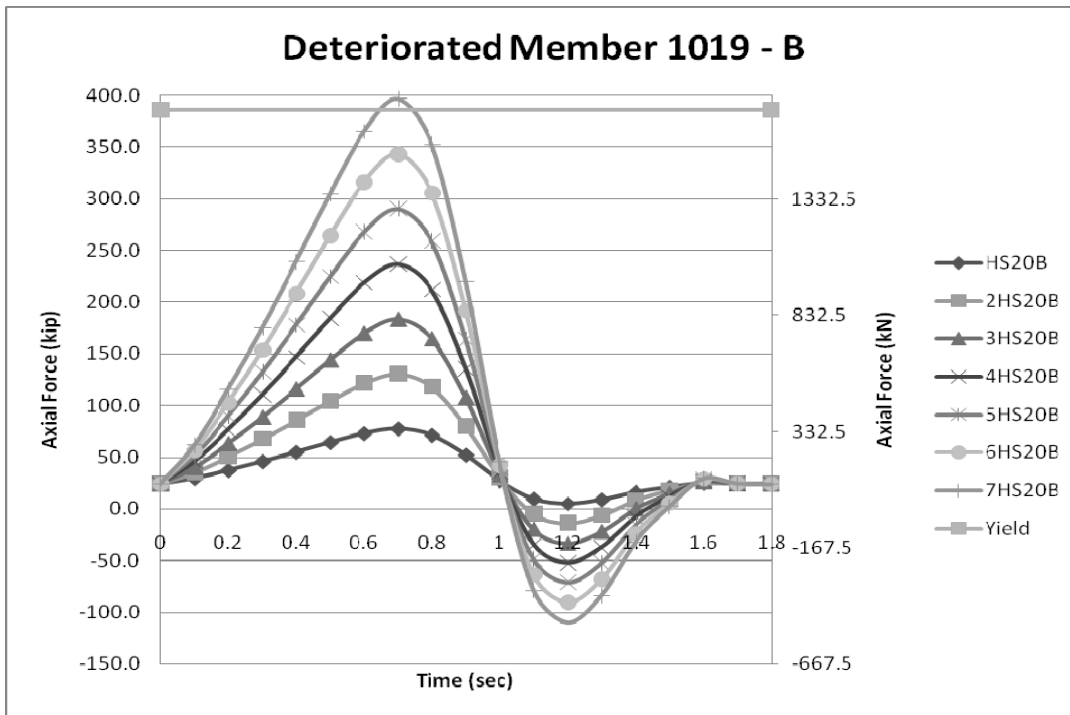
Figure 5-29. Axial Force in Member 1019 Due to Incrementing East to West HS-20 Trucks

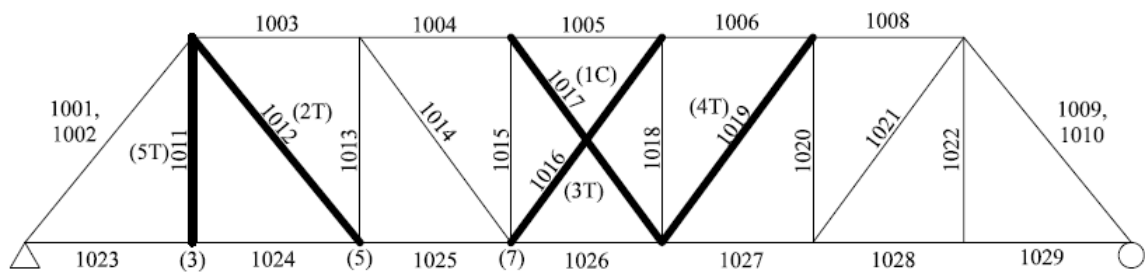
Figure 5-30. Failed Members, Deteriorated Critical Member 1012

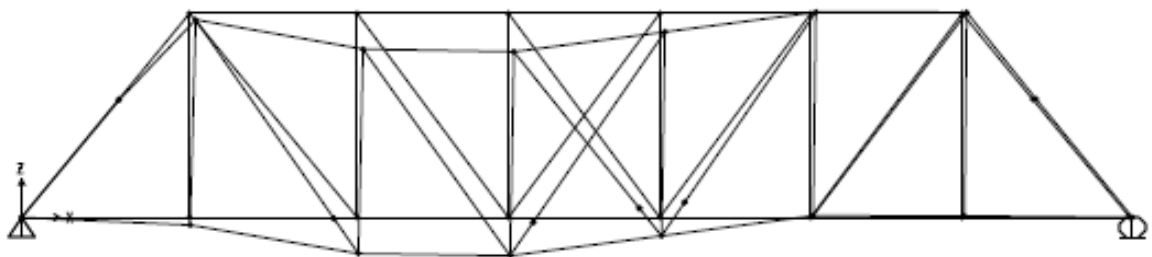
Figure 5-31. Deflected Shape, Deteriorated Critical Member 1012

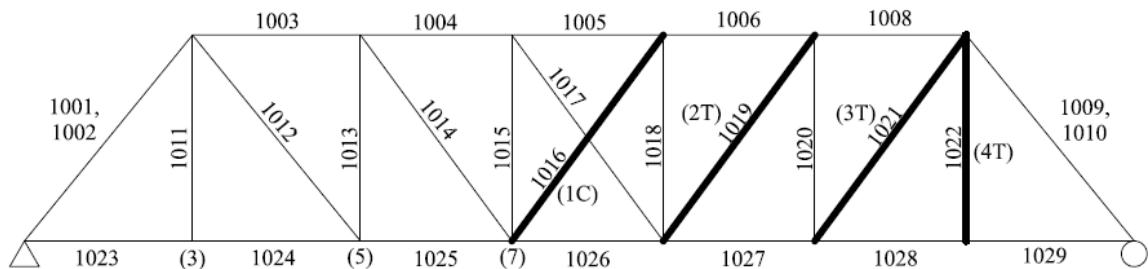
Figure 5-32. Failed Members, Deteriorated Critical Member 1019

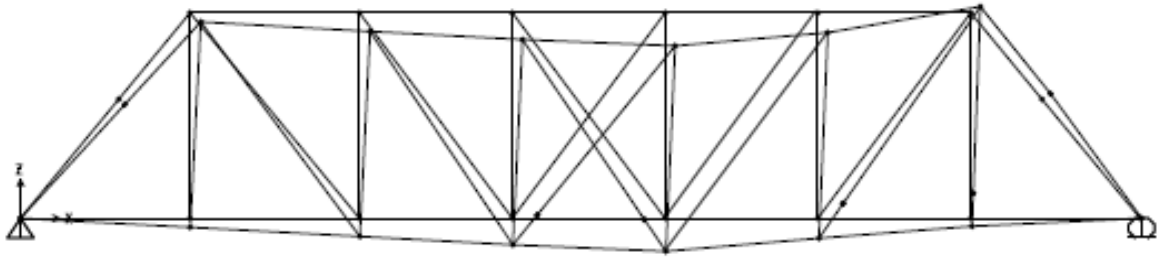
Figure 5-33. Deflected Shape, Deteriorated Critical Member 1019

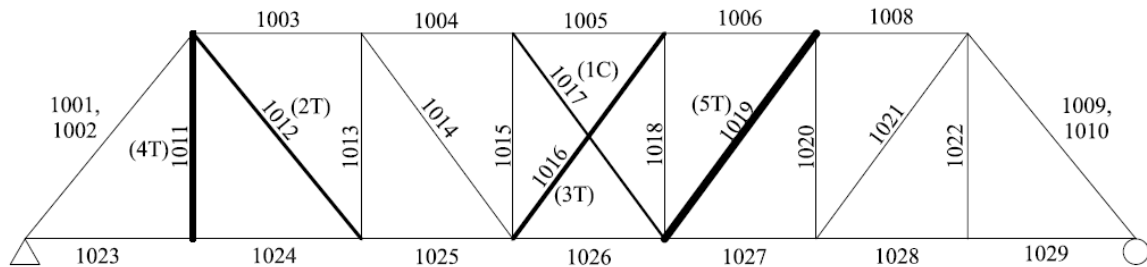
Figure 5-34. Failure Members of the Pristine Model, Critical Member 1012

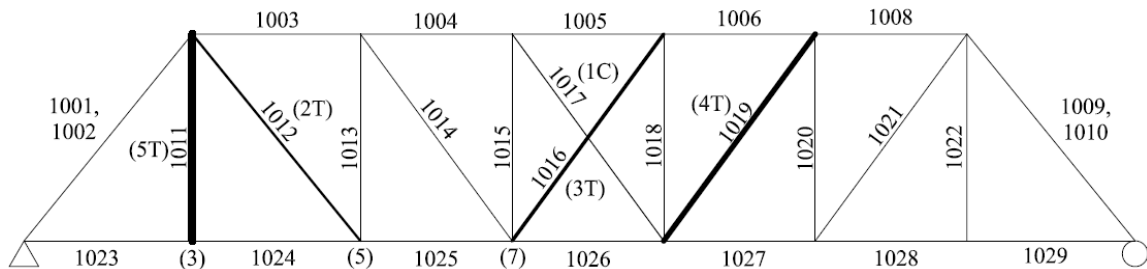
Figure 5-35. Failure Members of the Deteriorated Model, Critical Member 1012

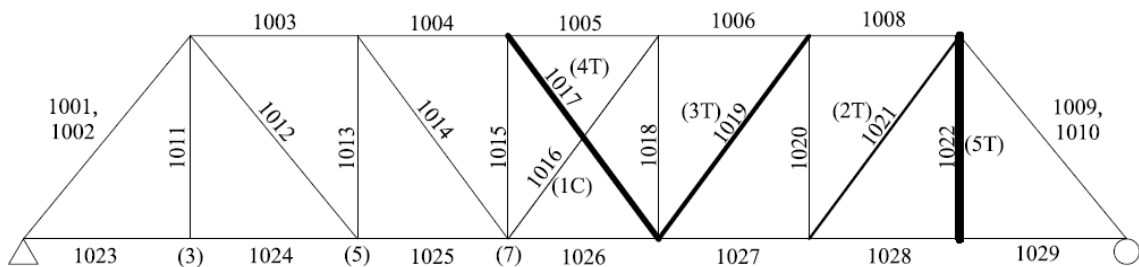
Figure 5-36. Failure Members of the Pristine Model, Critical Member 1021

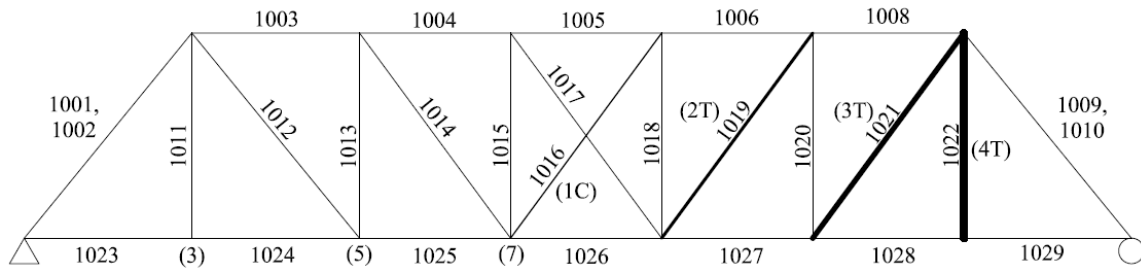
Figure 5-37. Failure Members of the Deteriorated Model, Critical Member 1019

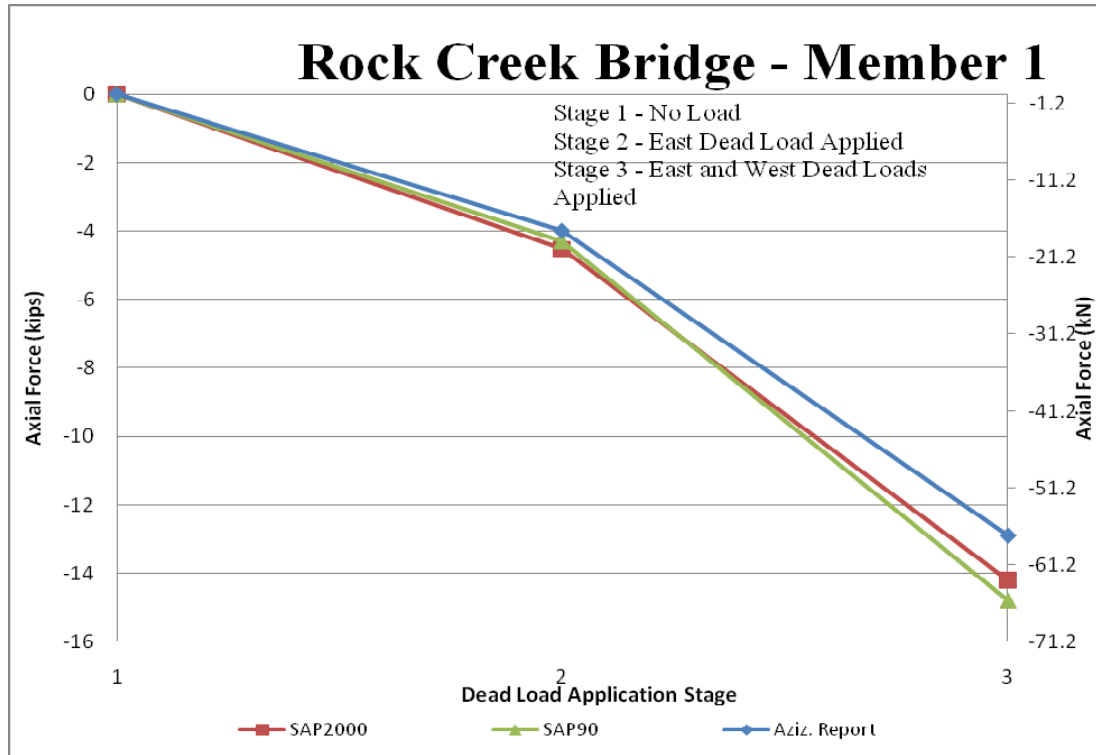
Figure A4.1 – Axial Force in Member 1, Rock Creek Bridge

Figure 4-7 shows representative axial forces in Member 1 of the model of Rock Creek Bridge. The results are reported at two stages corresponding to the placement of each concrete block on the bridge structure. The horizontal axis in this figure identifies each loading stage with Stage 1 corresponding to zero dead load and Stages 2 and 3 corresponding to placement of the first and second concrete blocks onto the bridge ignoring the self weight of the bridge. The vertical axis in the figure represents the axial force. Azizinamini and SAP90 results were compiled from previous research (Azizinamini 1997) while the SAP2000 results were from the current analytical model described in previous sections. Results for the other instrumented members are shown in Appendix A - Figures A4.1 to A4.10.

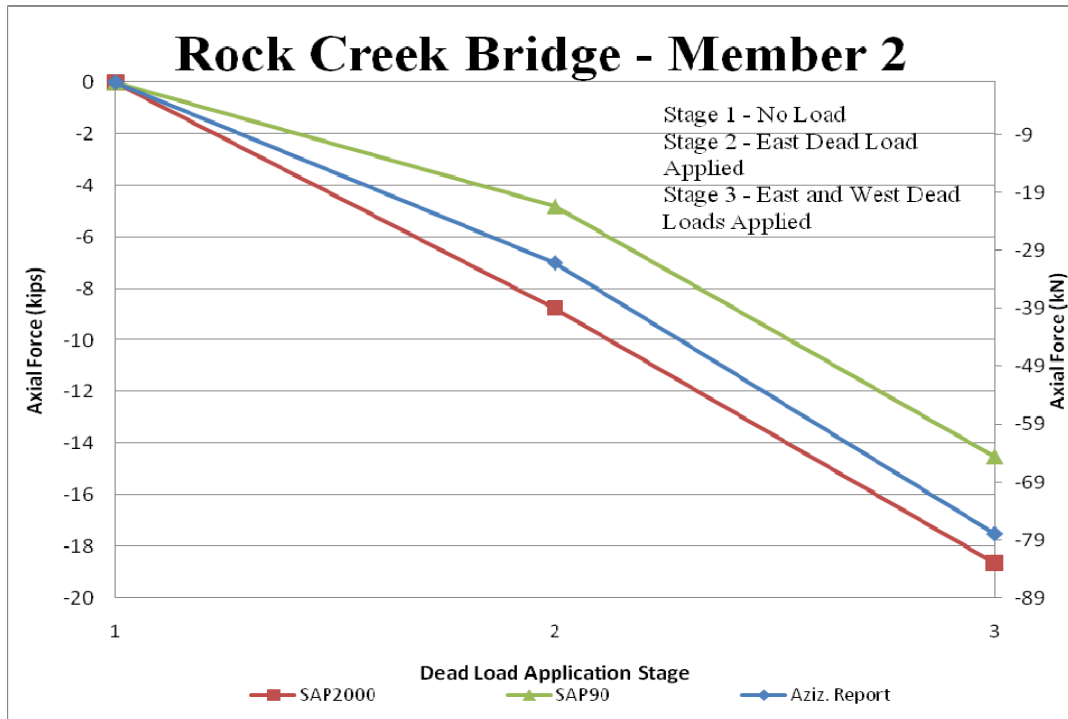
Figure A4.2 – Axial Force in Member 2, Rock Creek Bridge

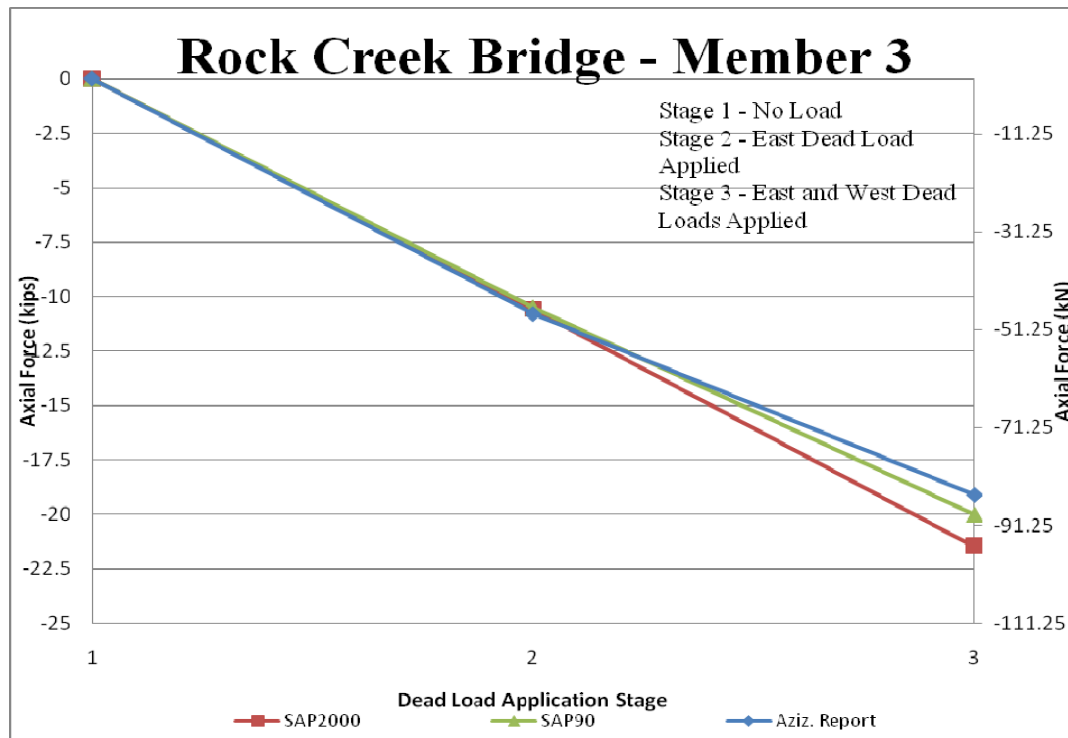
Figure A4.3 – Axial Force in Member 3, Rock Creek Bridge

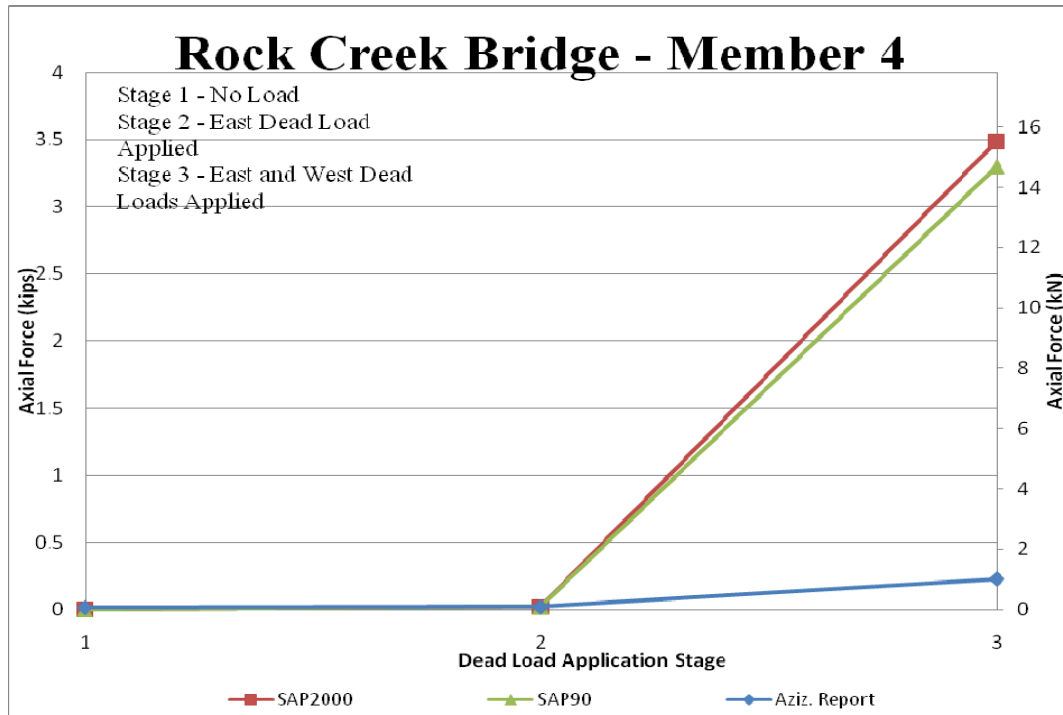
Figure A4.4 –Axial Force in Member 4, Rock Creek Bridge

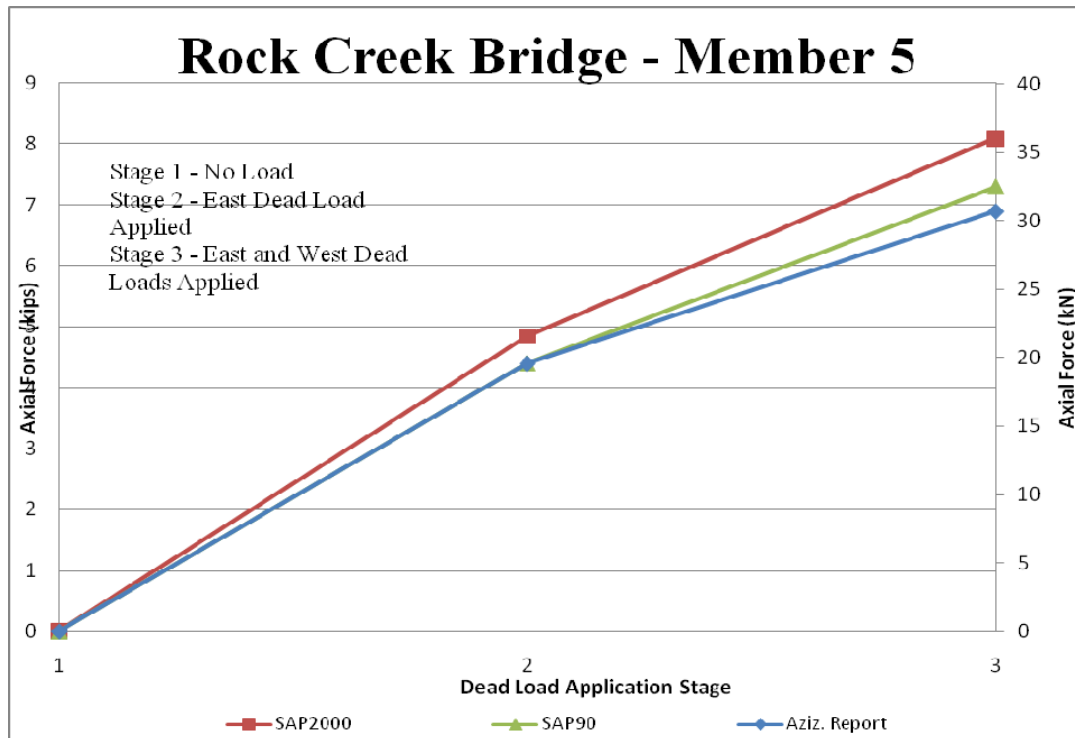
Figure A4.5 –Axial Force in Member 5, Rock Creek Bridge

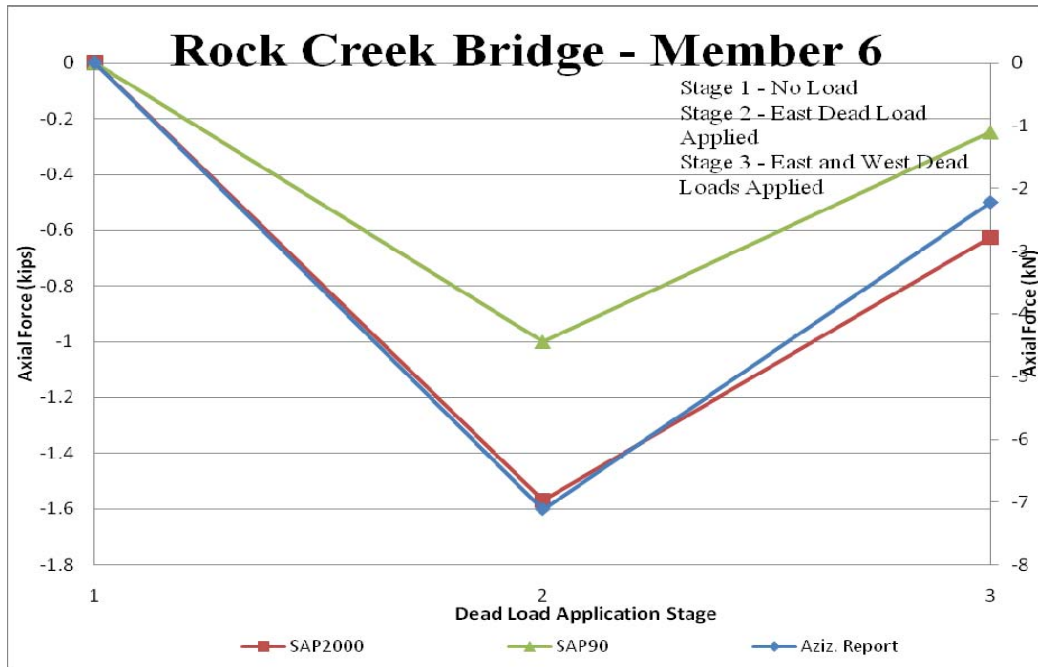
Figure A4.6 – Axial Force in Member 6, Rock Creek Bridge

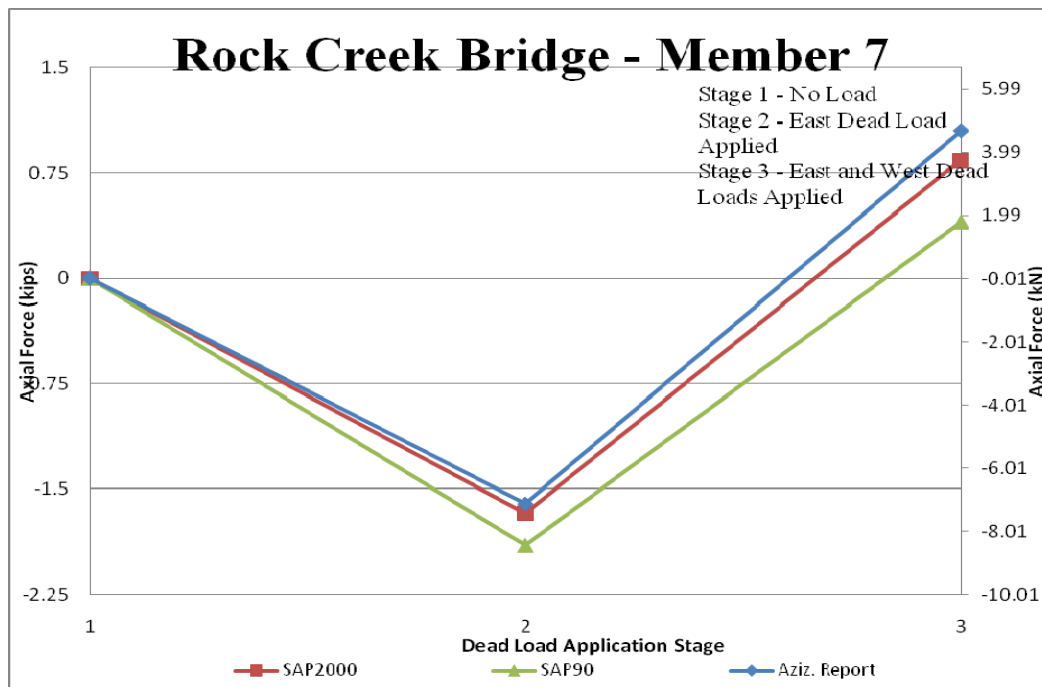
Figure A4.7 – Axial Force in Member 7, Rock Creek Bridge

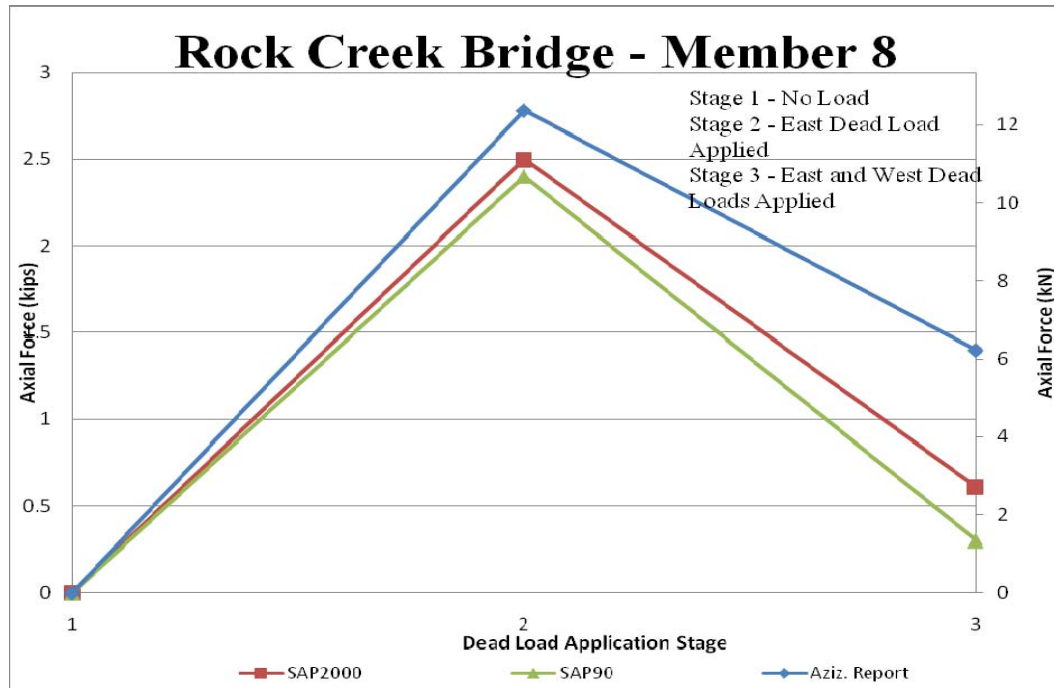
Figure A4.8 – Axial Force in Member 8, Rock Creek Bridge

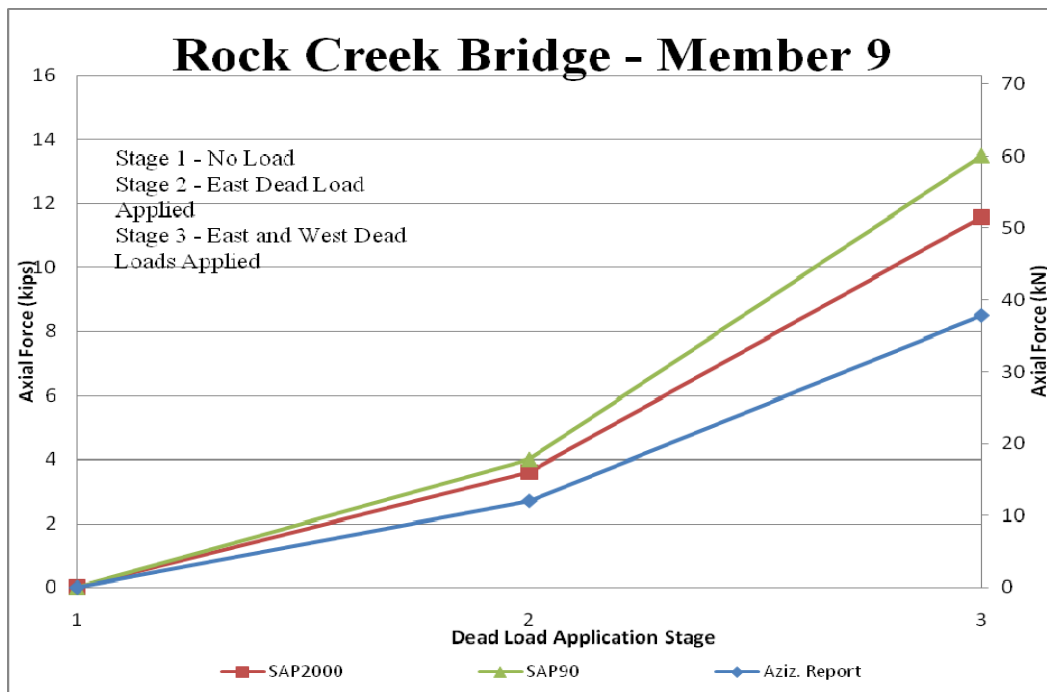
Figure A4.9 – Axial Force in Member 9, Rock Creek Bridge
