**CRITICAL MEMBER REMOVAL AND LOAD REDISTRIBUTION OF A  
DETERIORATED TRUSS BRIDGE**

A Thesis in

Civil Engineering

Lynsey D. Reese

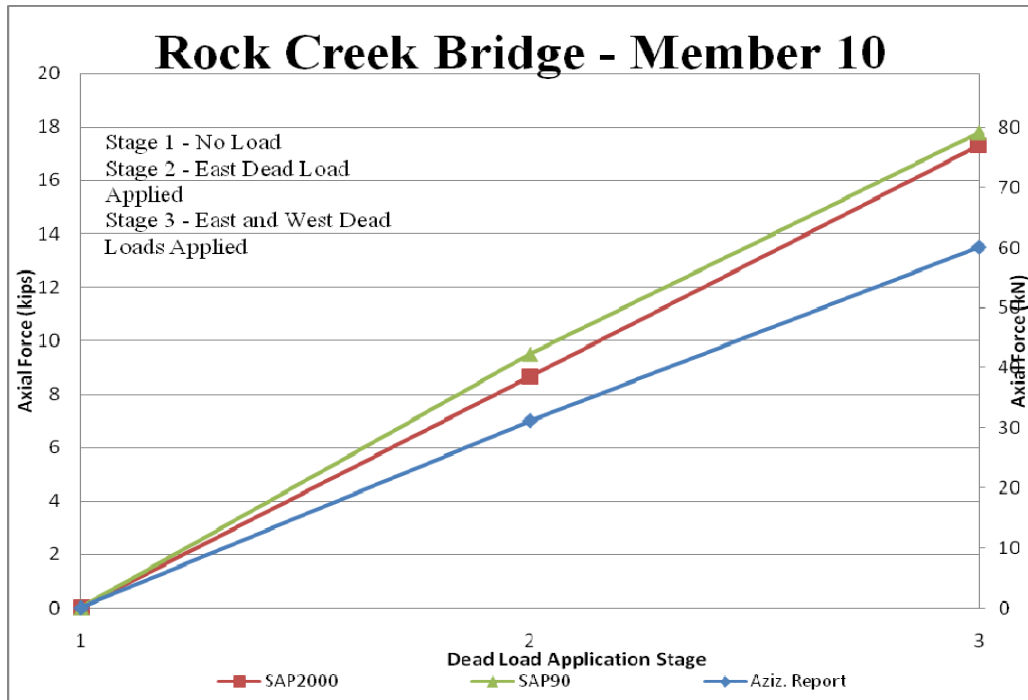
Figure A4.10 –Axial Force in Member 10, Rock Creek Bridge
