The Pennsylvania State University

**DESCRIBING DAMAGE TO STREAM MODIFICATION PROJECTS**

A Thesis in

Civil Engineering

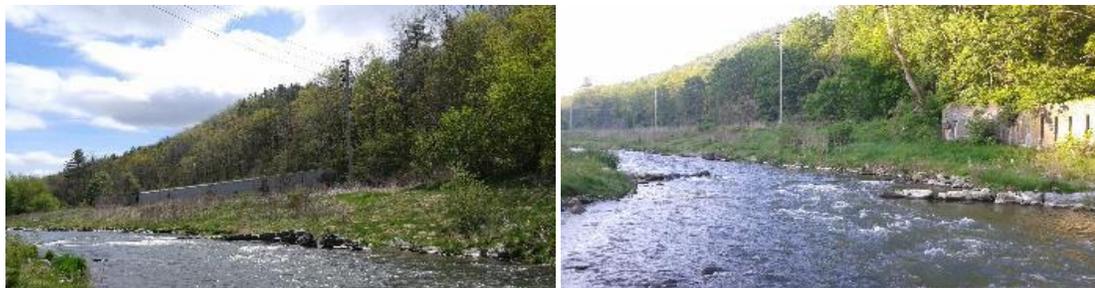
Telephone poles, the remainder of PA Route 144, and an active railroad are near the site but outside of project limits and well above the flood prone area of the modified channel. These infrastructure are located a minimum of 1.5 meters above the bankfull elevation and located at least 20 meters from the channel bank.

Figure 4-17: Infrastructure near the channel include telephone poles, railroad tracks (left), and a remaining dam wall (right).

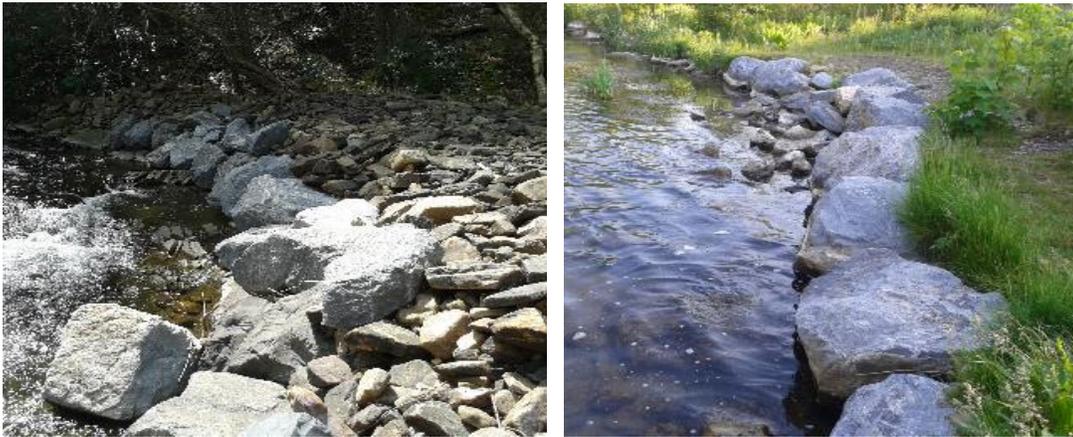
The following images depict riprap at the Roaring Run case study, left, and the Spring Creek case study, right. The large riprap at Roaring Run has a few displaced components (one that is evident in the photo below and one that is evident in the next set of photos) but less than 10% of structure has been displaced and is therefore undamaged. The riprap at Spring Creek may be experiencing some scour but it is similarly insufficient to indicate damage.

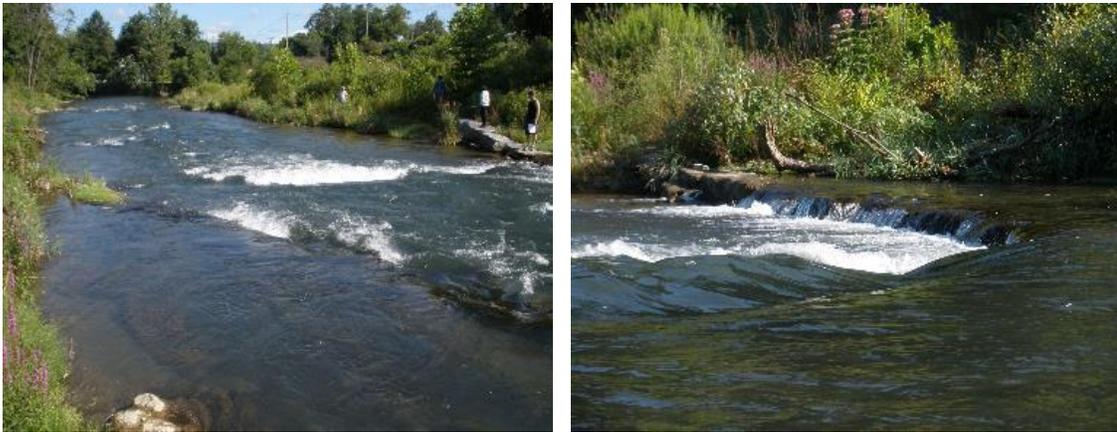
#### *Rock cross vane*

There were four large rock cross vanes installed in the Spring Creek stream modification project. The following images depict the parabolic shape and drop in head that occurs across these rock cross vanes.

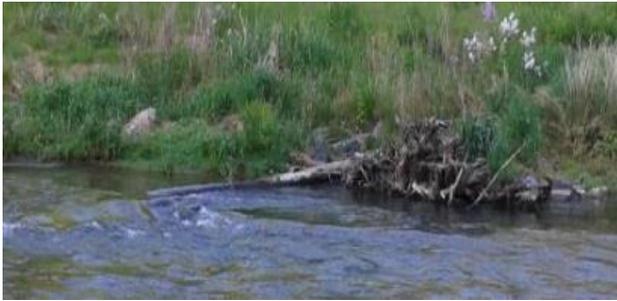
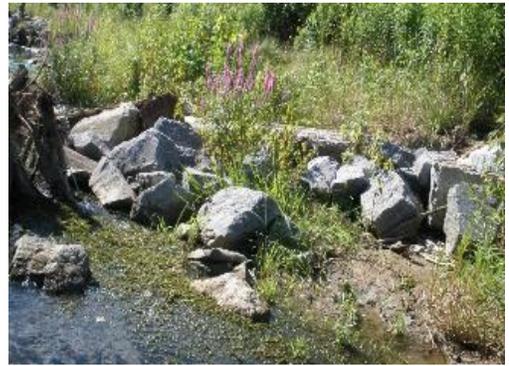
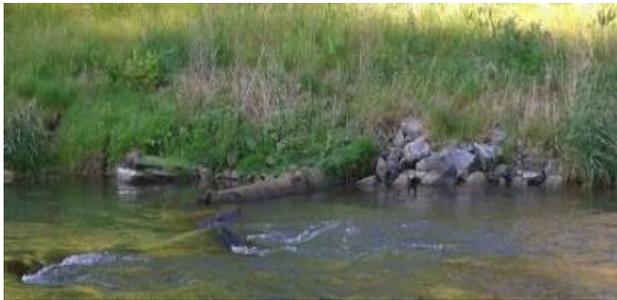
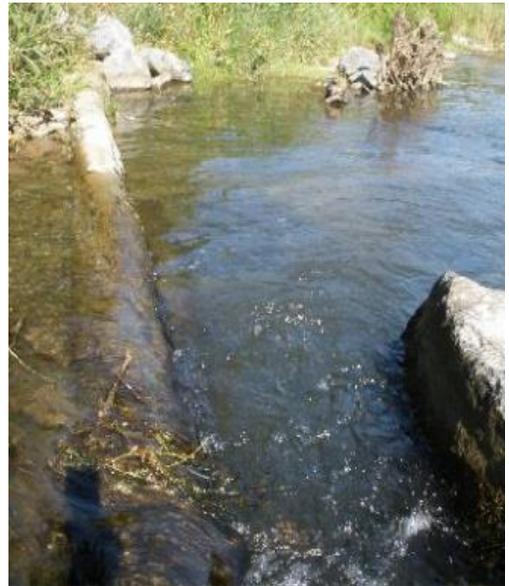
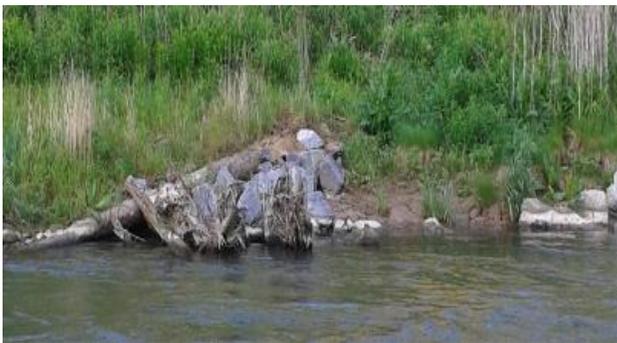
*Rootwad-Log Vane*

Photographs of various rootwad-log vanes on Spring Creek in Centre County, Pennsylvania. The most damaged rootwad-log vane missing the rootwad while moderately damaged structures showed signs of scour everywhere the structure was in contact with the bank (the top right and lower left photographs).

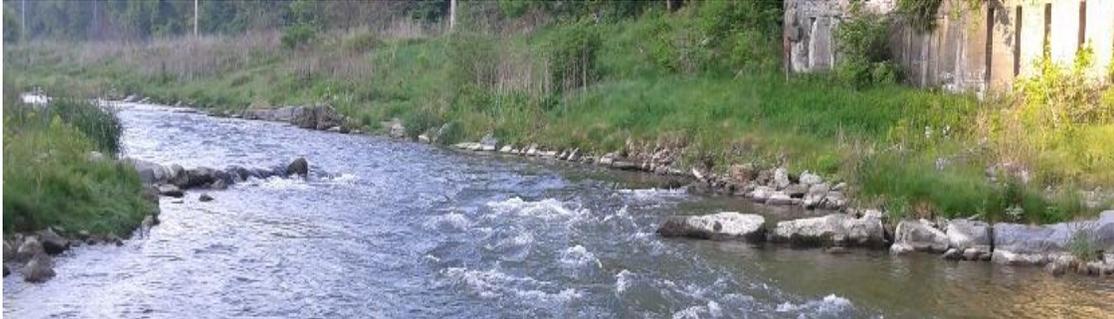
### *Rock Vanes*

The following image depicts two rock vanes on Spring Creek, one coming from each bank.

Rock vanes on Spring Creek did not experience component displacement, although without As-built plans it would be difficult to determine whether the end of the structure is intact. Moderately damaged rock vanes experienced scour everywhere the structure was in contact with the bank (left). There were two rock vanes that were completely detached from the bank and therefore completely damaged (right). This structure is completely detached from the bank and the raw banks visible in this photo count contribute to damage in the *bank stability and migration* category of damage.

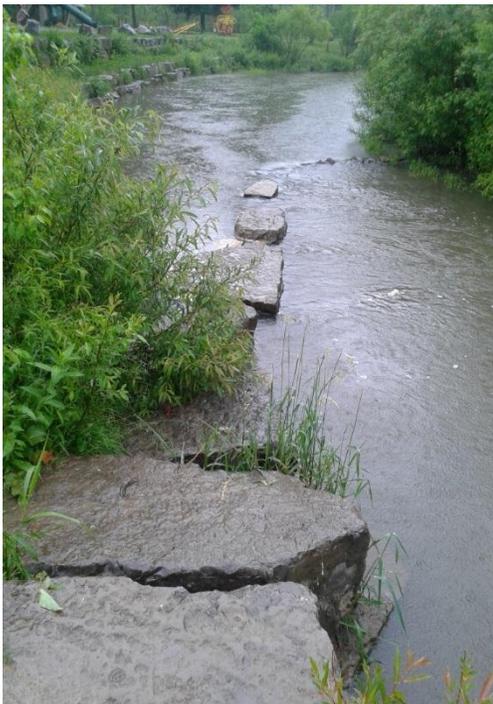
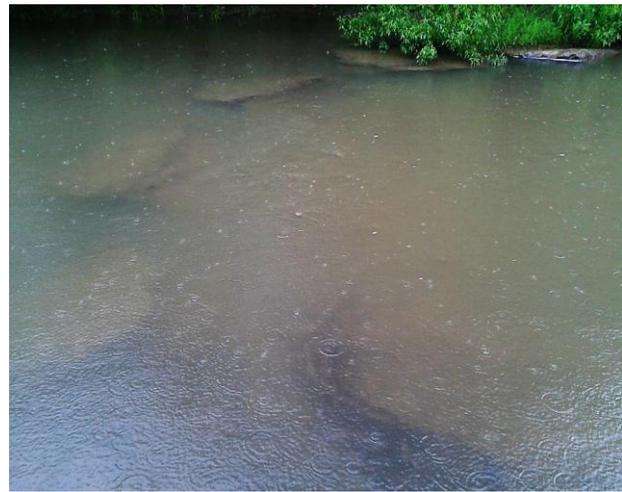
*J-Hooks*

J-Hook vanes are channel-spanning structures similar to rock cross vanes with only one bank tie-in. These structure were used on Bald Eagle Creek in Port Matilda, Pennsylvania. These structures were very low and submerged during most site visits but the following images show the shape of typical J-Hooks. The structures installed in Bald Eagle Creek were undamaged except for one that is shown in Figure 4-11 of the report.

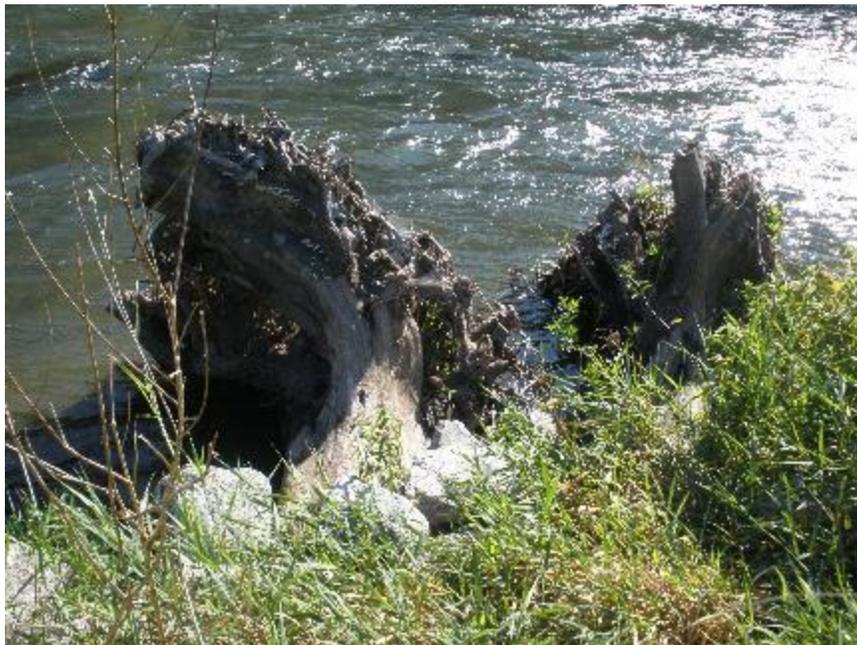
*Rootwad*

The following photograph is of rootwads on Spring Creek in Centre Country, Pennsylvania. Rootwads are oriented facing upstream to dissipate energy. These rootwad has undergone some damage from passing flows. While the rootwad-log vanes in Spring Creek were intended to be permanent, rootwads can also be installed independently of log vanes and degradation may be expected and intended.
